# Tent Mountain Pass

## Boundary Survey Phase 1

**Global Raymac Contact:** Luke Dixon, ALS  
**Contract:** 19OPP801  
**Job Number:** 18CS0125  
**Revision:** 2.0

October 31<sup>st</sup>, 2018

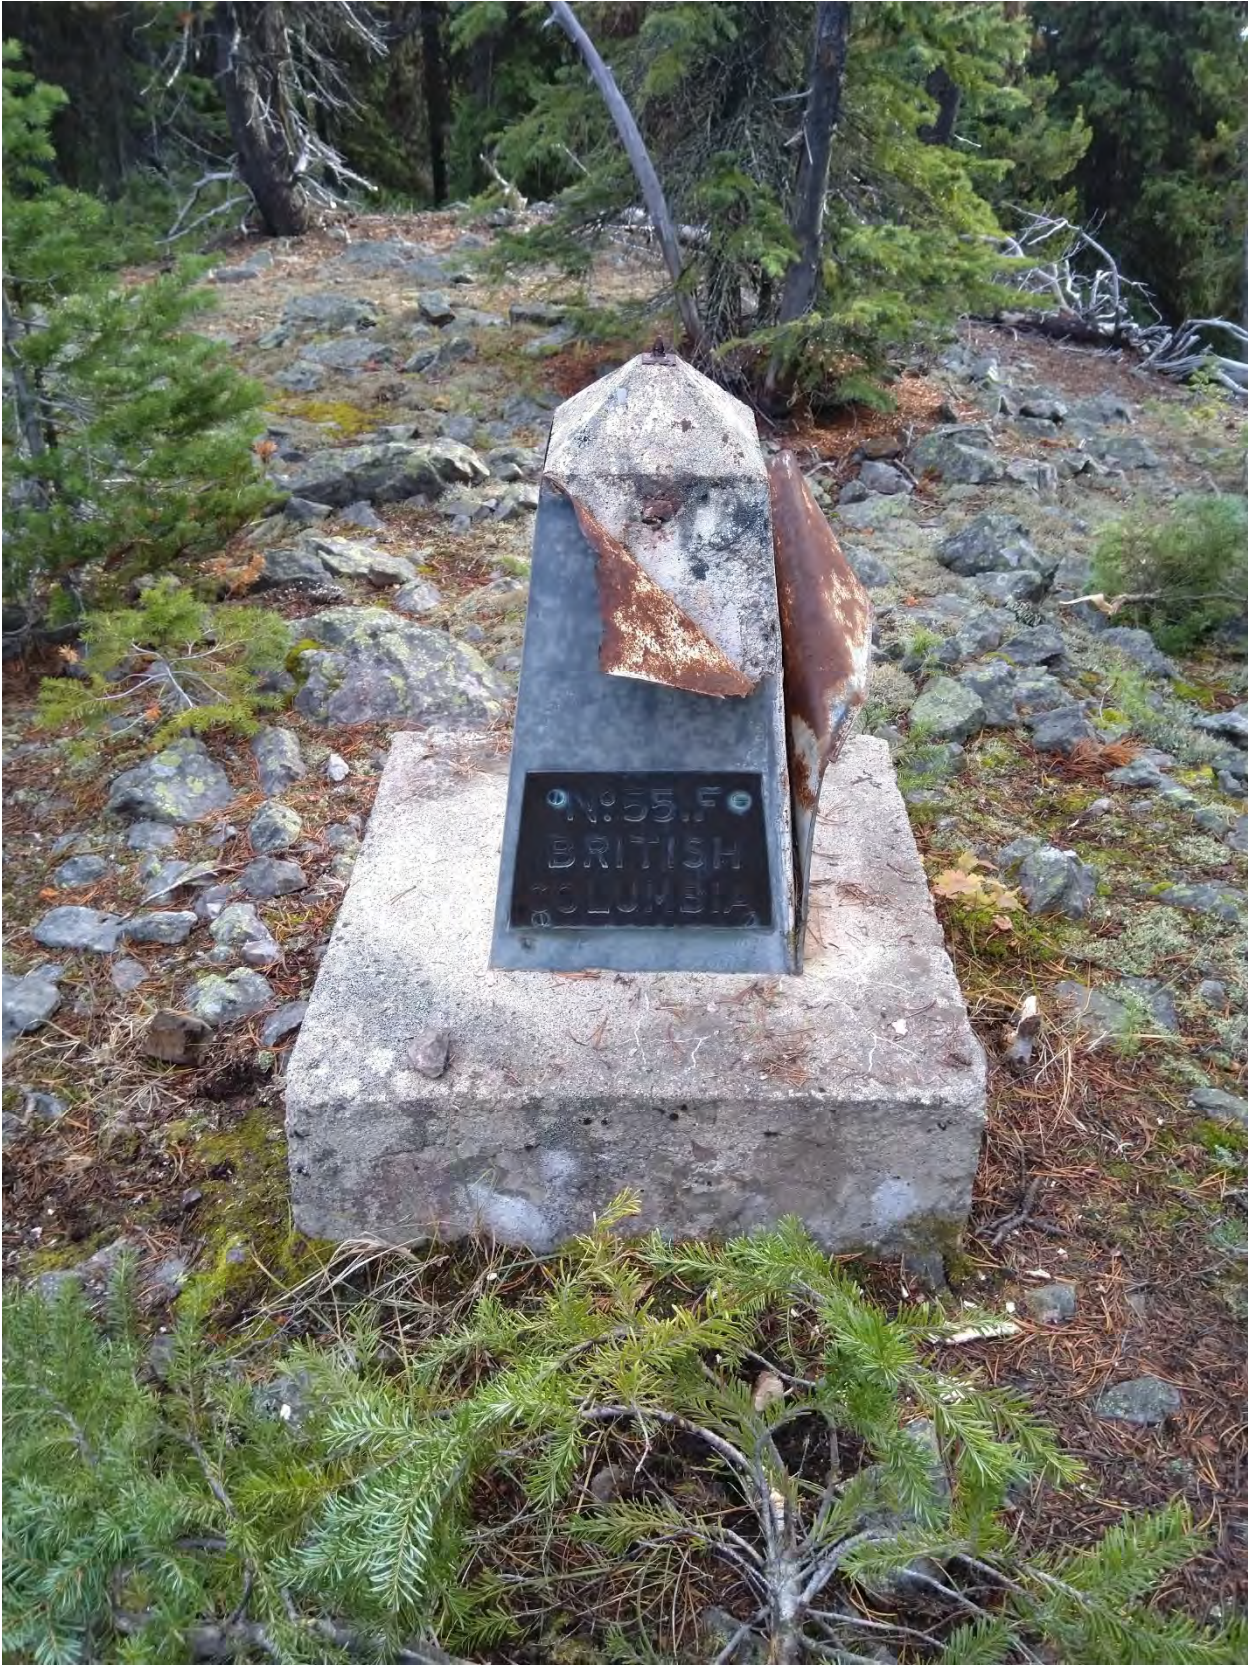
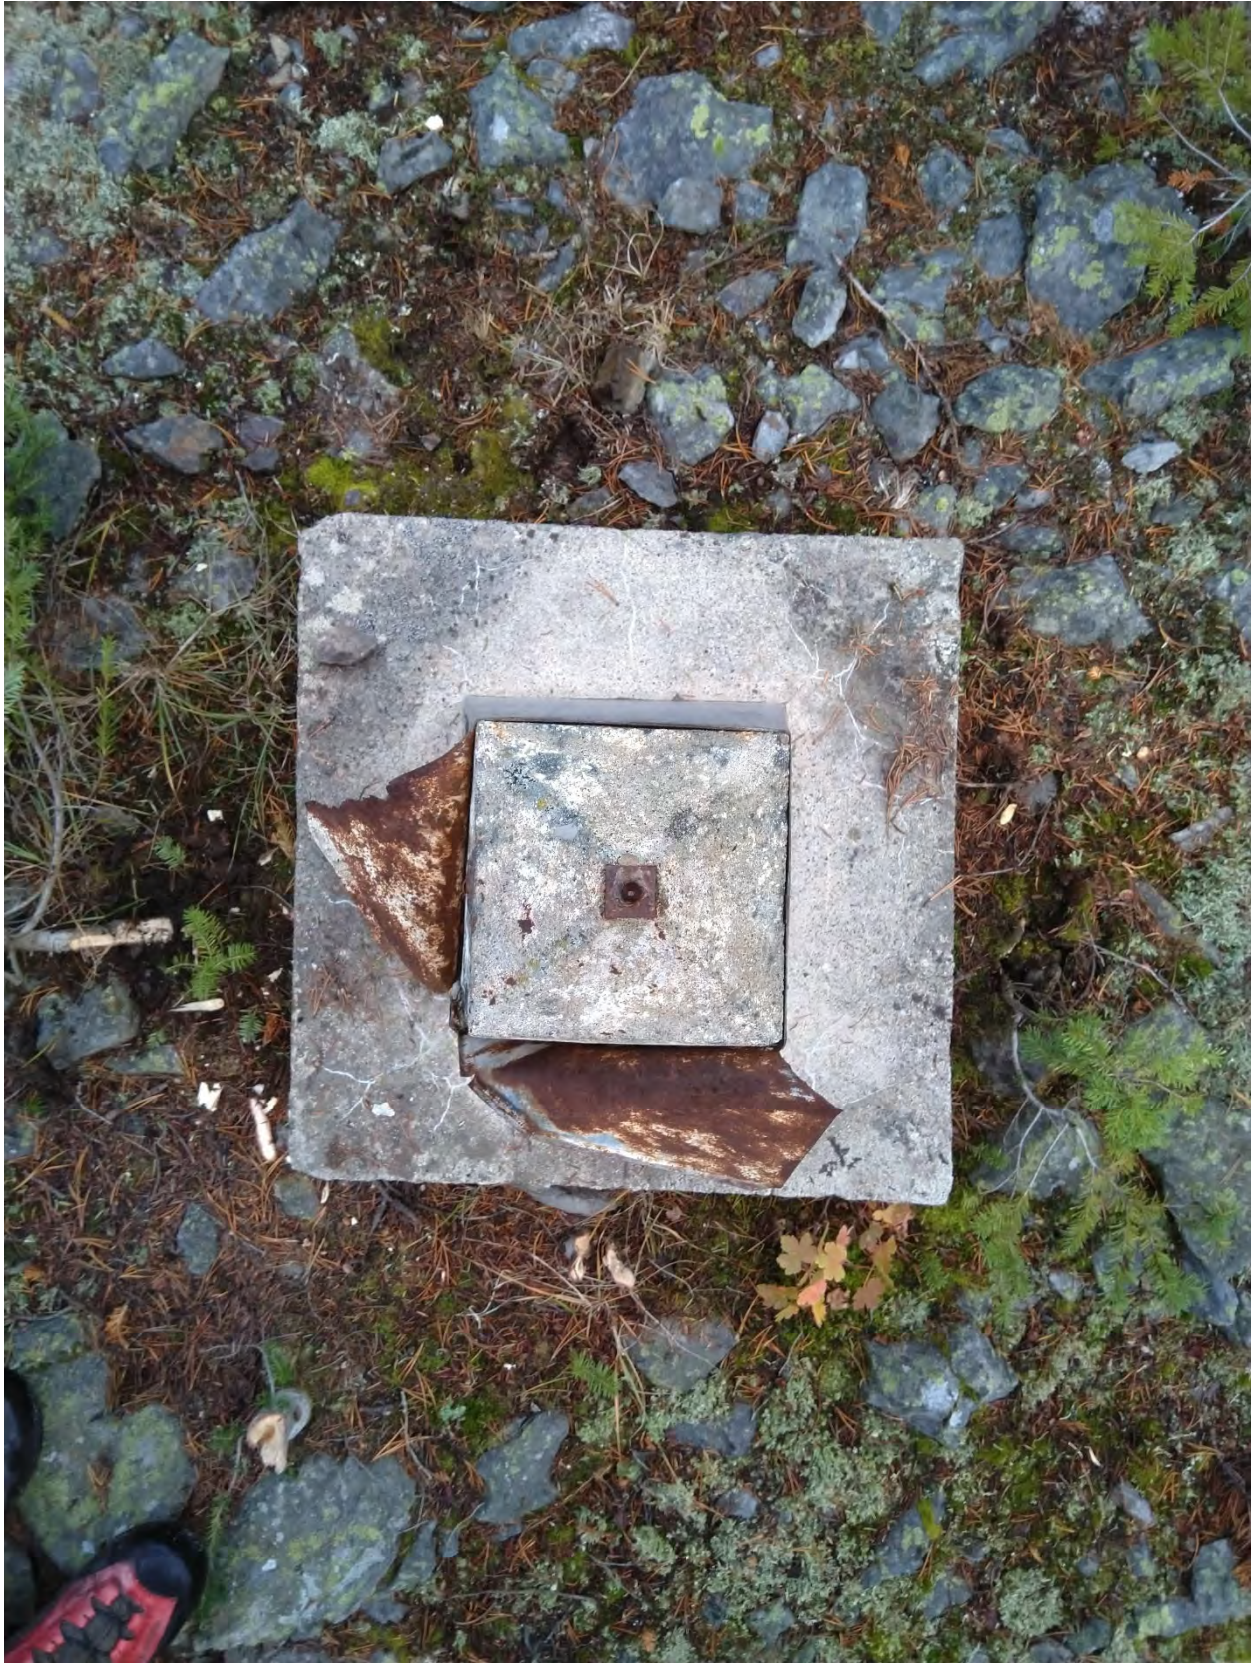
- Access Comments:** The monument was the first accessed on September 20<sup>th</sup>. The Ridge was gained approximately 200m south of the monument and then traversed north to the monument. There were some very tight forested areas on the ridge to hike through in order to access 55F.
- Position Comments:** The boundary position can be determined through the bolt in to the top of monument.
- Base Condition:** Likely the best base of all 13 monuments.
- Pillar Condition** Metal is peeling back.
- Plate Condition:** Both plates are attached to the monument.
- GPS Suitability:** Good sky view and suitable for GPS survey.

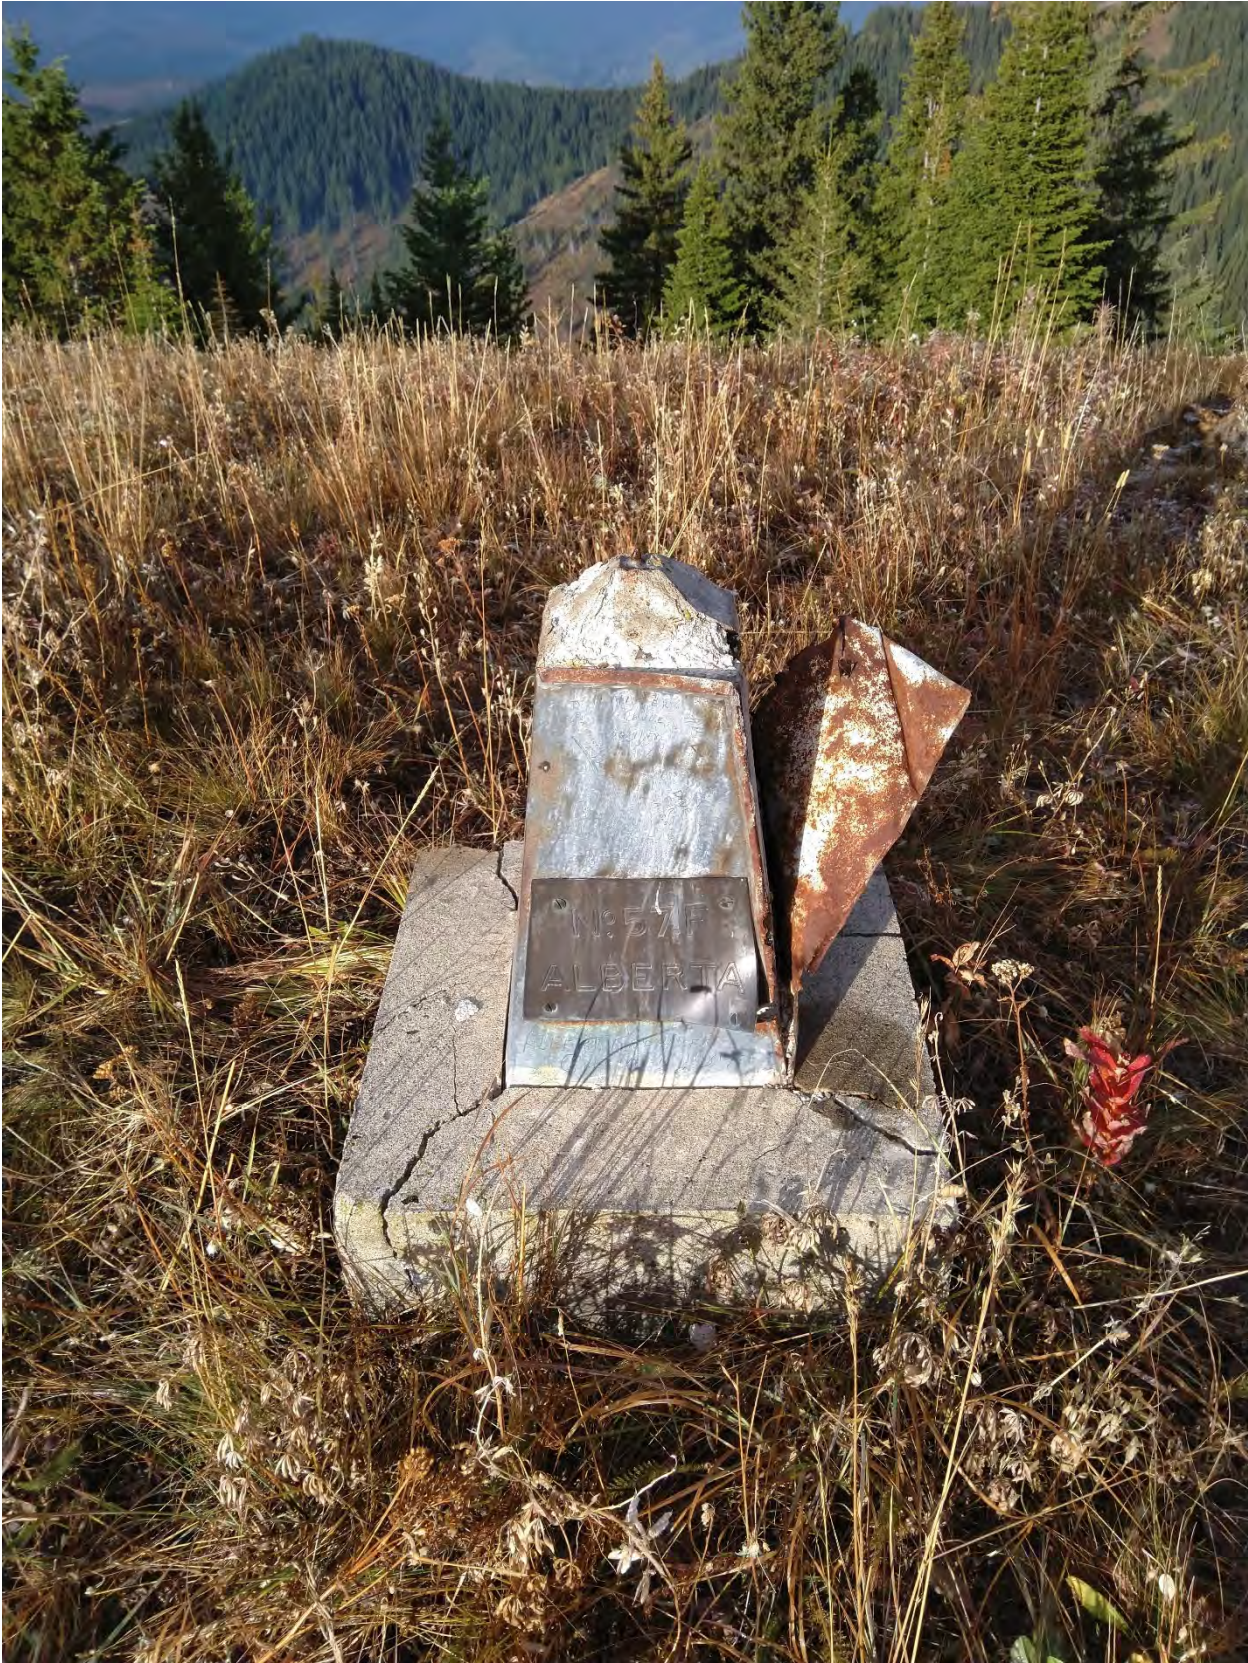
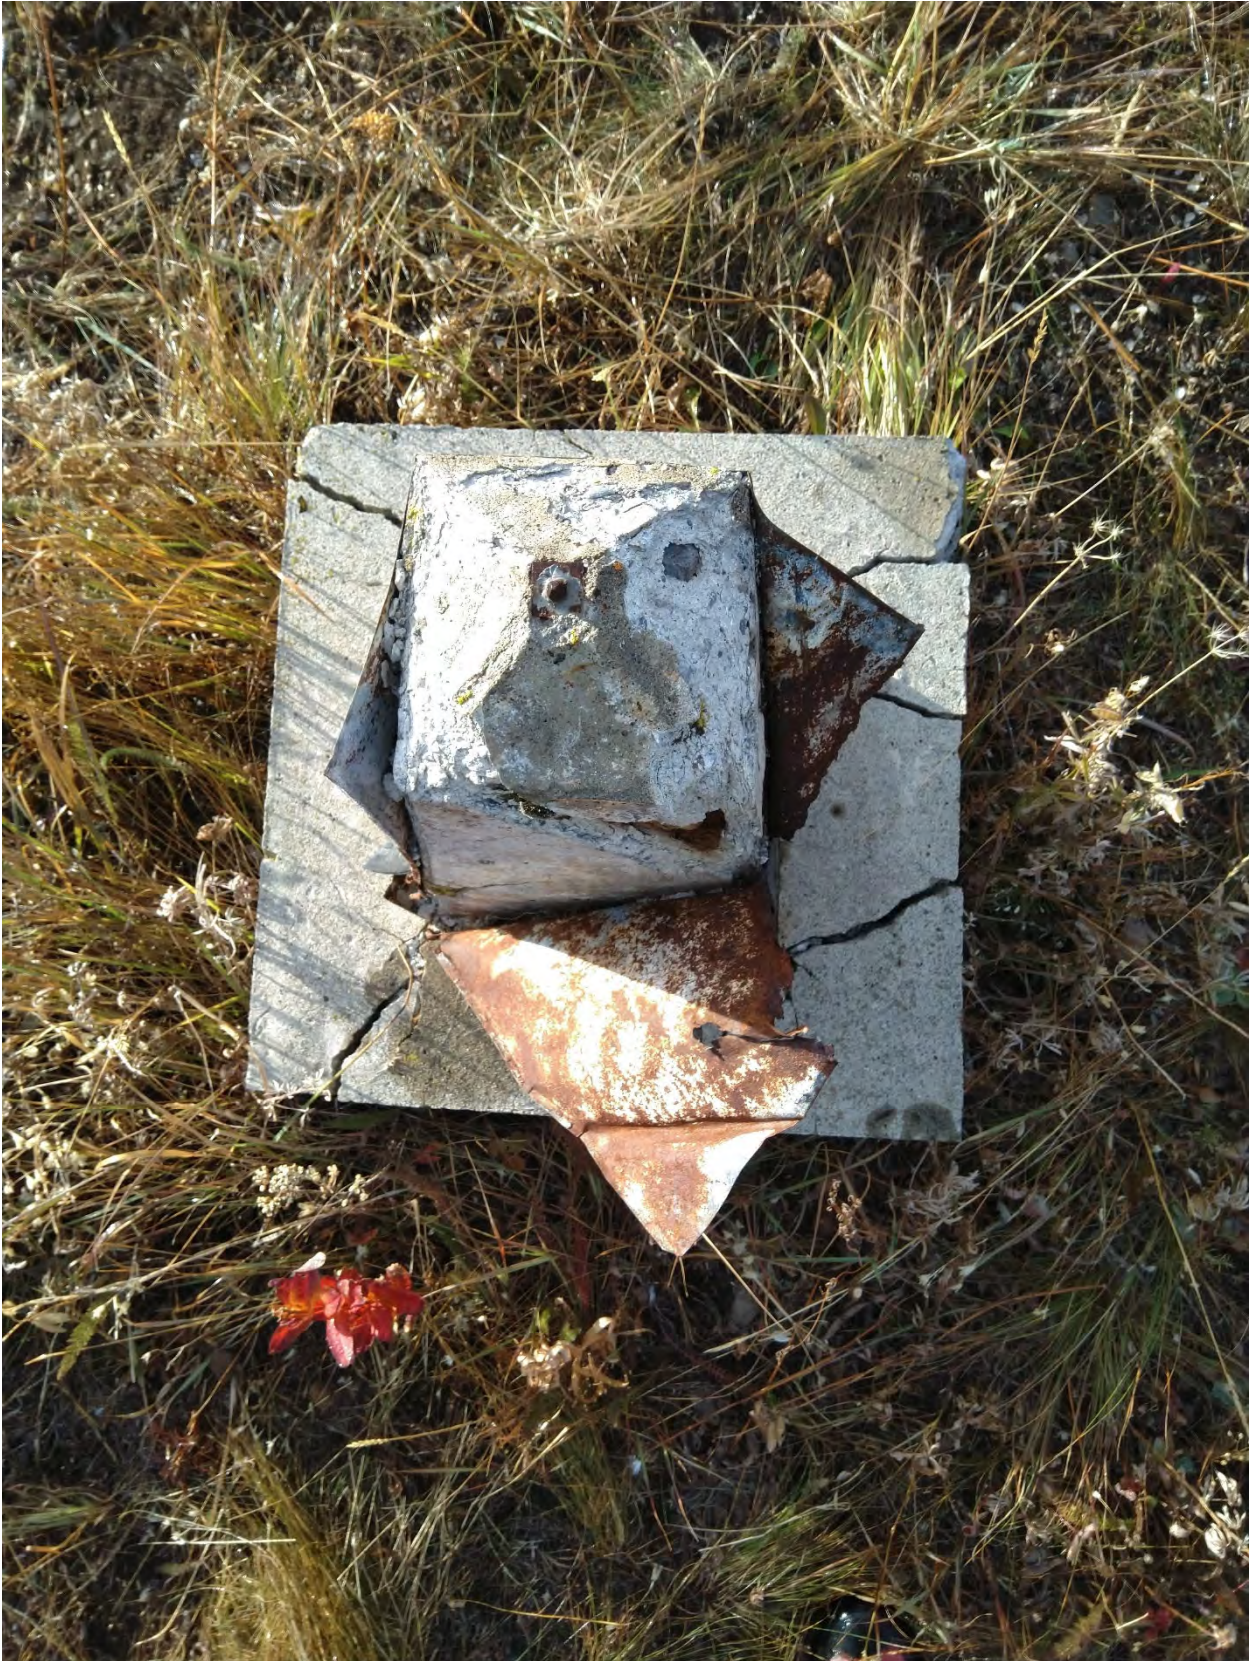
- Access Comments:** This monument was accessed by walking the ridge between 55F and 57F. The ridge is reasonably open between these two monuments and has some spectacular views.
- Position Comments:** The boundary position can be determined through the bolt on the top of monument.
- Base Condition:** The base of the monument is severely cracked.
- Pillar Condition:** Metal is peeling back.
- Plate Condition:** Both plates are attached to the monument.
- GPS Suitability:** Excellent sky view and suitable for GPS survey.

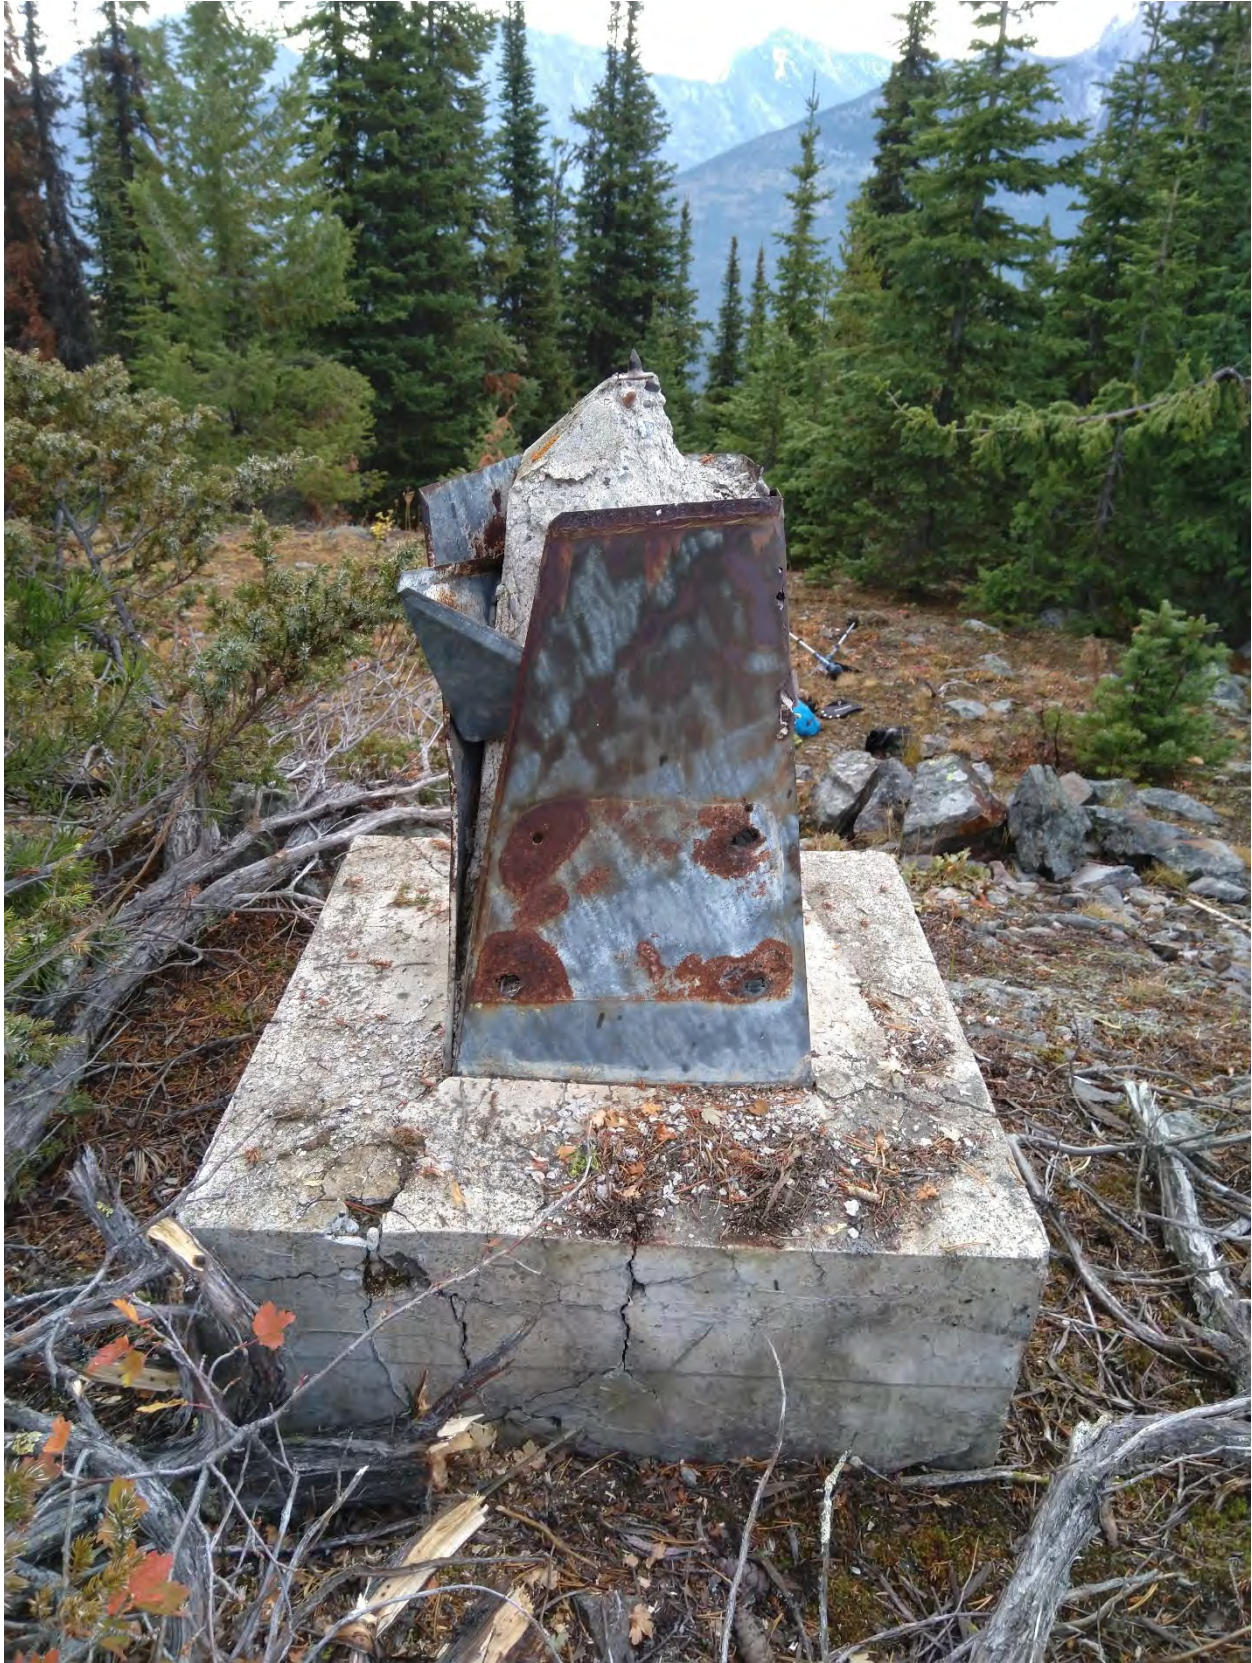
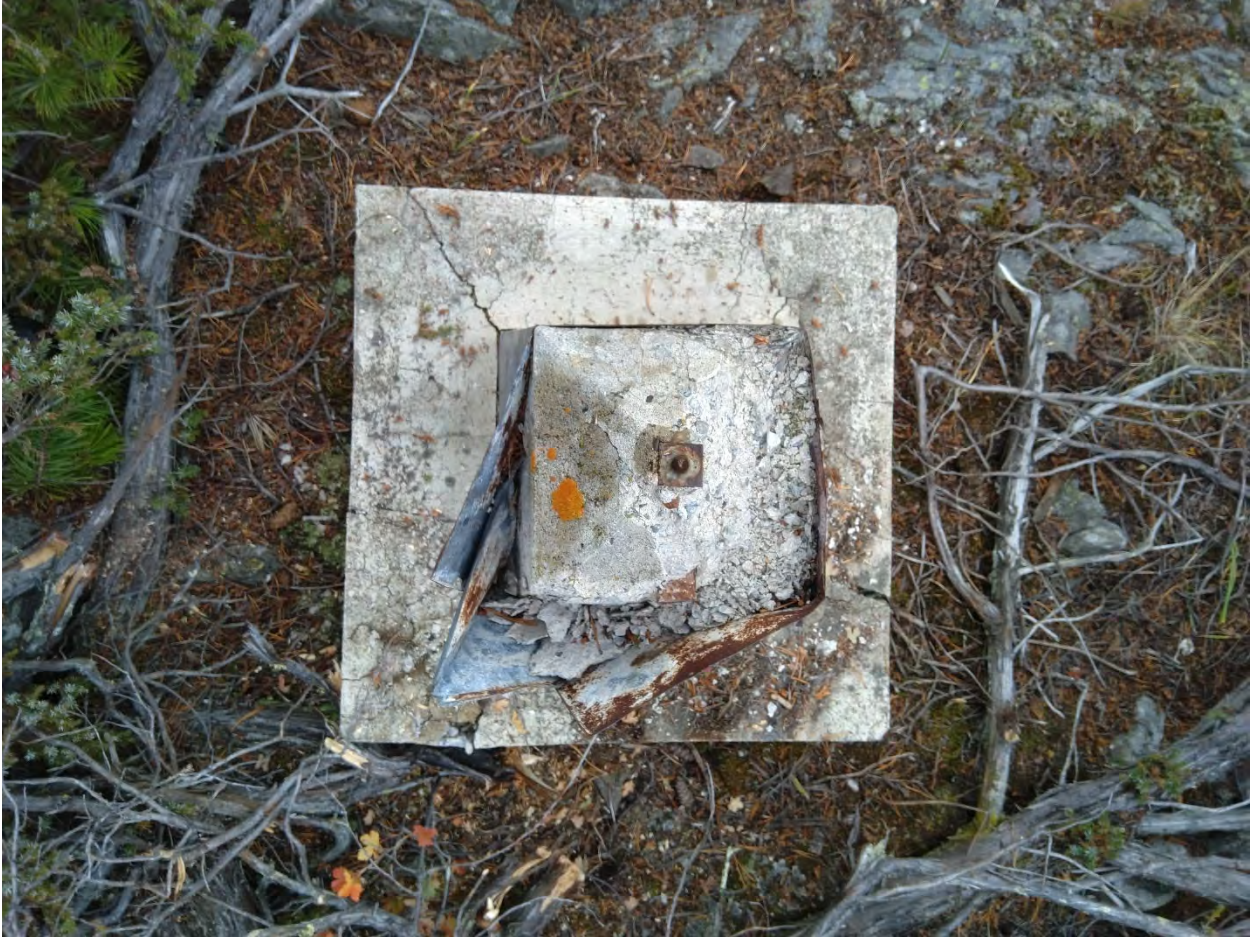
- Access Comments:** This monument was accessed by retracing steps from 55F past 57F and continuing to southward along the ridge. There are some tight trees between 57F and 59F; which opens up while hiking the final slope towards 59F. Some clearing of juniper bushes was required to ascertain the condition of the base.
- Position Comments:** The boundary position can be determined through the bolt on the top of monument.
- Base Comments:** The base of the monument is moderately cracked.
- Pillar Condition:** Metal is peeling back, and the concrete is crumbling.
- Plate Condition:** The British Columbia plate is missing from the monument.
- GPS Suitability:** Excellent sky view and suitable for GPS survey.

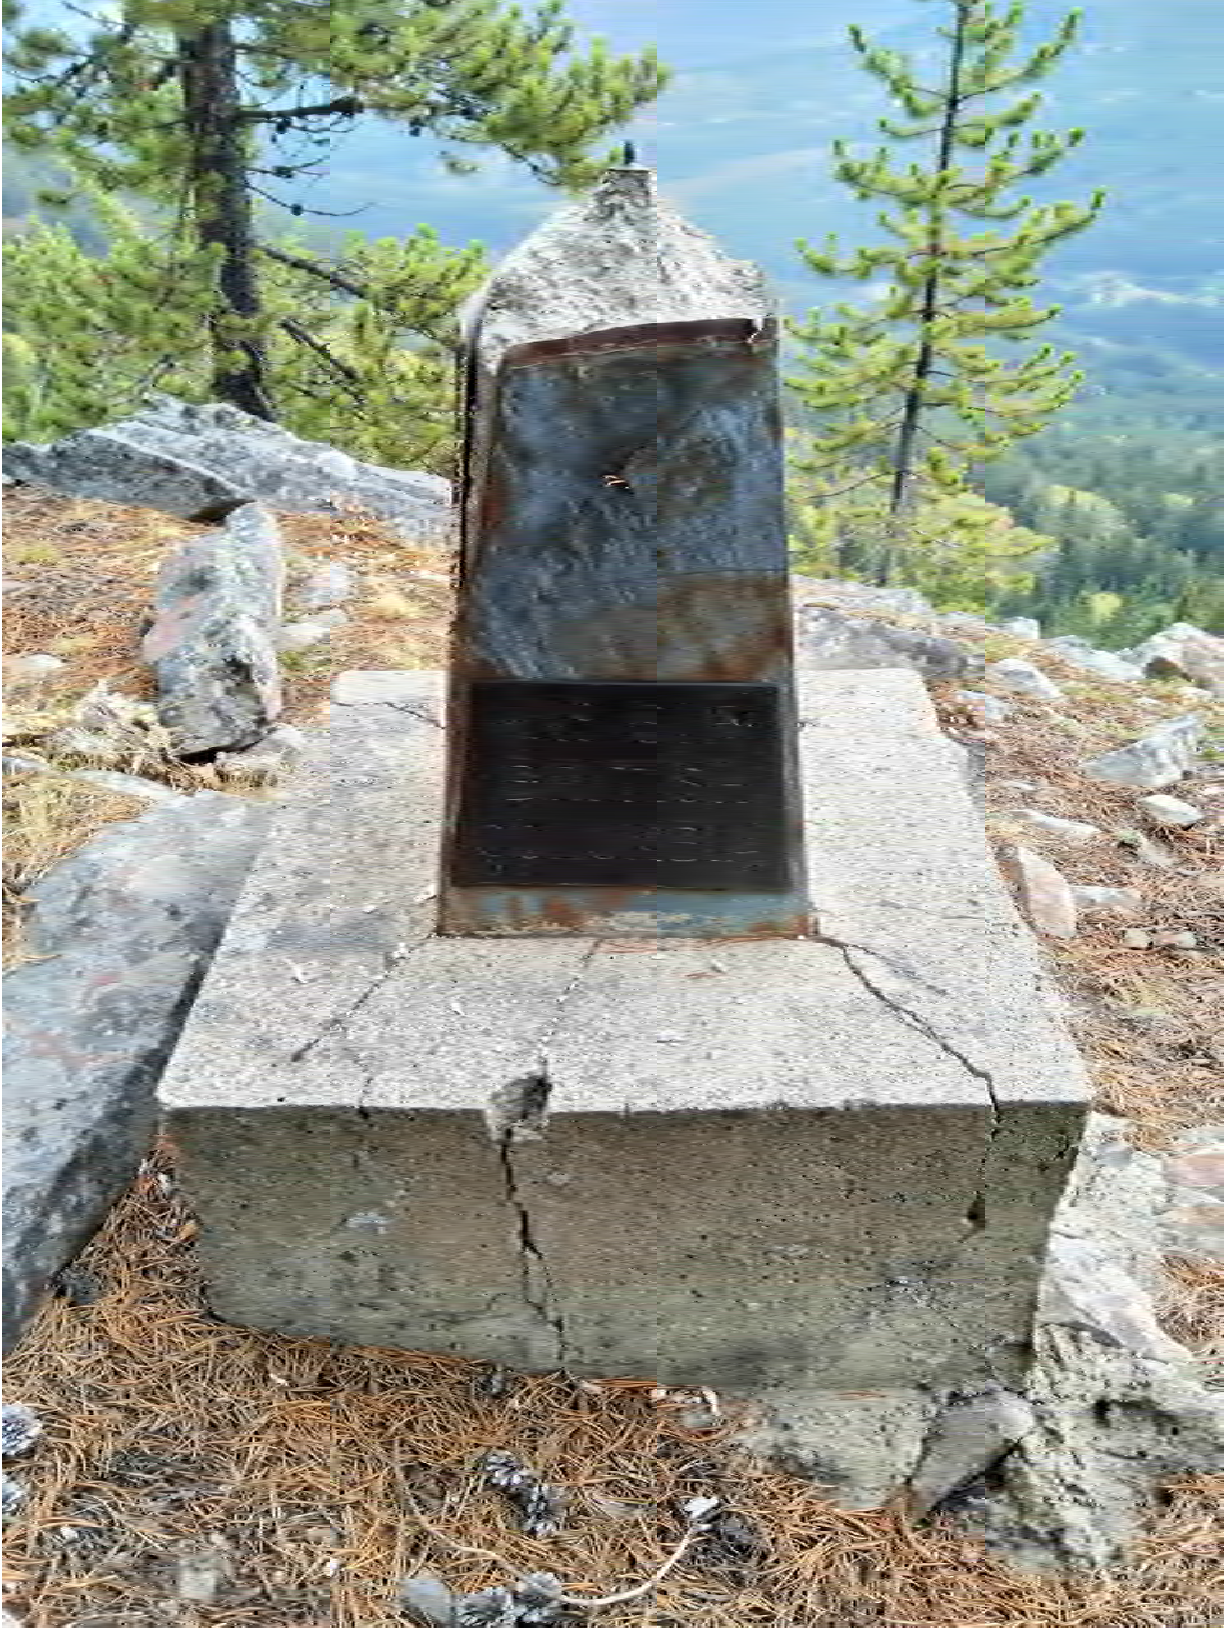
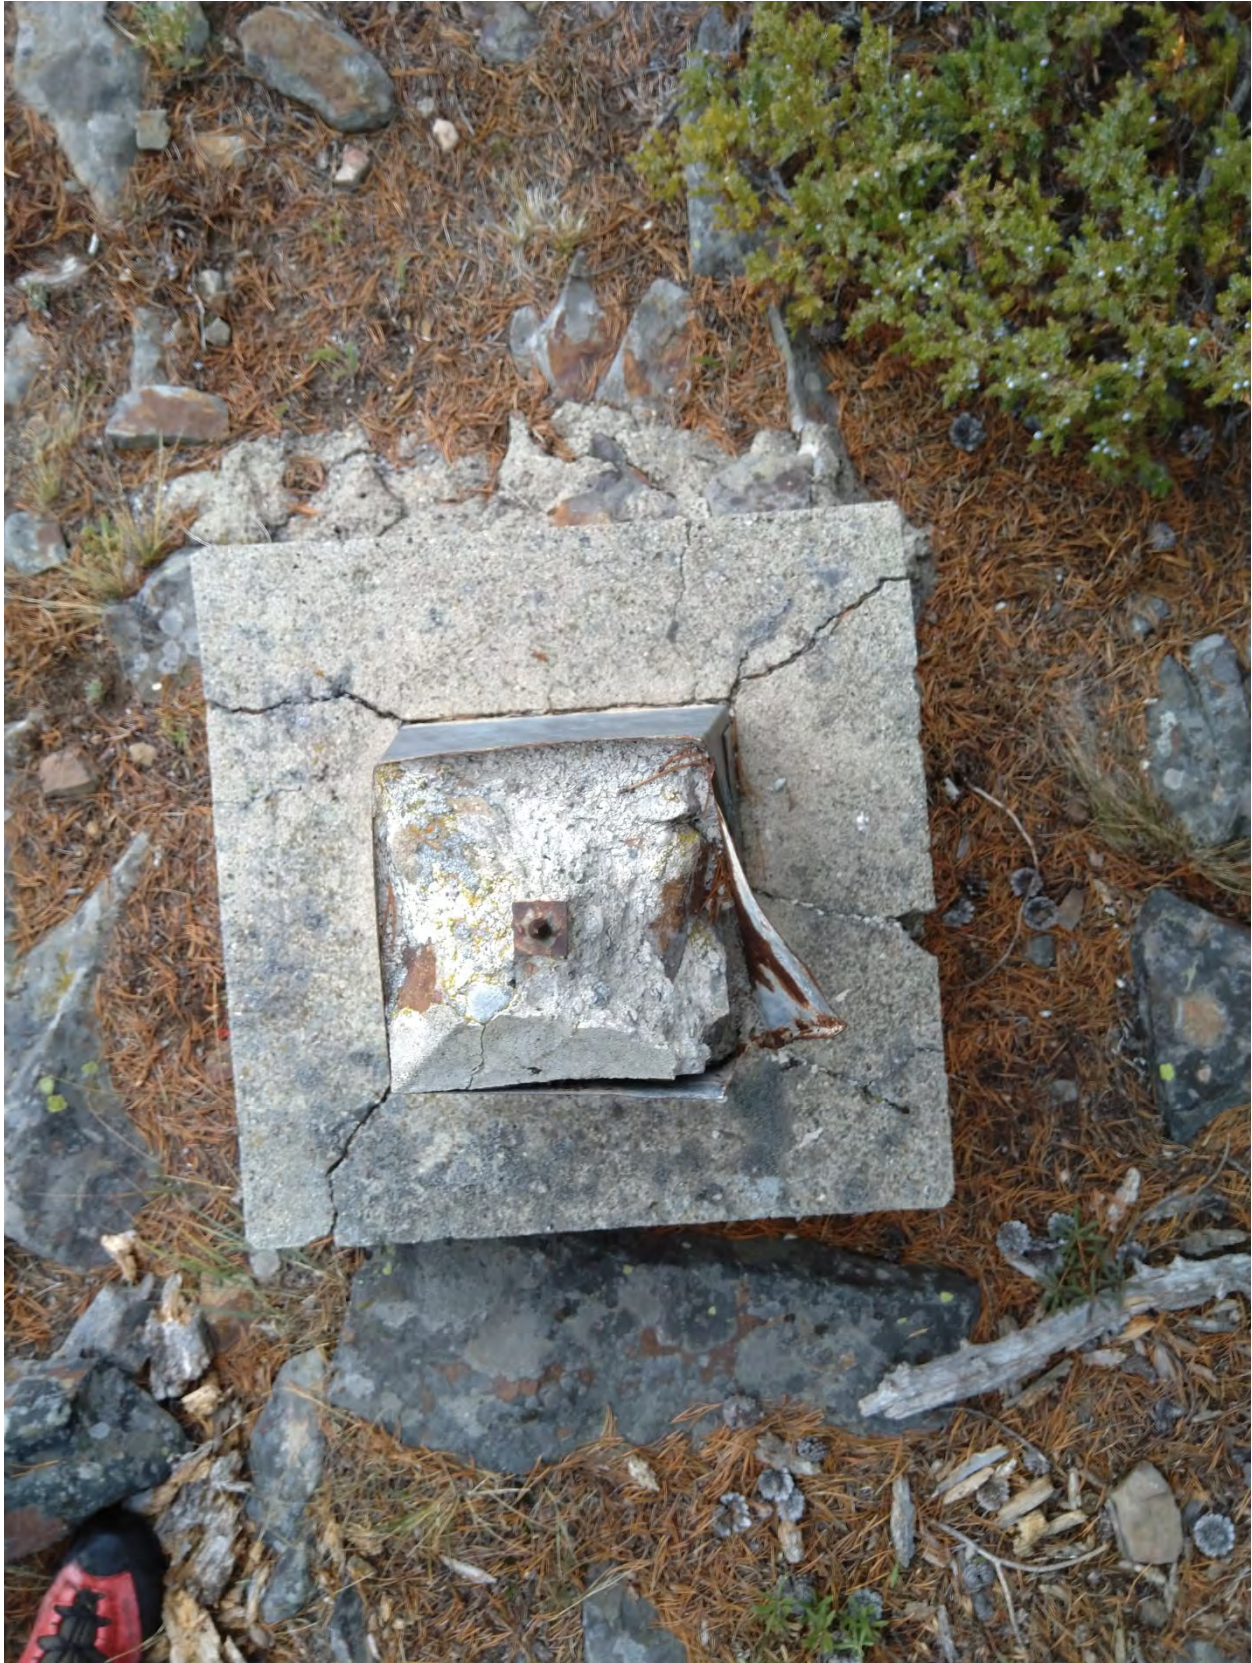
- Access Comments:** This monument was accessed by walking the ridge south from 59F. The ridge is reasonably open between these two monuments and has great views.
- Position Comments:** The boundary position can be determined through the bolt on the top of monument.
- Base Condition:** The base of the monument is moderately cracked.
- Pillar Condition:** Metal is peeling back.
- Plate Condition:** Both plates are attached to the monument.
- GPS Suitability:** Good sky view and suitable for GPS survey.

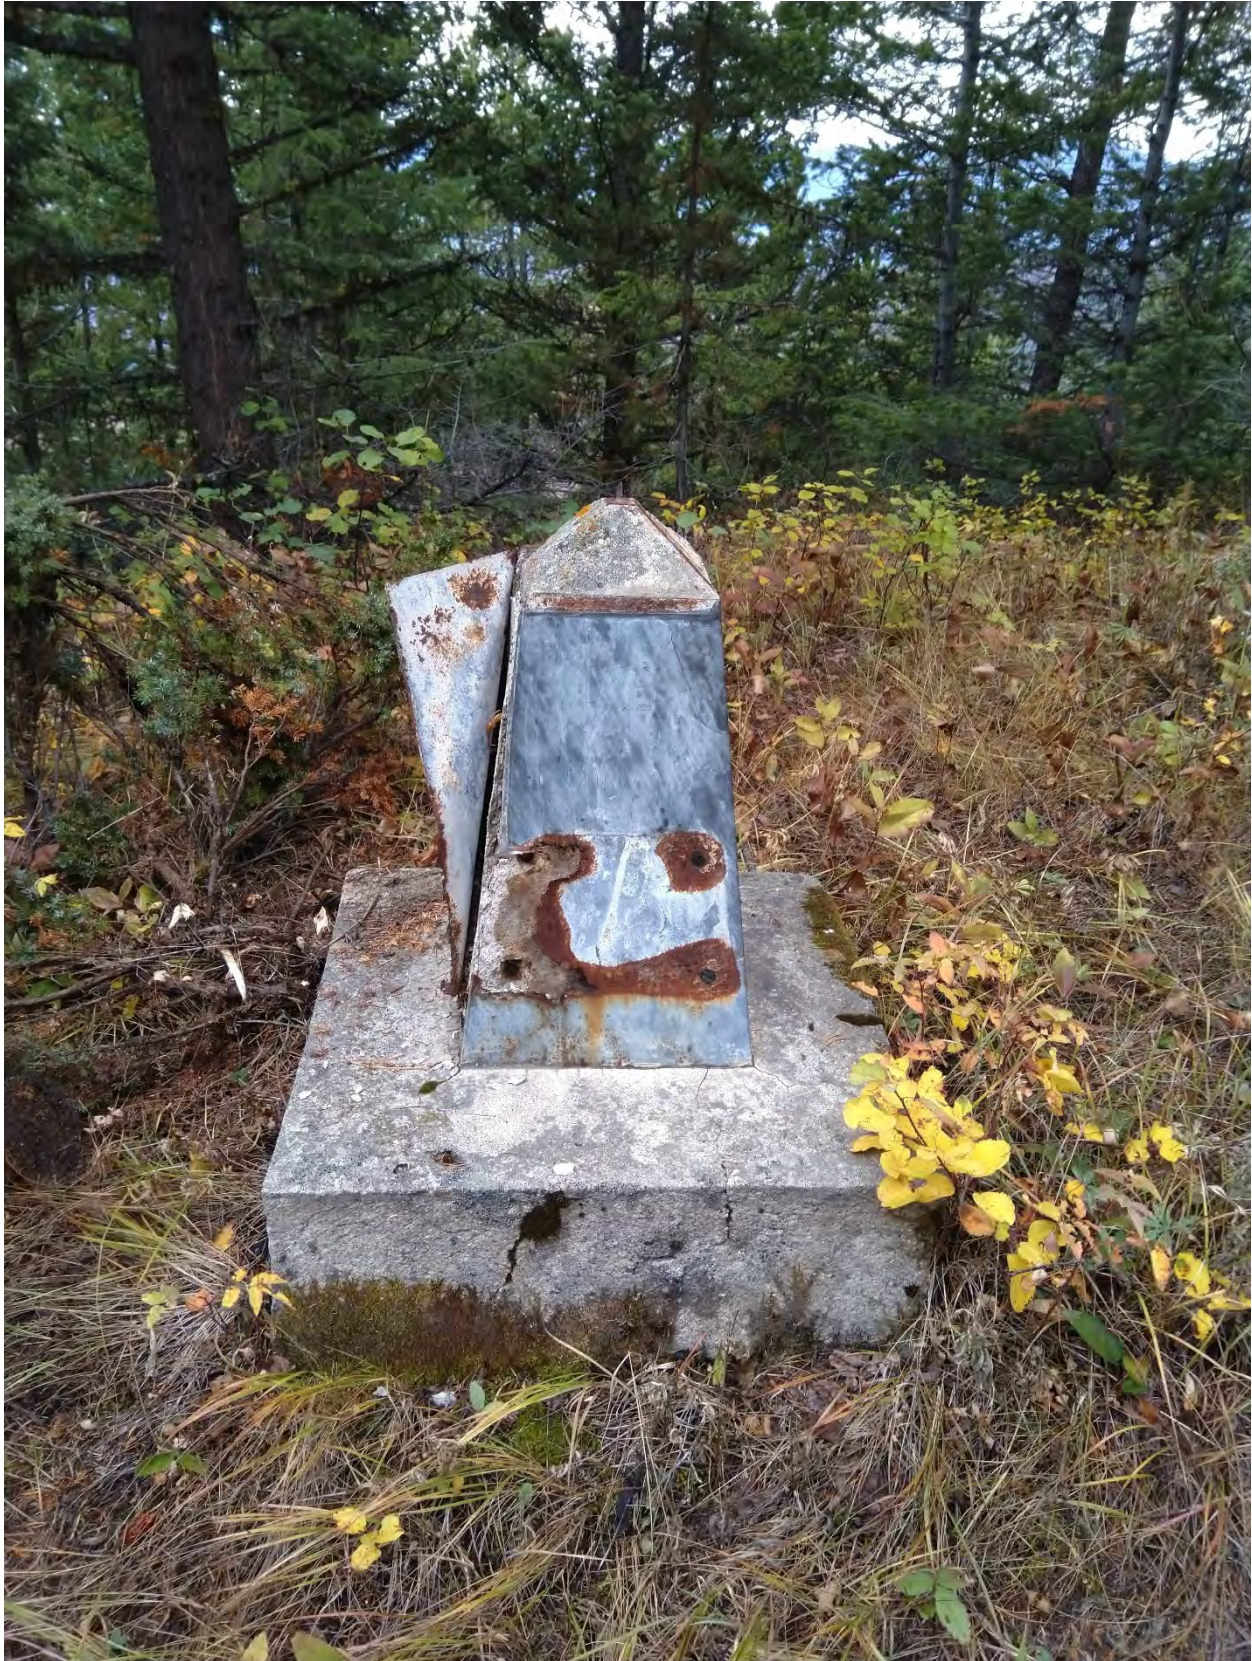
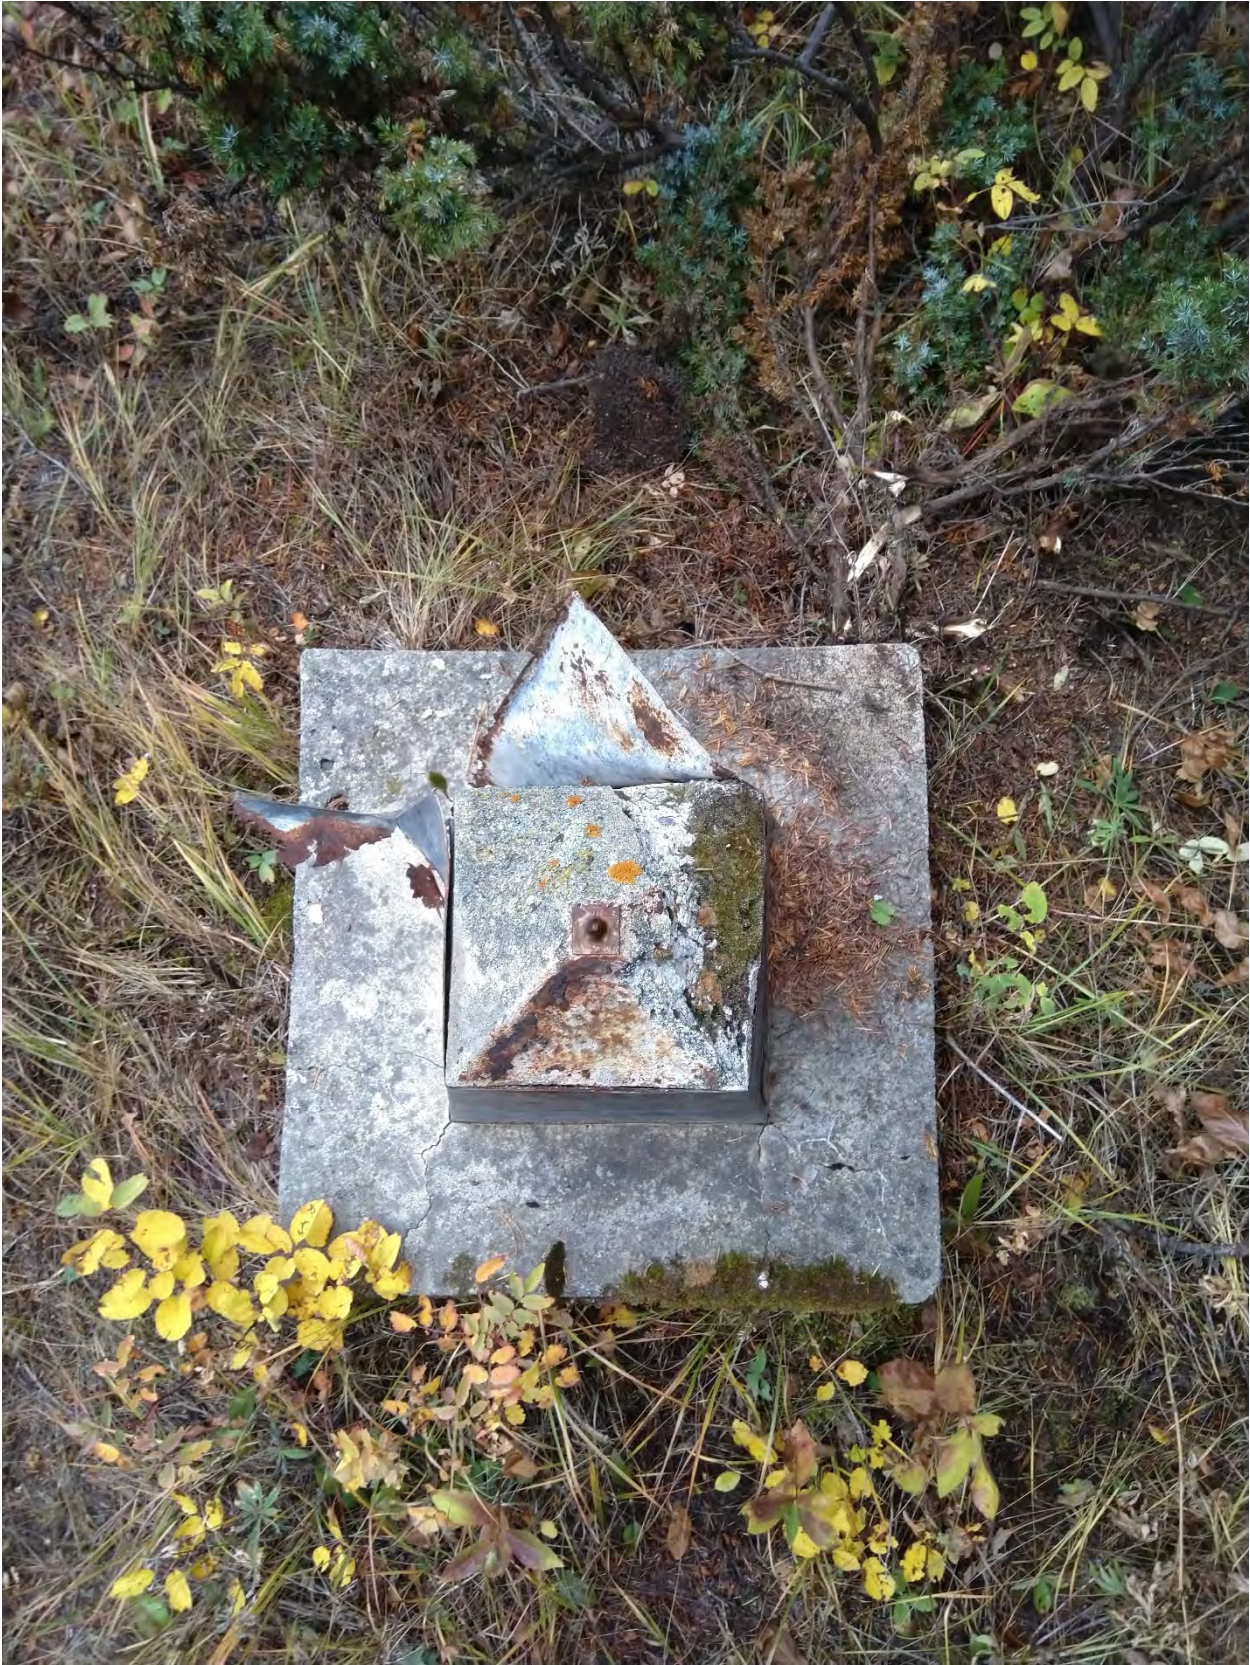
- Access Comments:** This monument was accessed by walking south from 61F. There the ridge drops in elevation noticeably between these two monuments.
- Position Comments:** The boundary position can be determined through the bolt on the top of monument.
- Base Condition:** The base of the monument is in quite good condition
- Pillar Condition:** Metal is peeling back.
- Plate Condition:** Alberta side plate is missing from the monument.
- GPS Suitability:** Reasonable sky view and suitable for GPS survey.
