# Tent Mountain Pass

## Boundary Survey Phase 1

**Global Raymac Contact:** Luke Dixon, ALS  
**Contract:** 19OPP801  
**Job Number:** 18CS0125  
**Revision:** 2.0

October 31<sup>st</sup>, 2018

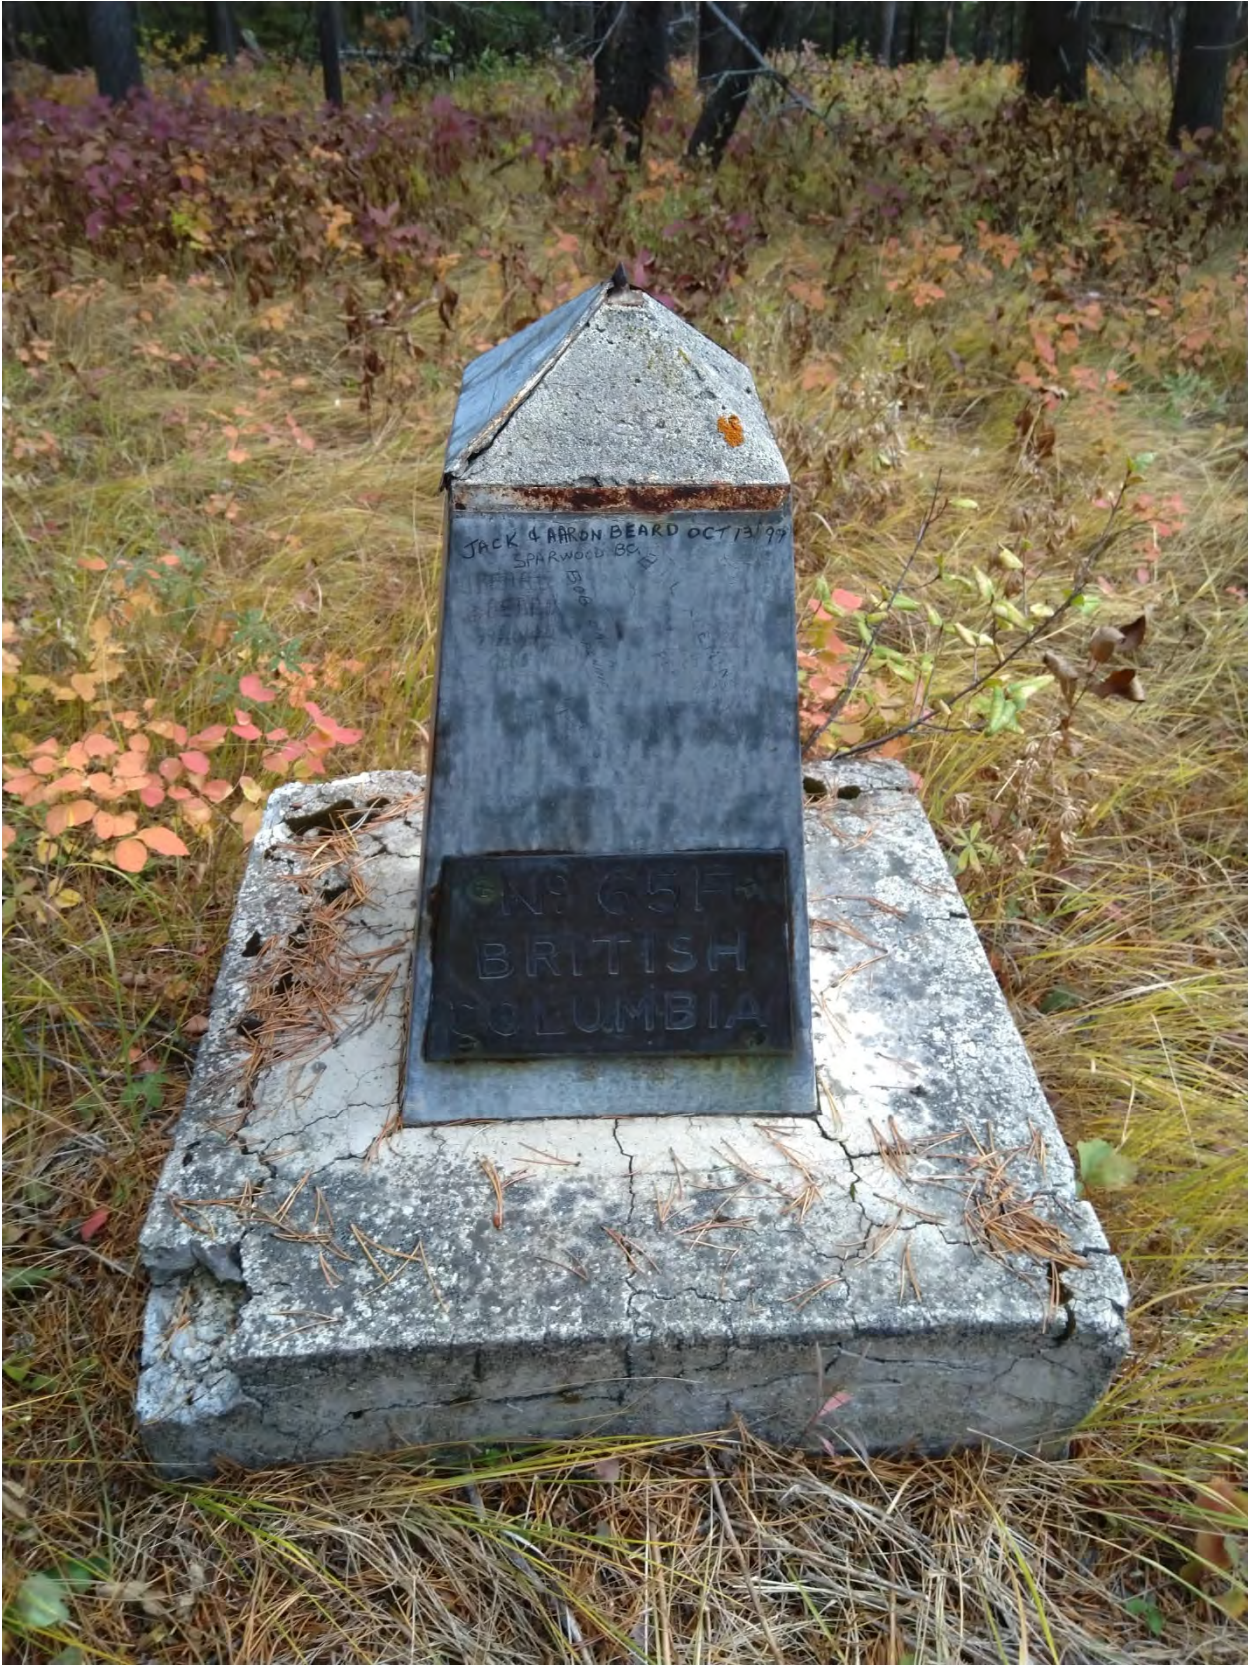
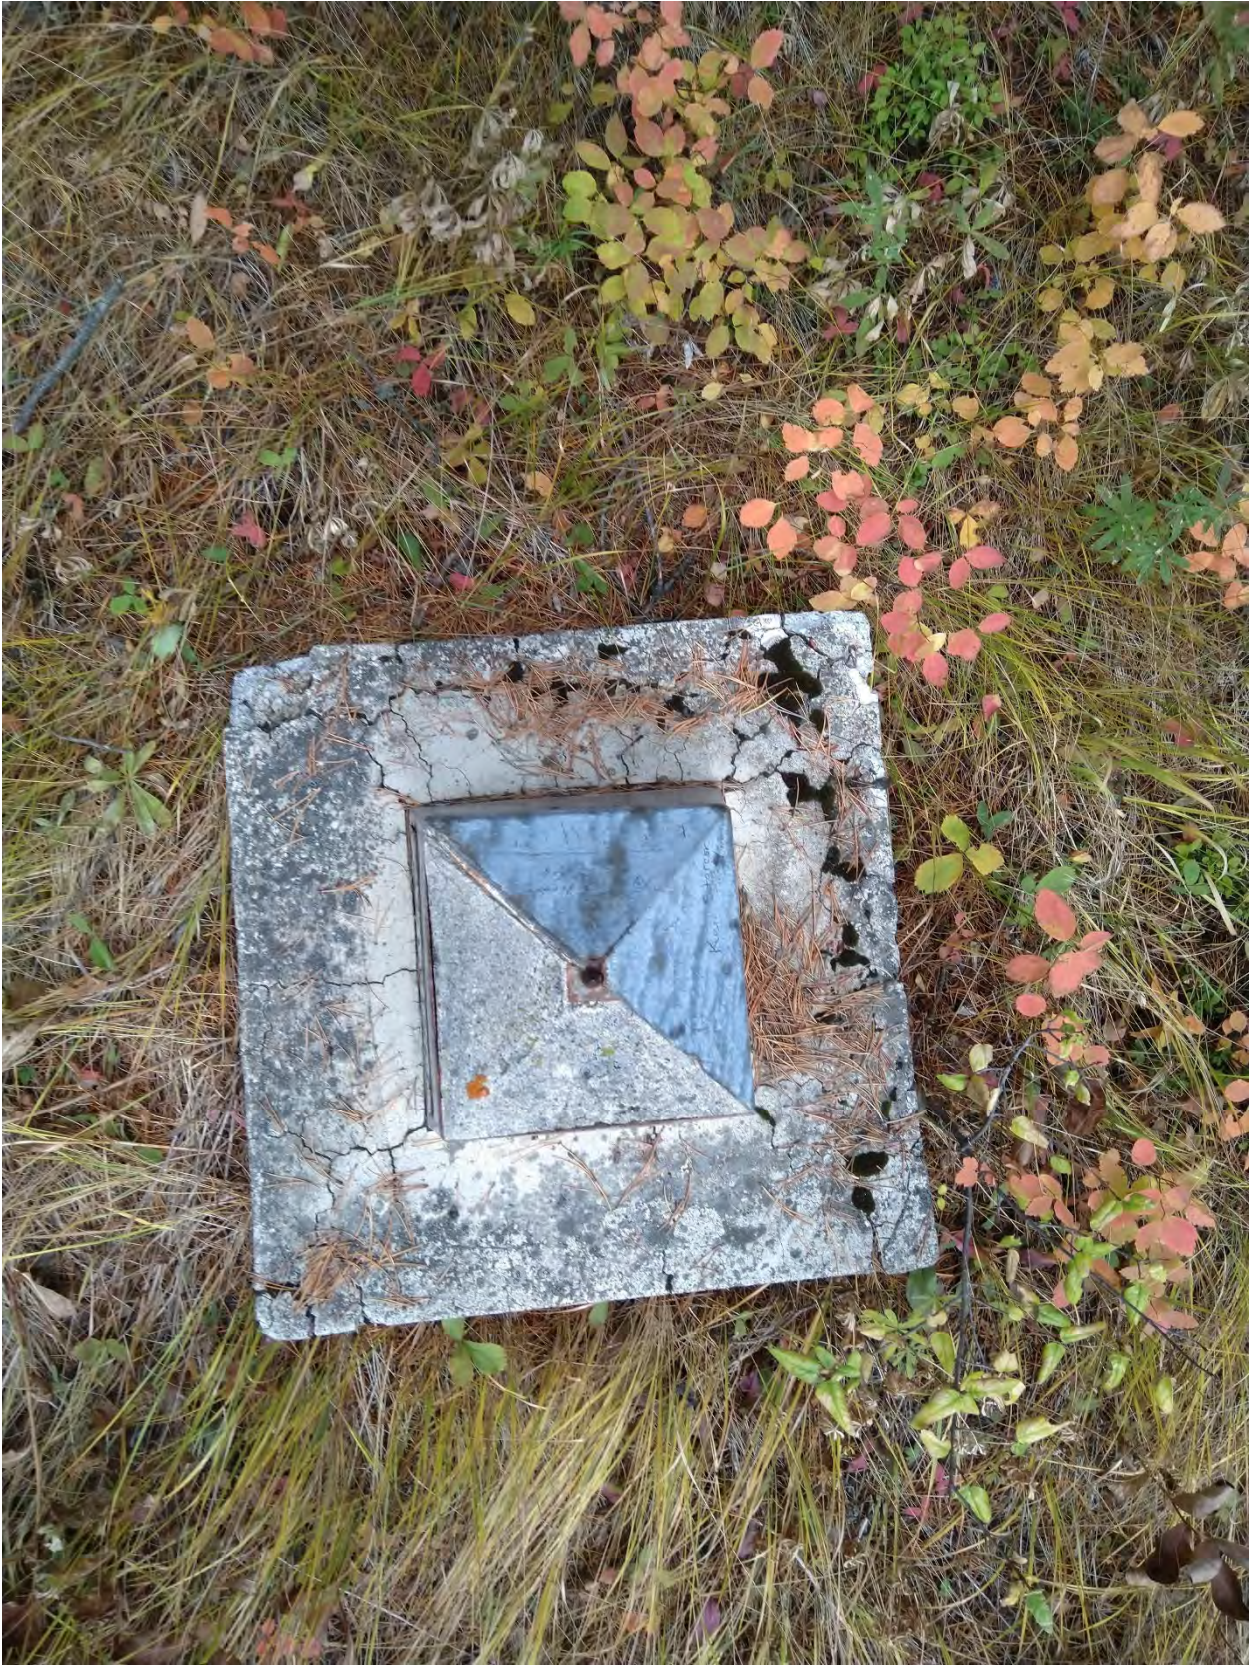
- Position Comments:** The boundary position can be determined through the bolt on the top of monument.
- Base Condition:** The base of the monument is cracked.

- Pillar Condition:** This monument had the most intact metal cladding with only a couple pieces of the top missing. This gives some indication of the decomposition process. One would expect with the top pieces now missing that water combined with freeze thaw will continue to deteriorate the pillar

- Plate Condition:** Both plates are attached to the monument.
- GPS Suitability:** Mediocre sky view. We had difficulty obtaining a GPS fix and resulting positional quality is mediocre. The removal of a handful of trees to 20cm would result in excellent ability sky view for GPS survey.

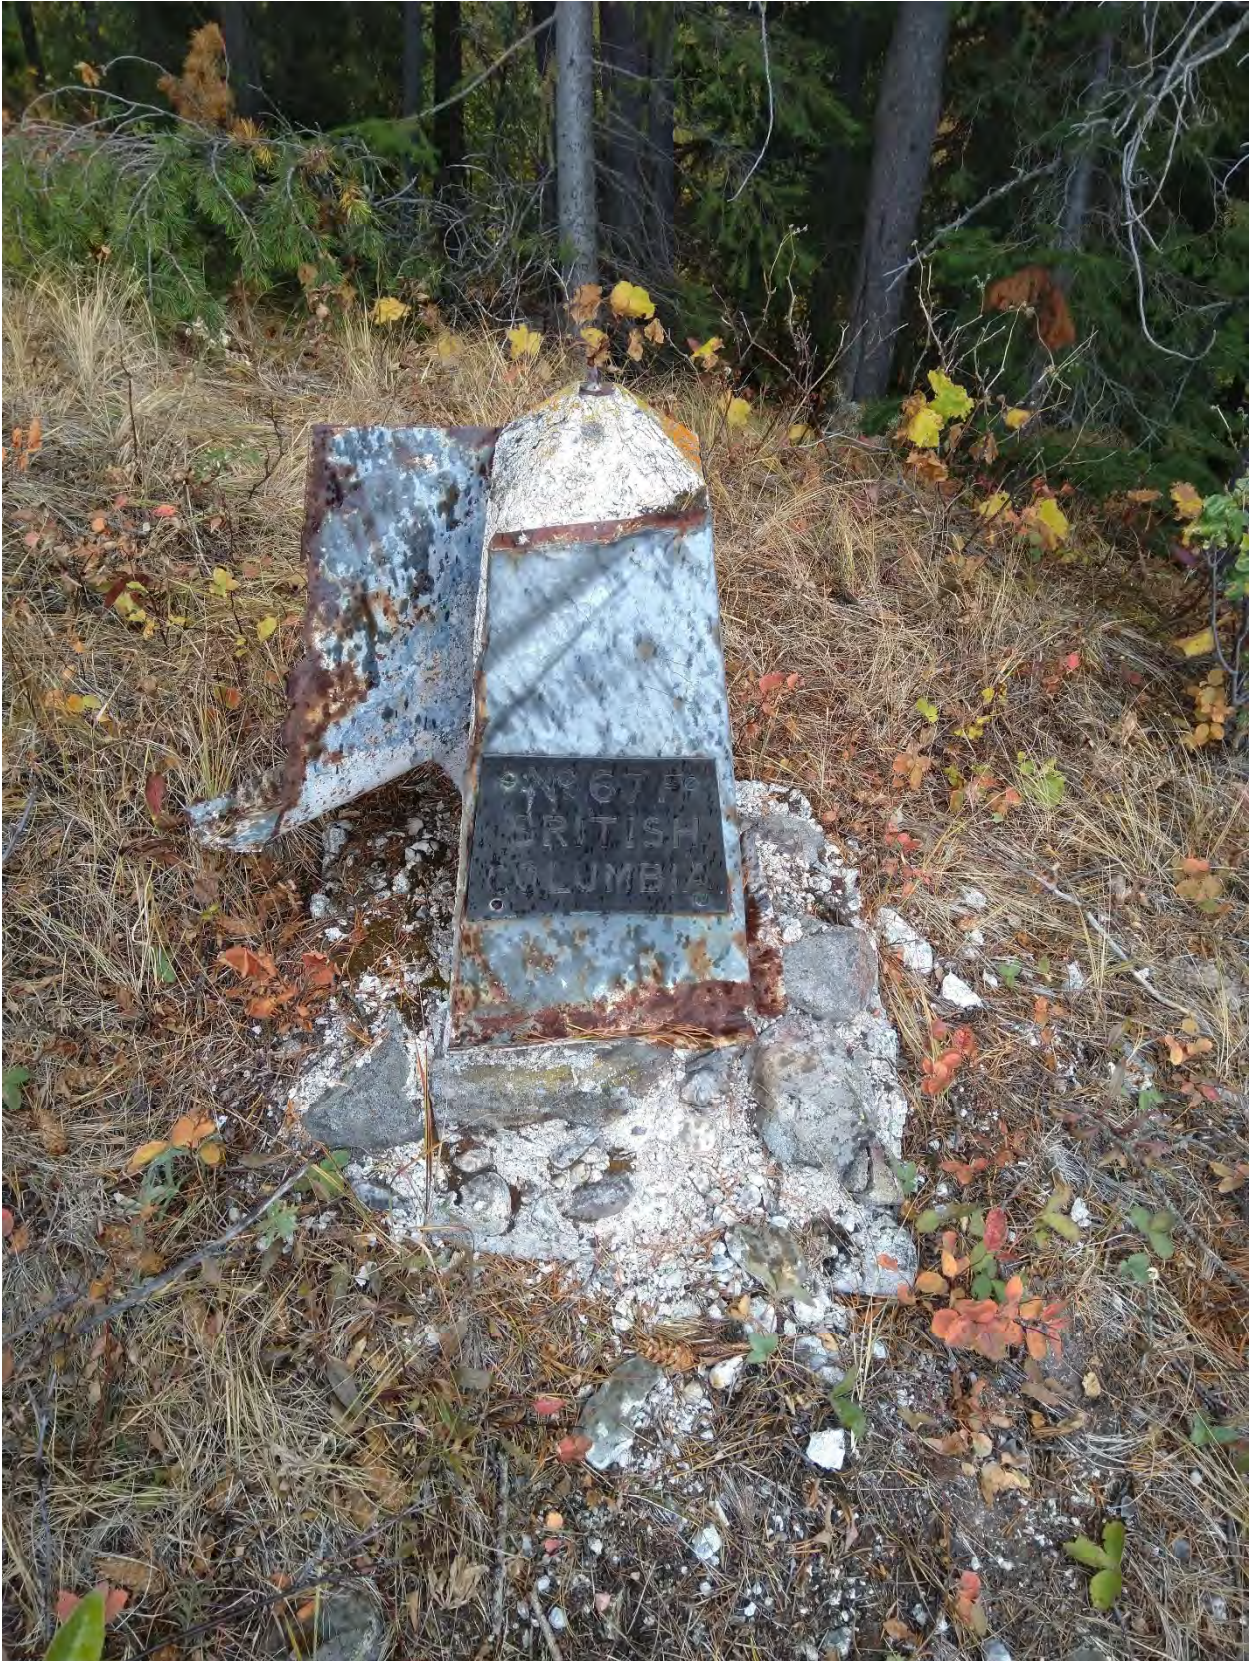
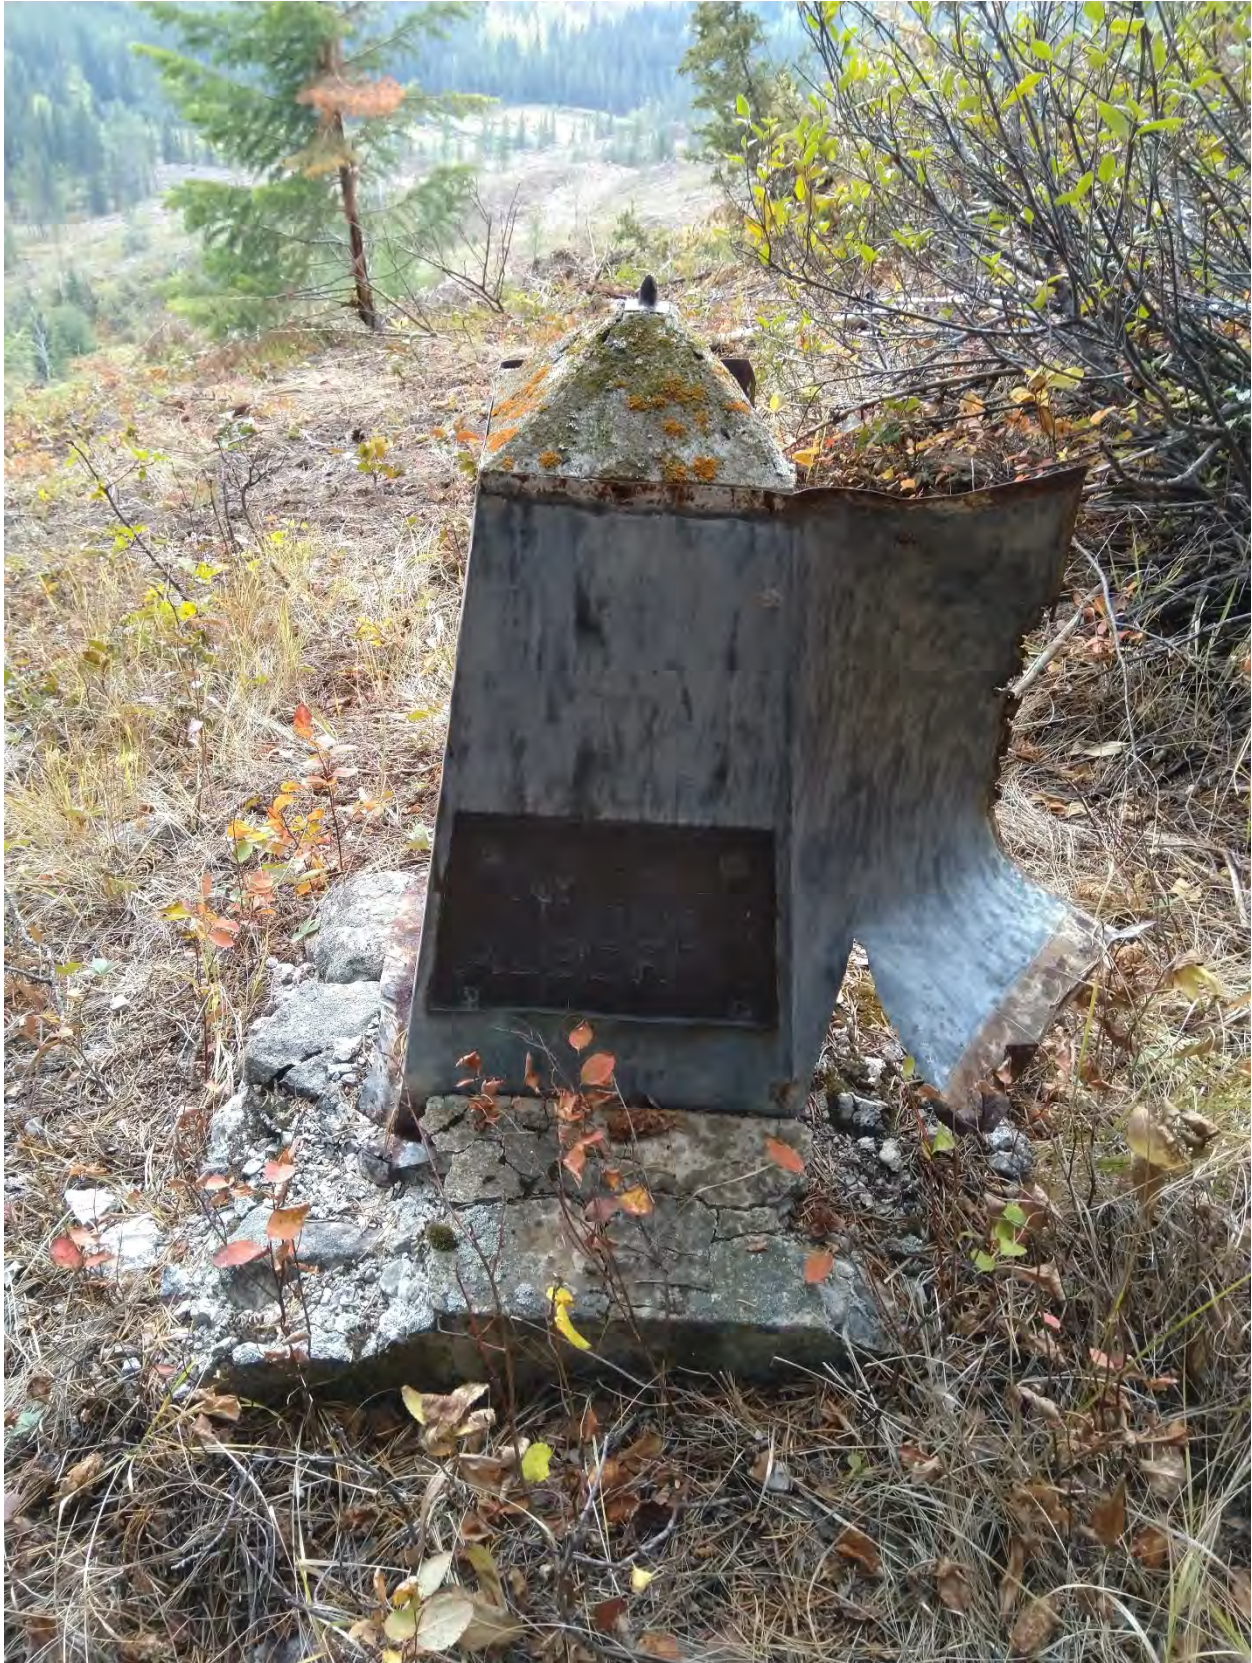
- Access Comments:** This monument was accessed by walking downhill due east from 65F. Partway towards 67F it became evident that the intention of 2017 logging was to log up to the AB-BC boundary between 65F and 71F.
- Position Comments:** The boundary position can be determined through the bolt on the top of monument.
- Base Condition:** The base of the monument is severely decayed.
- Pillar Condition:** Metal is severely peeling back.
- Plate Condition:** Both plates are attached to the pillar.
- GPS Suitability:** The logging activities have created clear views to south and west. However, the remaining trees create mediocre GPS conditions. The removal of 4 large 30-40cm diameter trees would allow for a GPS survey of 67F. Conversely, temporary points can be established in the cut-block and 67F surveyed from those points.

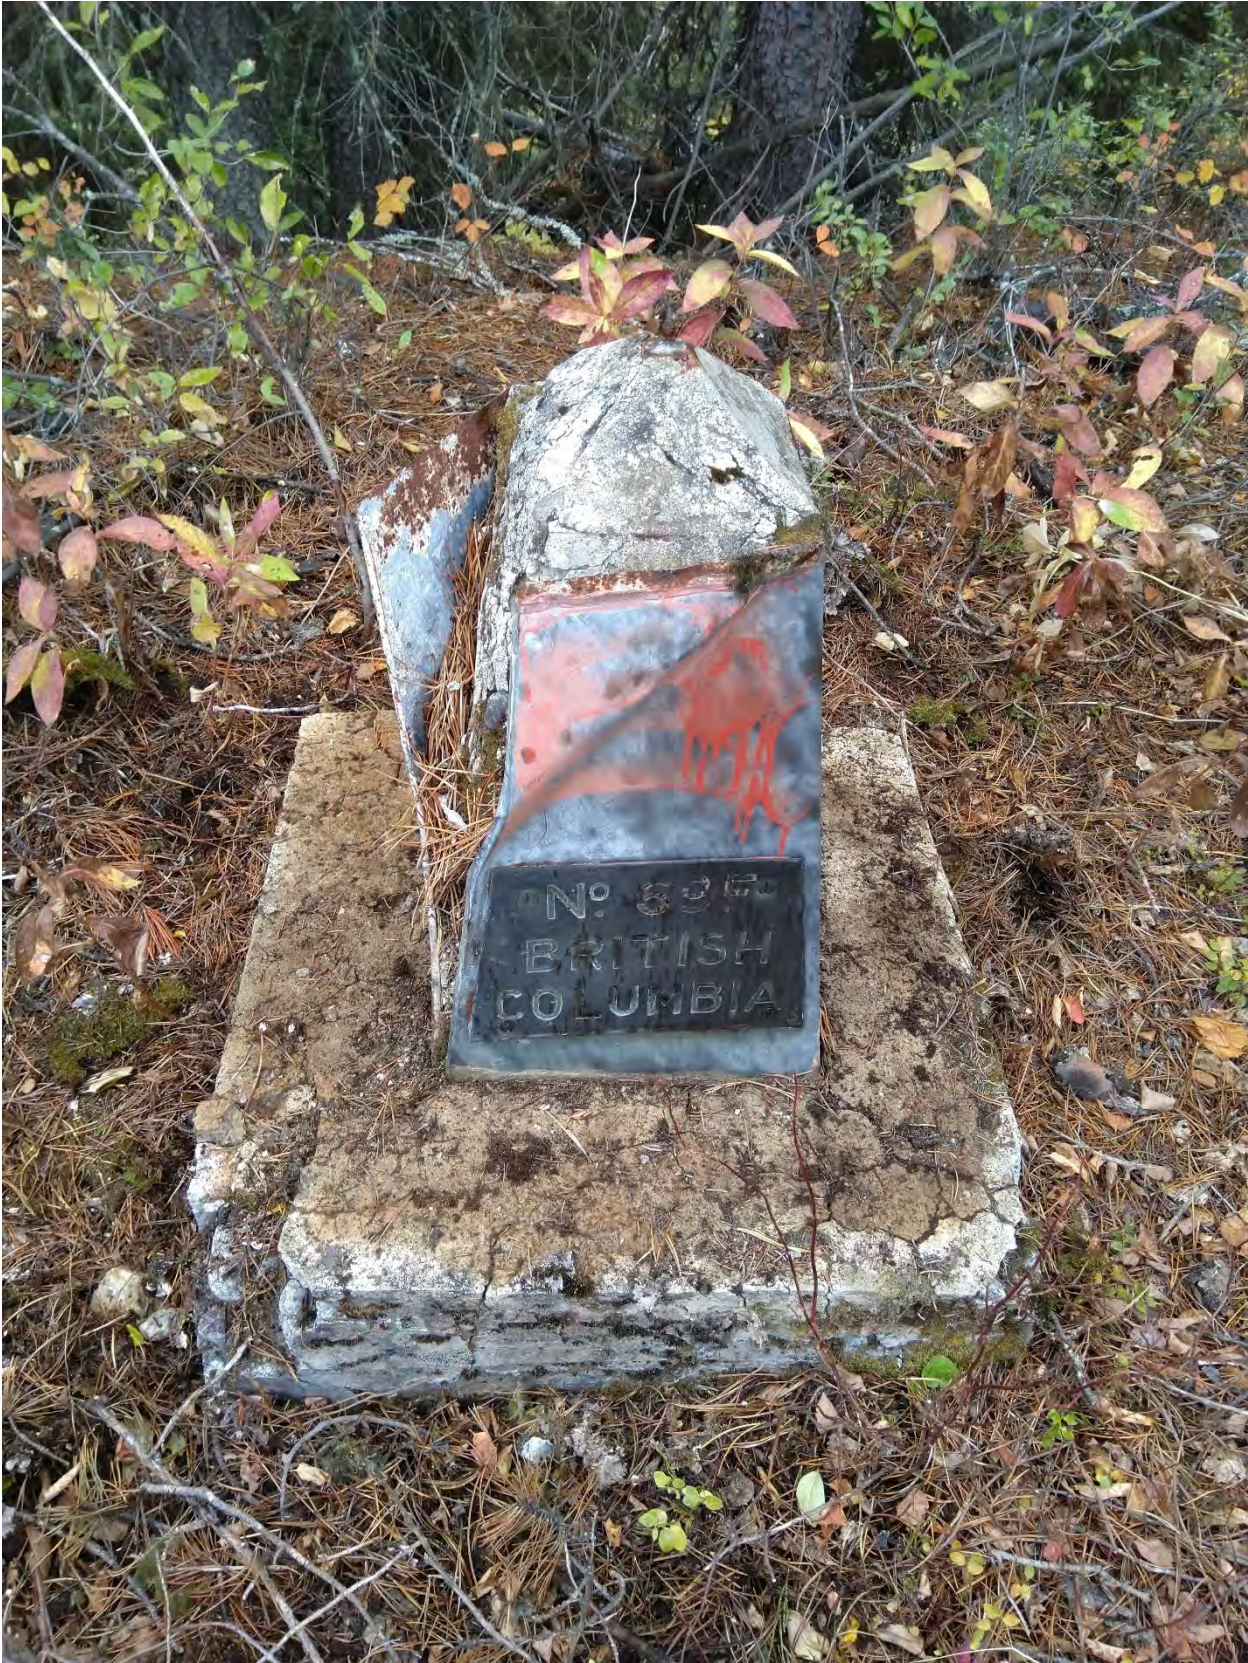
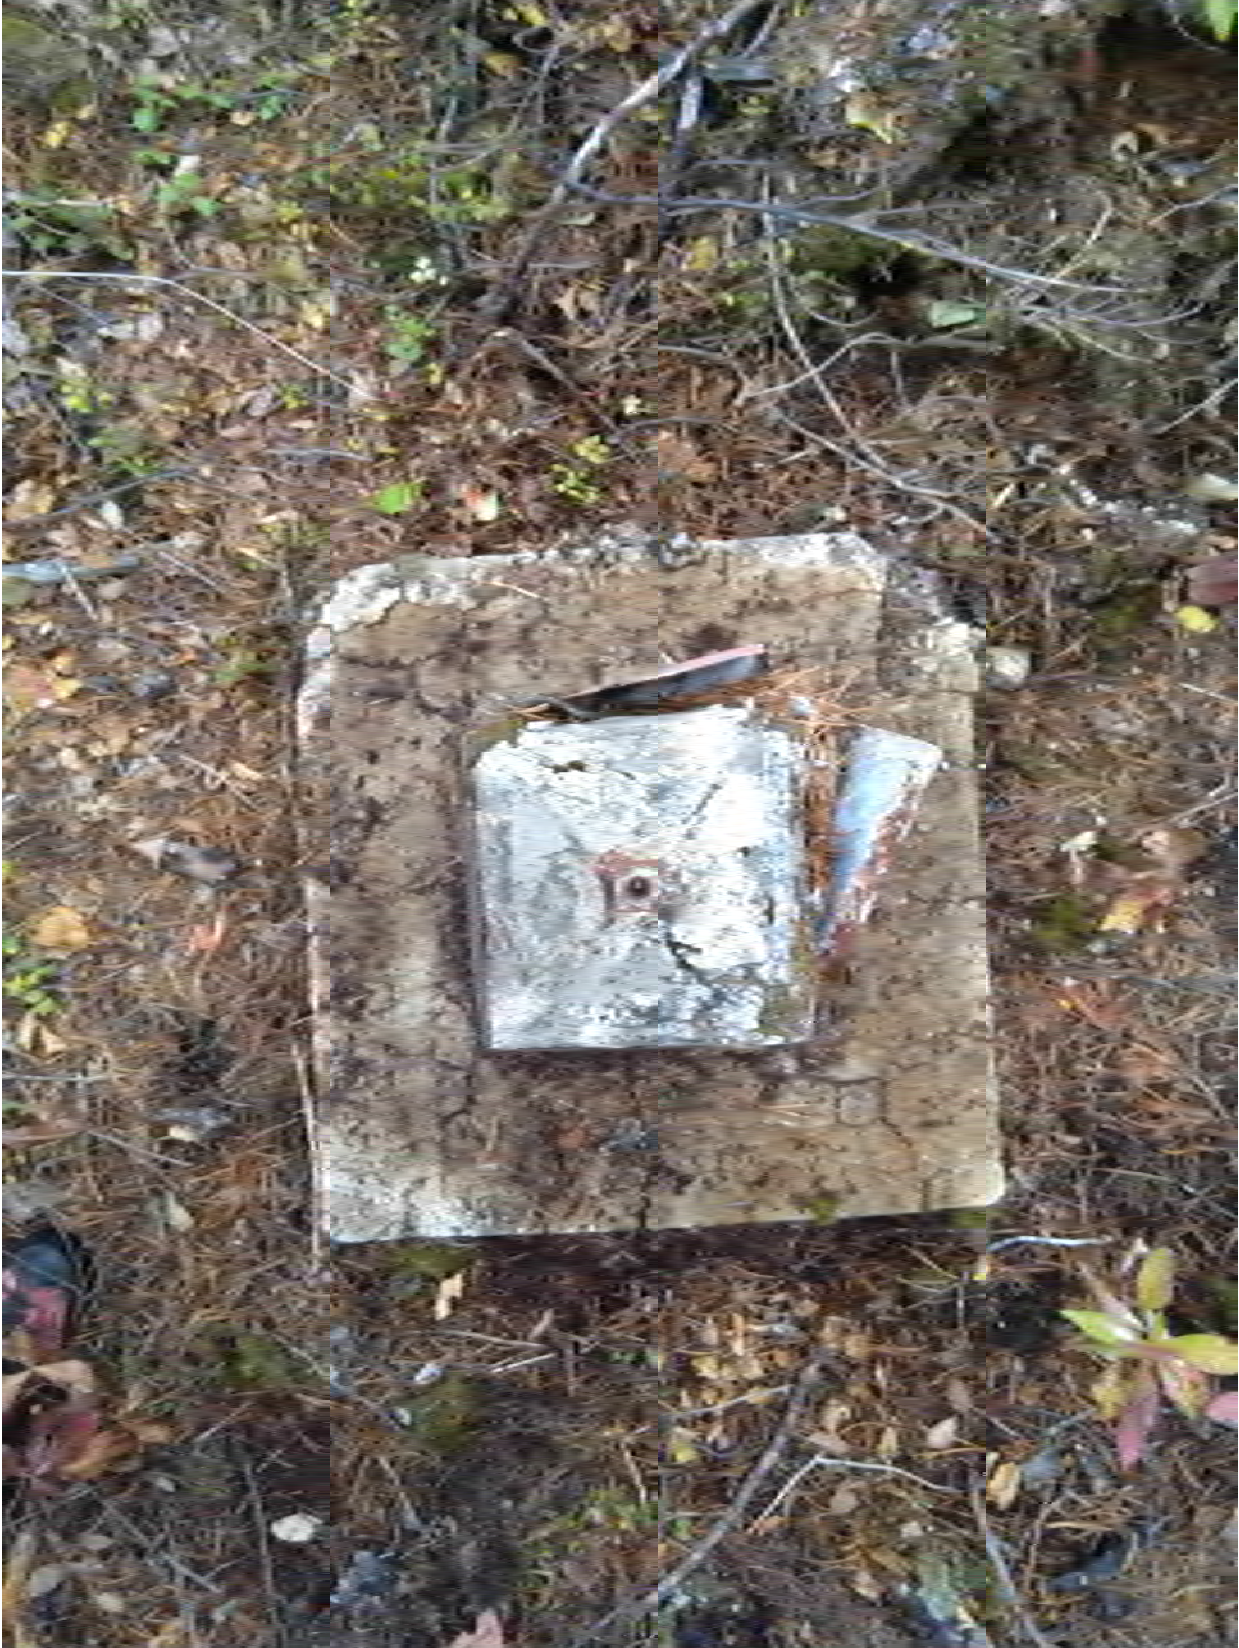
- Position Comments:** The boundary position can be determined through the bolt in to the top of monument.
- Base Comments:** The base of the monument is severely cracked.

- Pillar Condition:** Metal is peeling back. The monument has been painted red in the distant pass.
- Plate Condition:** Both plates are attached to the monument.

- GPS Suitability:** The logging activities have created partial sky view to north and west. The monument is set several meters into the forest. This point could not be GPS surveyed without many trees being cut. Temporary points can be established in the cut-block and 69F surveyed from those points.

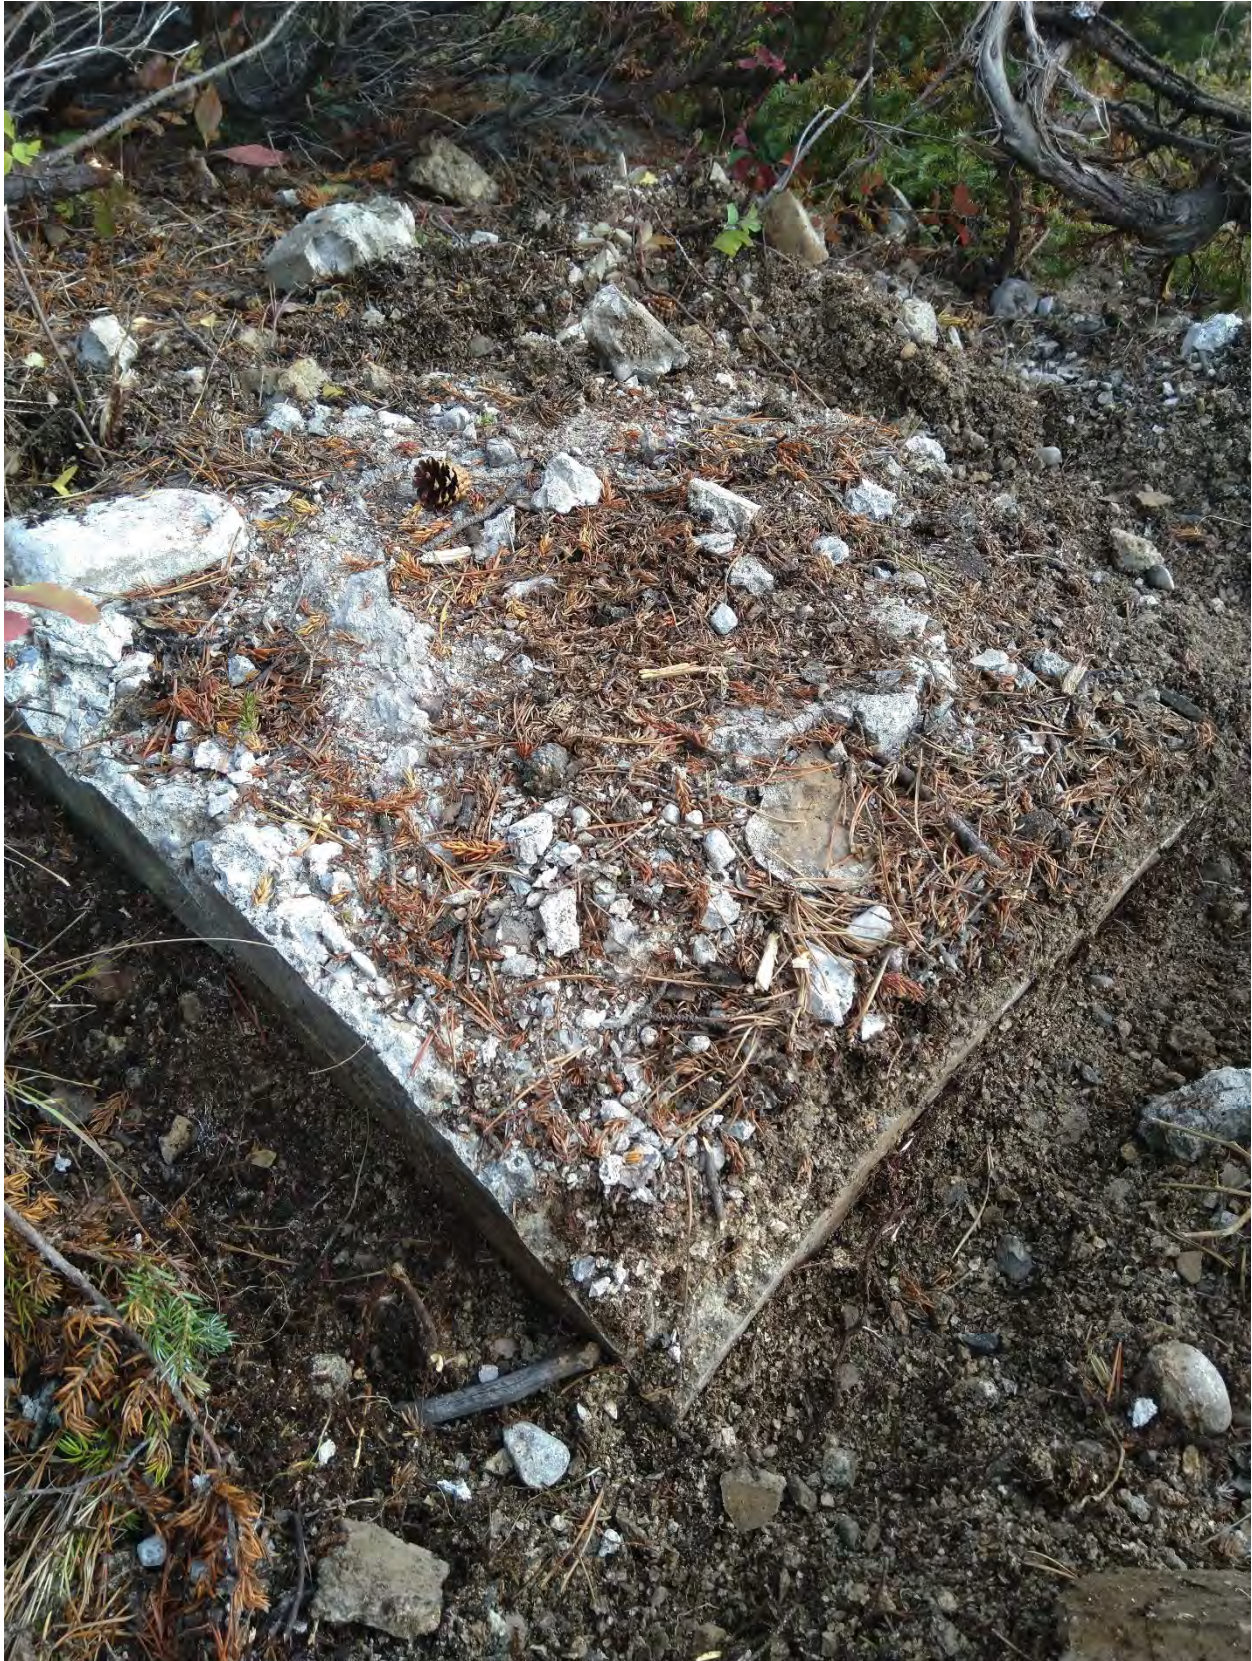
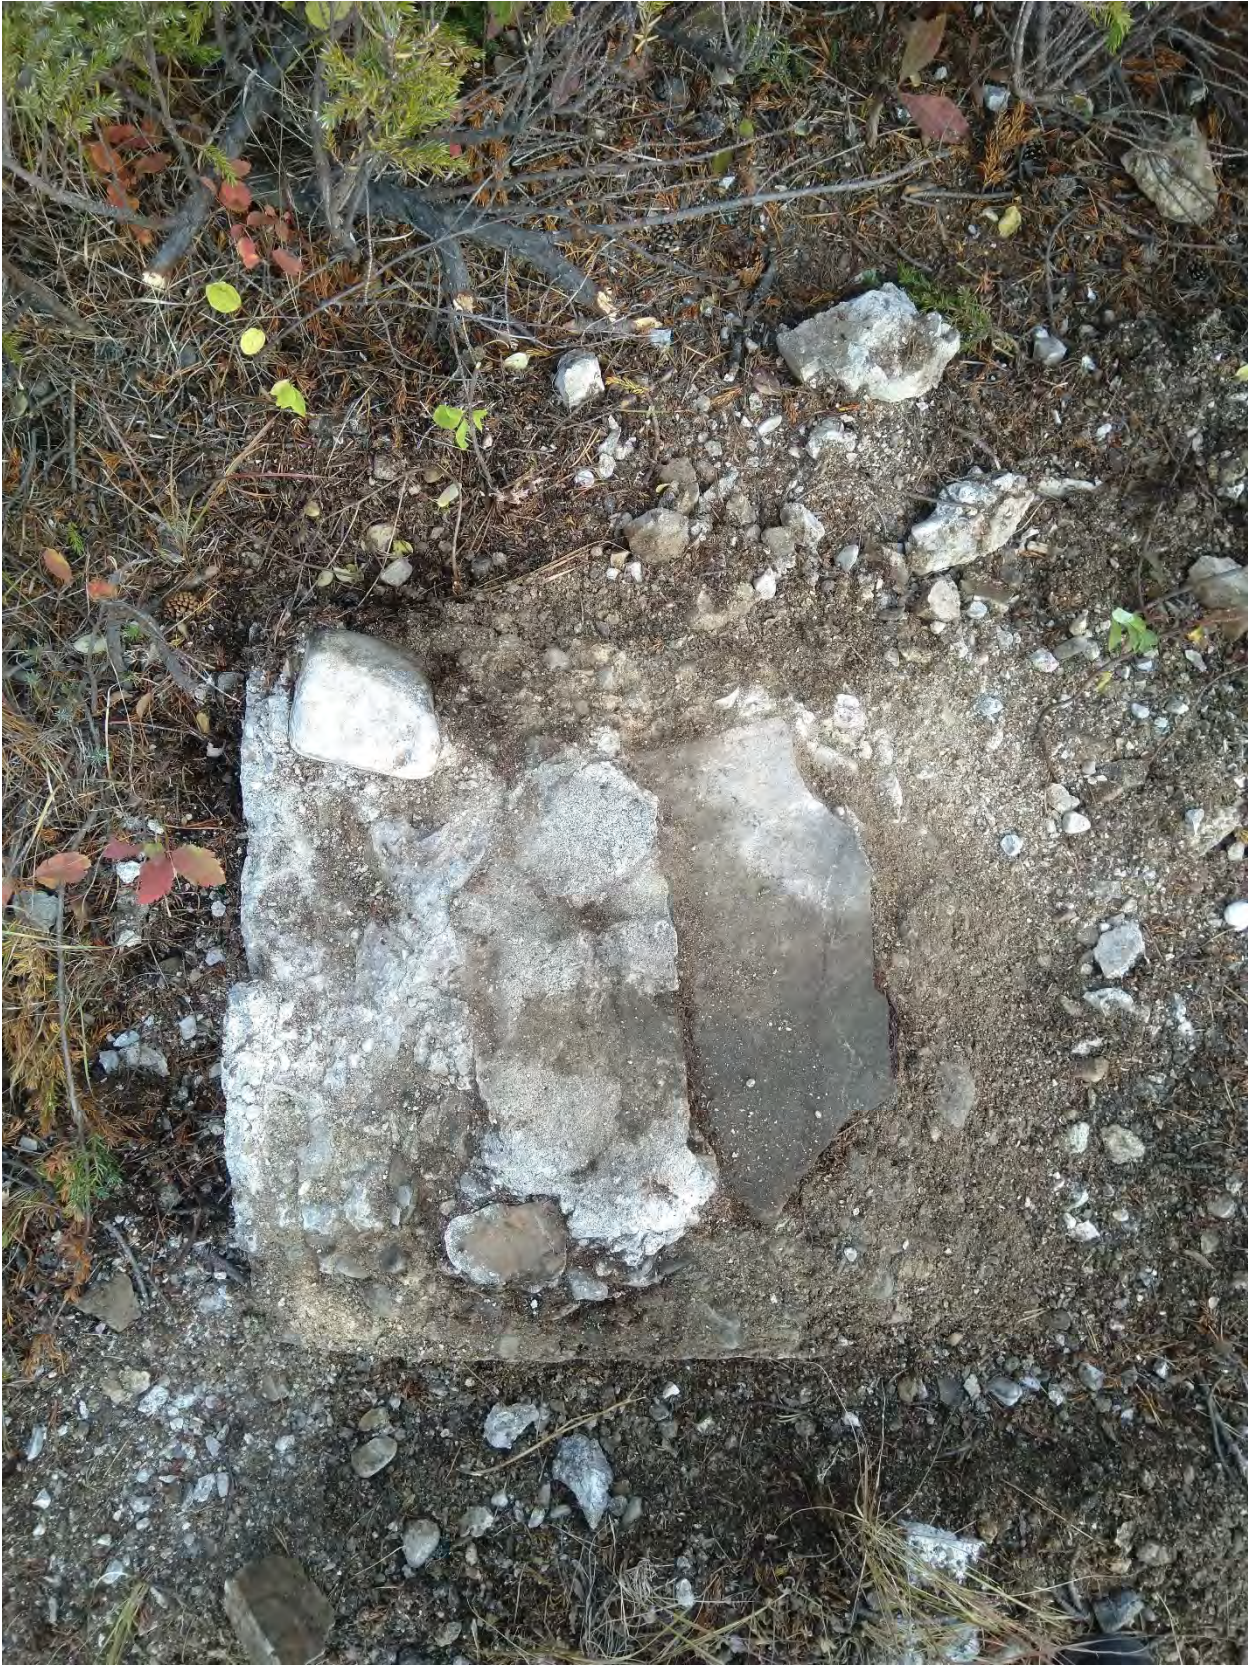
- Access Comments:** This monument was accessed by walking approximately 200m through the cut block from the parked truck on September 19<sup>th</sup>. The vehicle was parked at the end of the brand new 2017 logging road described earlier in the general access comments.
- Position Comments:** The boundary position can be determined by using two intact corners of the base.
- Base Condition:** The base of the monument is severely deteriorated with two corners missing. Two corners can be determined.
- Pillar Condition:** The pillar was entirely missing.
- Plate Condition:** Both plates were missing.
- GPS Suitability:** This monument has open sky views on three sites and is suitable for GPS observations.

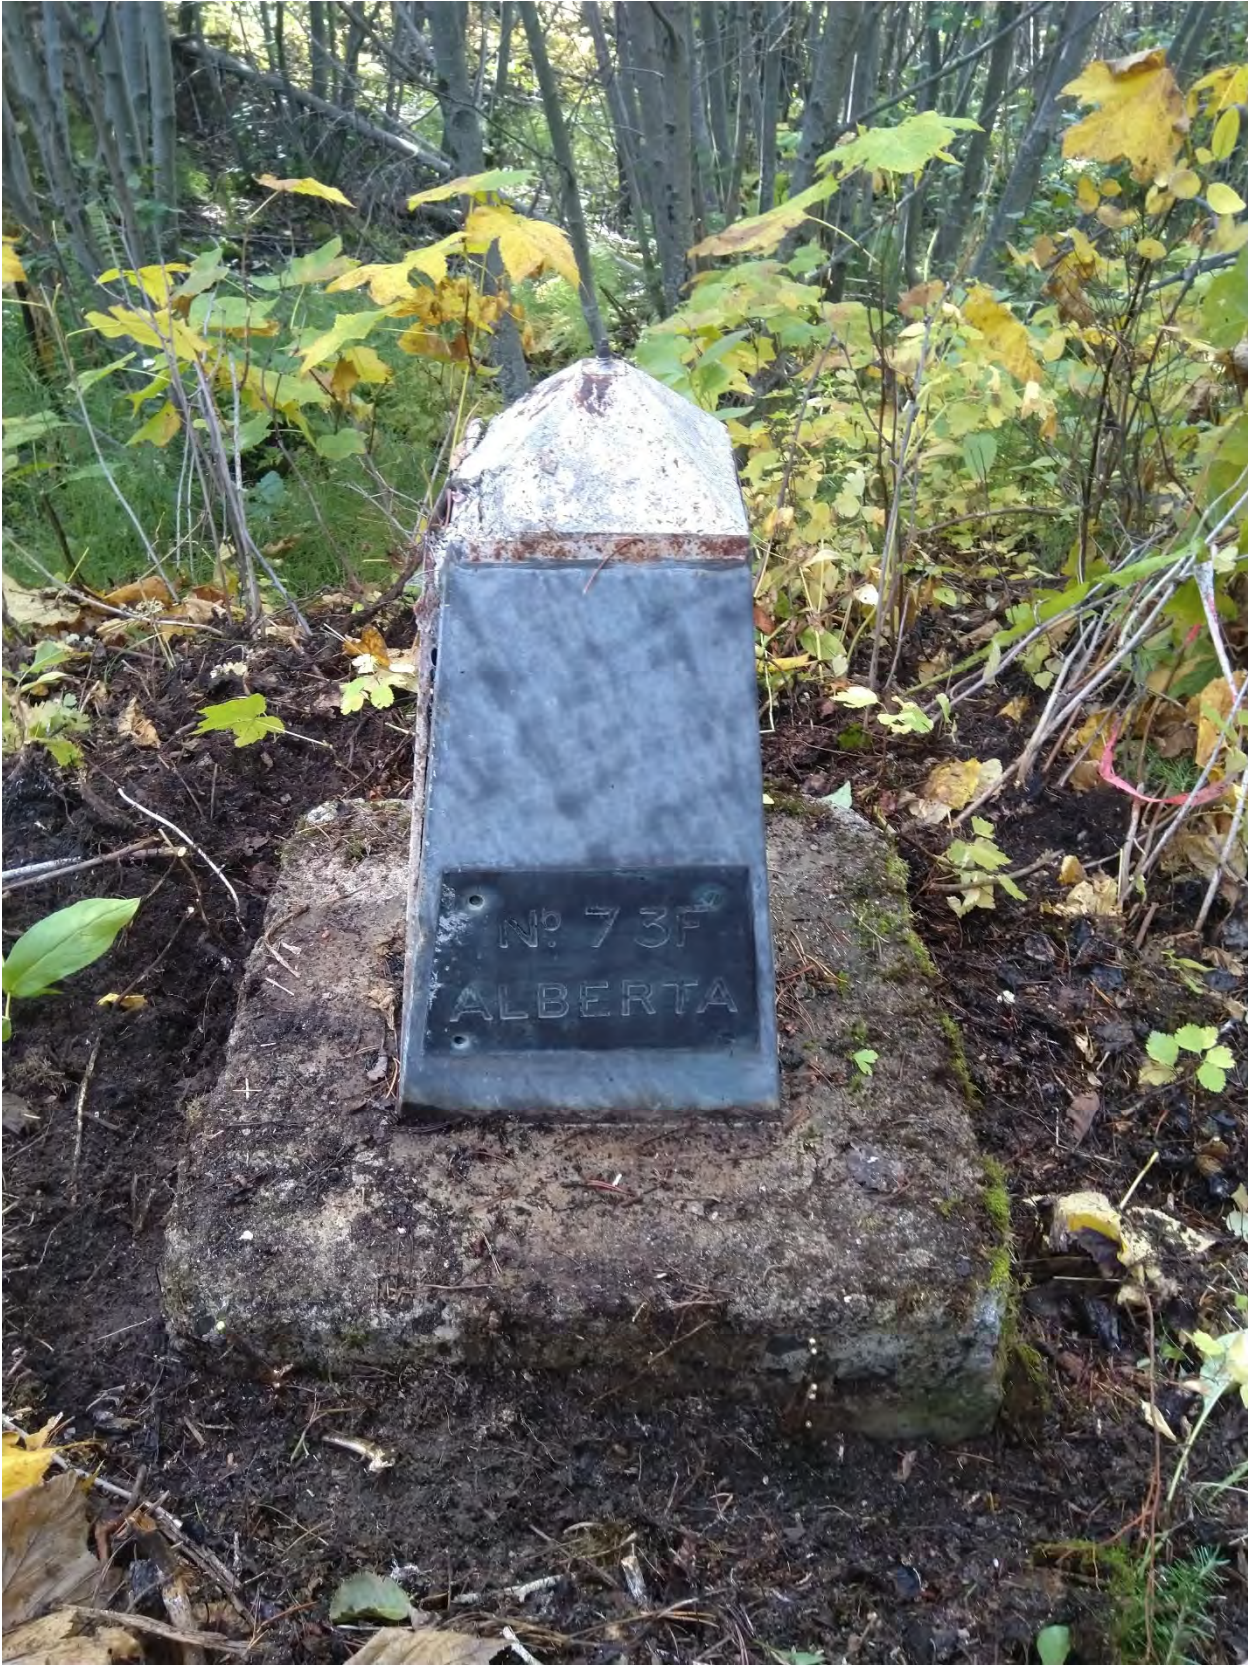
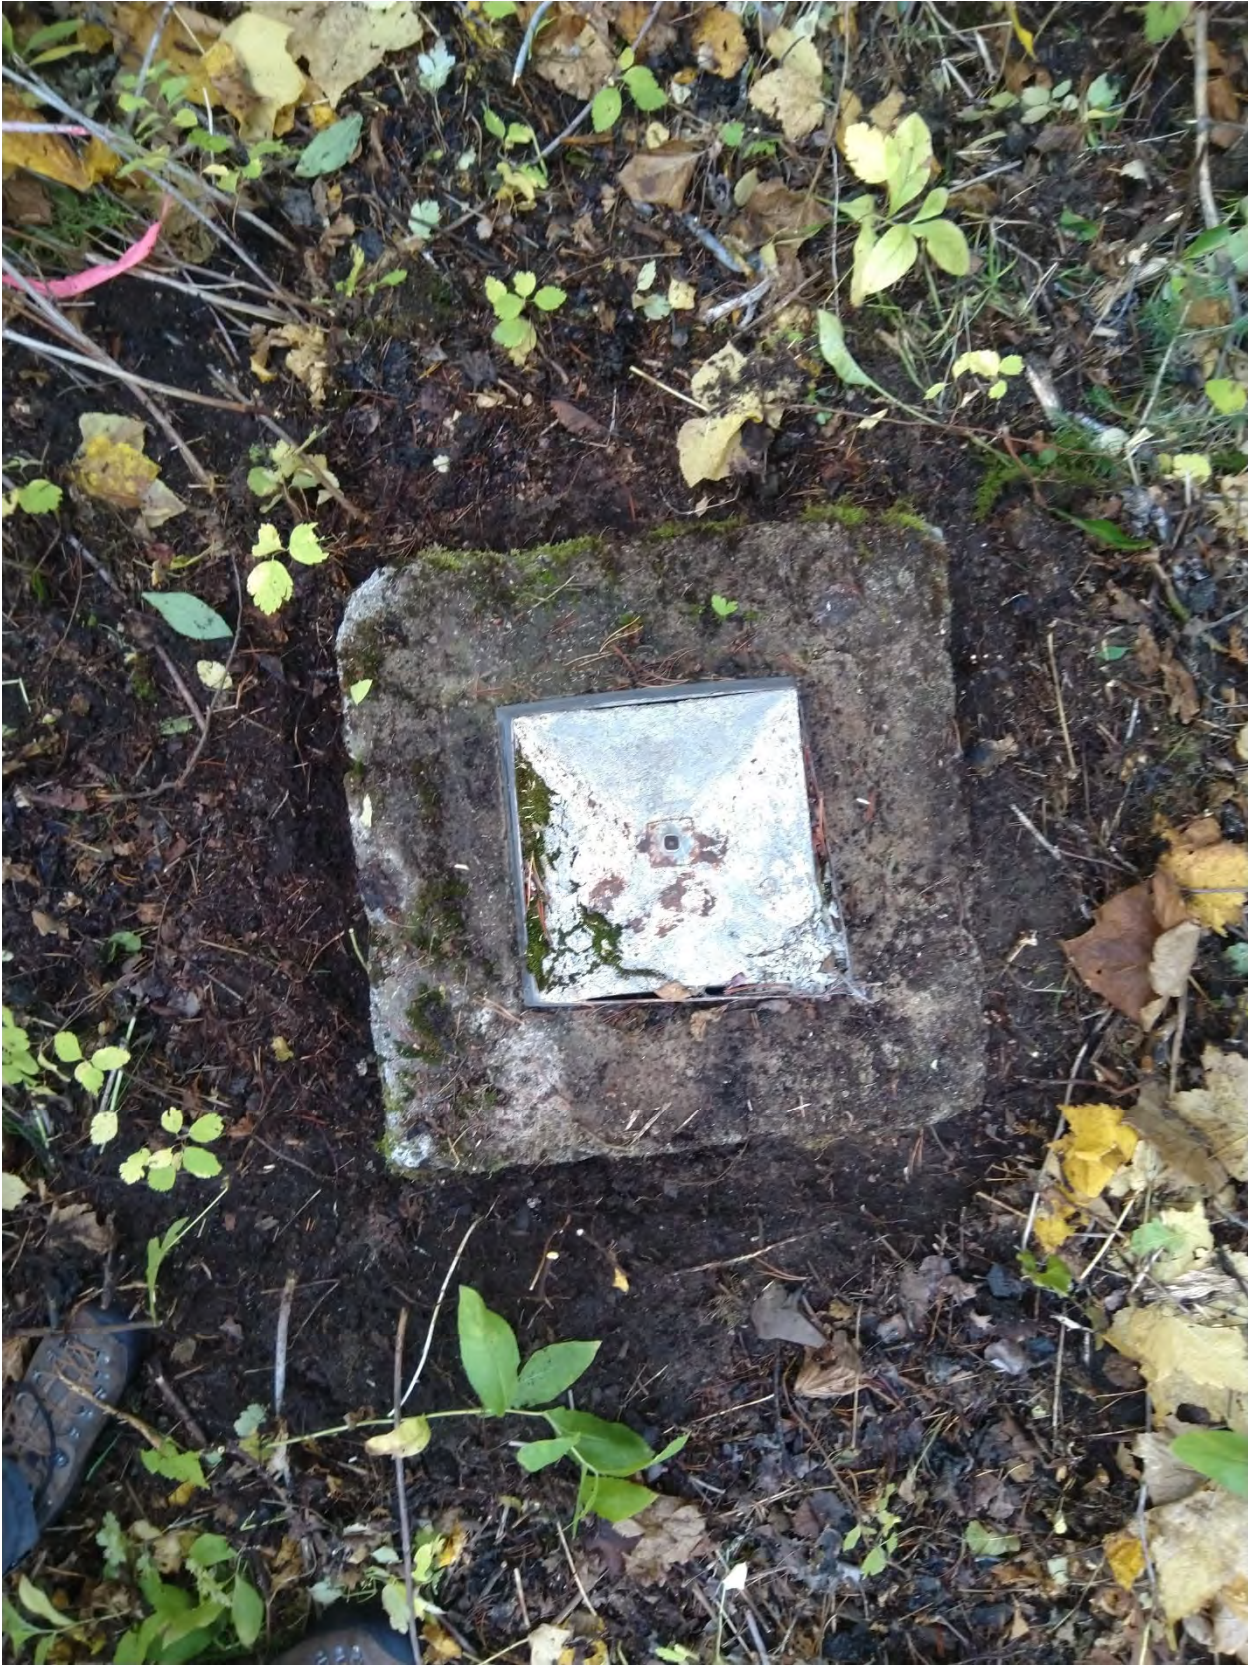
- Access Comments:** This monument was accessed by walking down a steep hill from 75F and through the forest. There is a small creek approximately 1m wide 5m west of the monument.
- Position Comments:** The boundary position can be determined through the bolt on the top of monument.
- Base Condition:** The base of the monument is reasonable condition. Soil and vegetation had encroached around the edges requiring some excavation to properly observe the base.
- Pillar Condition:** The pillar was in good condition with some peeling of the metal.
- Plate Condition:** Both plates were attached to the pillar.
- GPS Suitability:** This monument is in thick tall forest and is not suitable for GPS observations. Survey of this position would require either a large GPS window or conventional traversing from the low areas to the north, or from 75F to the south.
