# Tent Mountain Pass

## Boundary Survey Phase 1

**Global Raymac Contact:** Luke Dixon, ALS  
**Contract:** 19OPP801  
**Job Number:** 18CS0125  
**Revision:** 2.0

October 31<sup>st</sup>, 2018

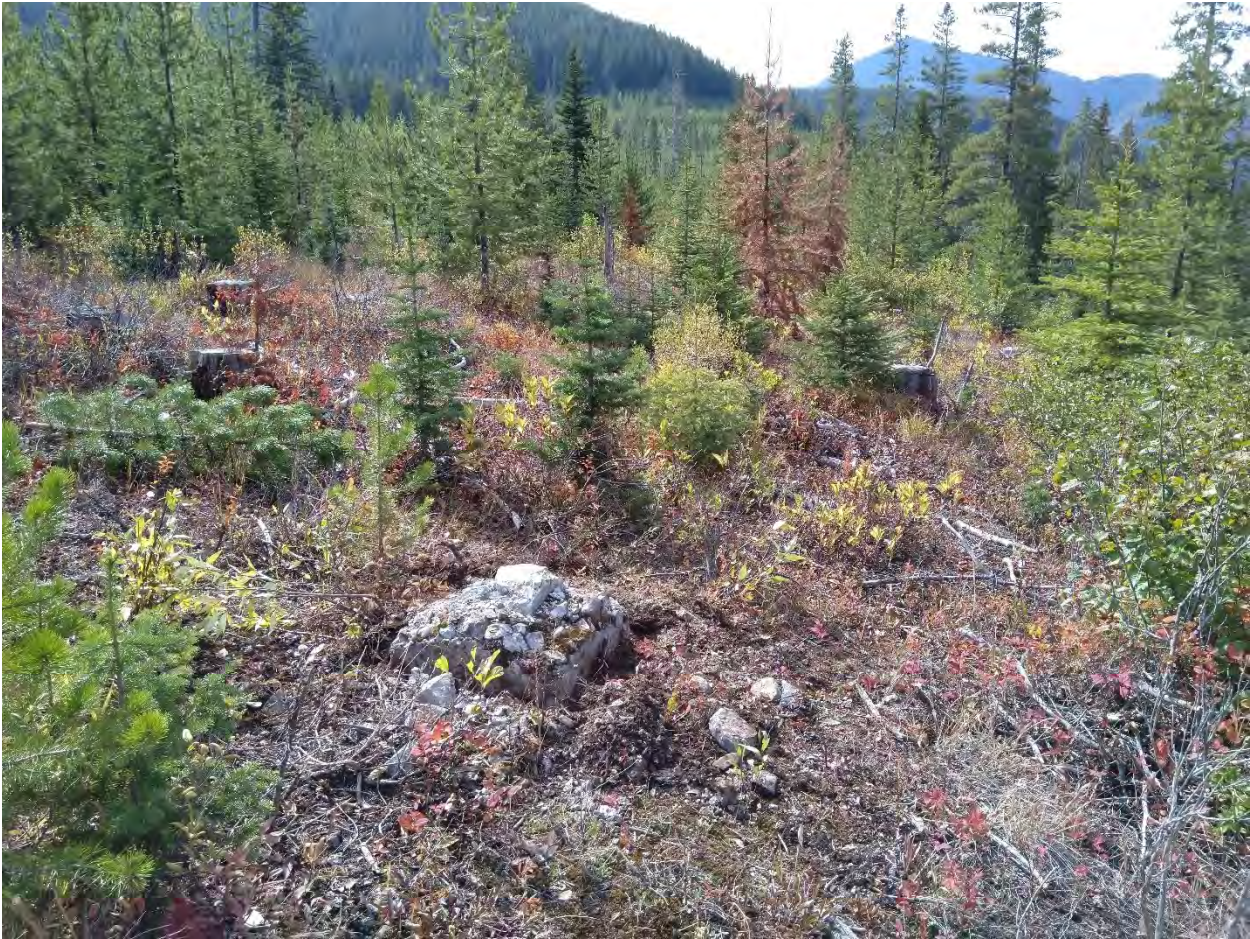
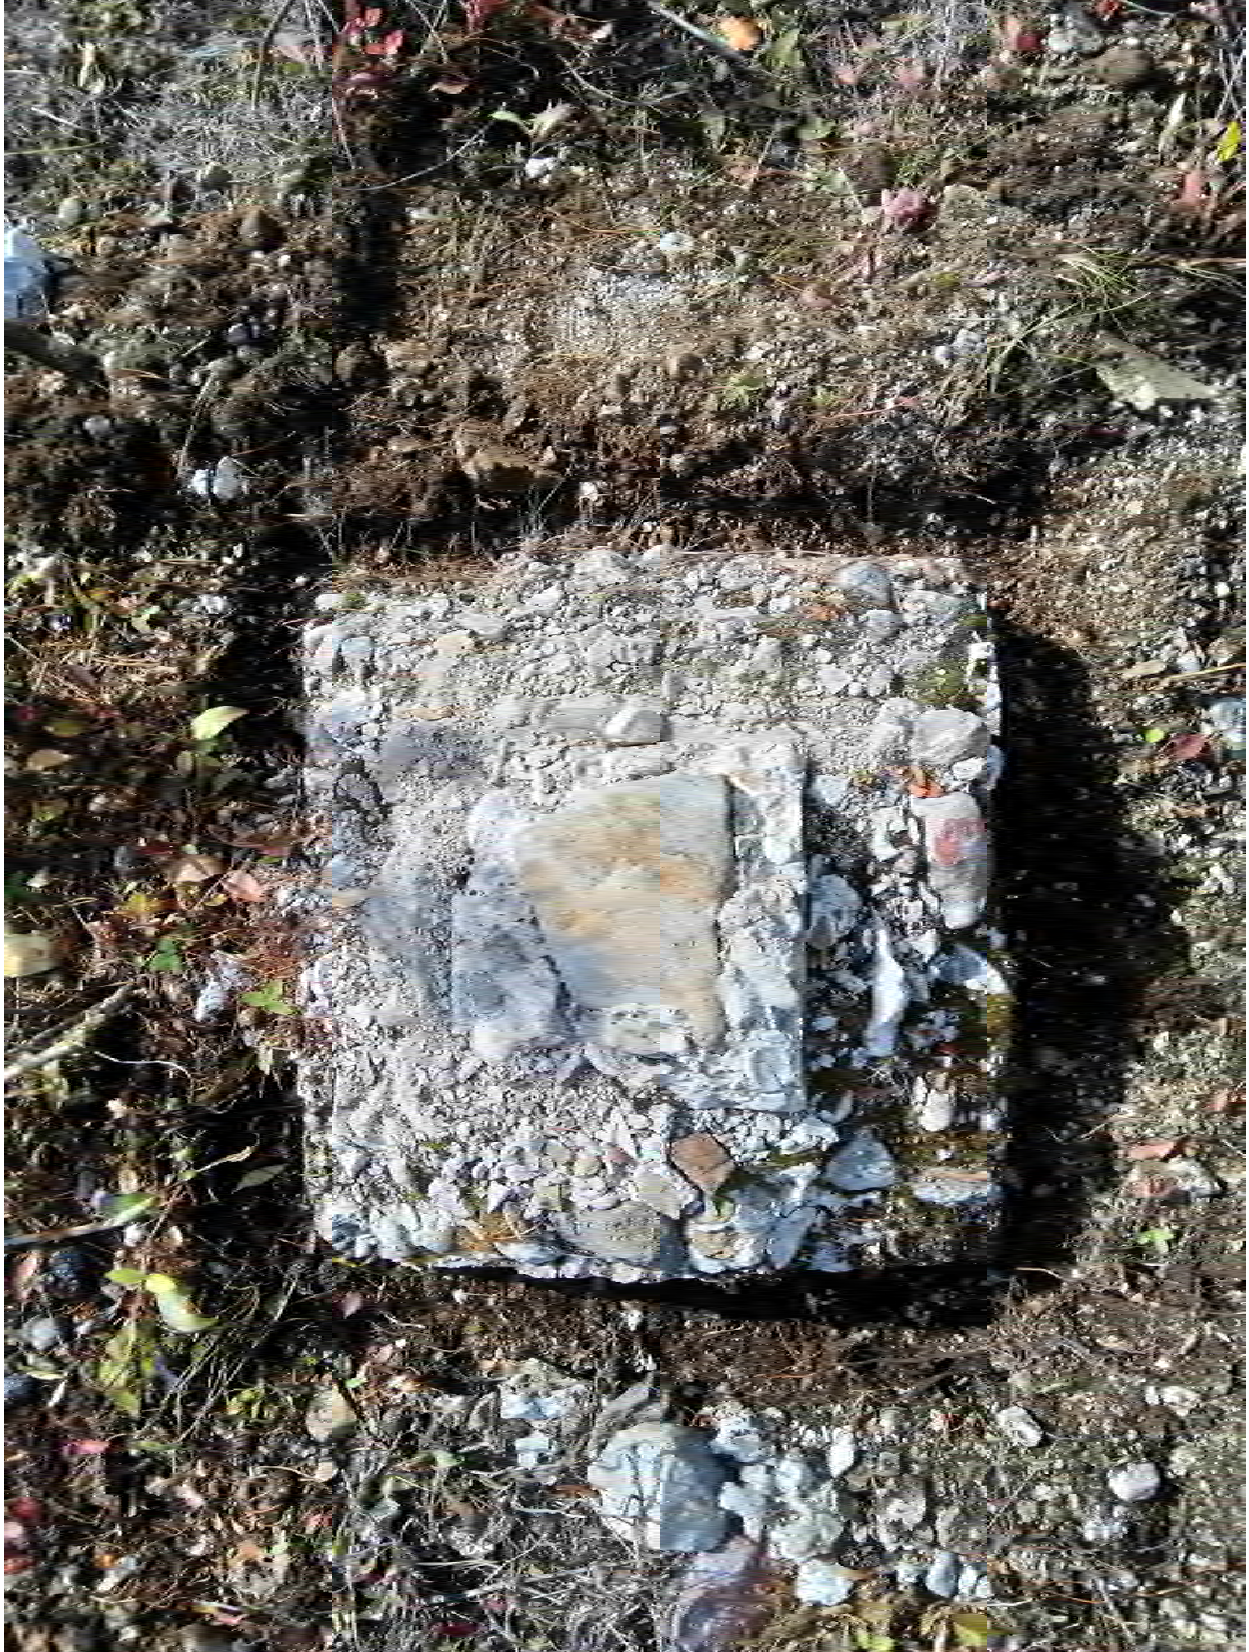
- Access Comments:** This monument was accessed by walking from the 2017 parking area on the south fork of the logging road, along the original logging road for approximately 100m and then through trails in the reseeded cut block.
- Position Comments:** The boundary position can be determined through the corners of the base.
- Base Condition:** The base of the monument is mostly destroyed condition. Soil and vegetation had encroached around the edges requiring some excavation to properly observe the corners.
- Pillar Condition:** The pillar was entirely destroyed.
- Plate Condition:** Both plates were missing.
- GPS Suitability:** This monument is in re planted cut block. GPS views are excellent, and this location is suitable for GPS survey.

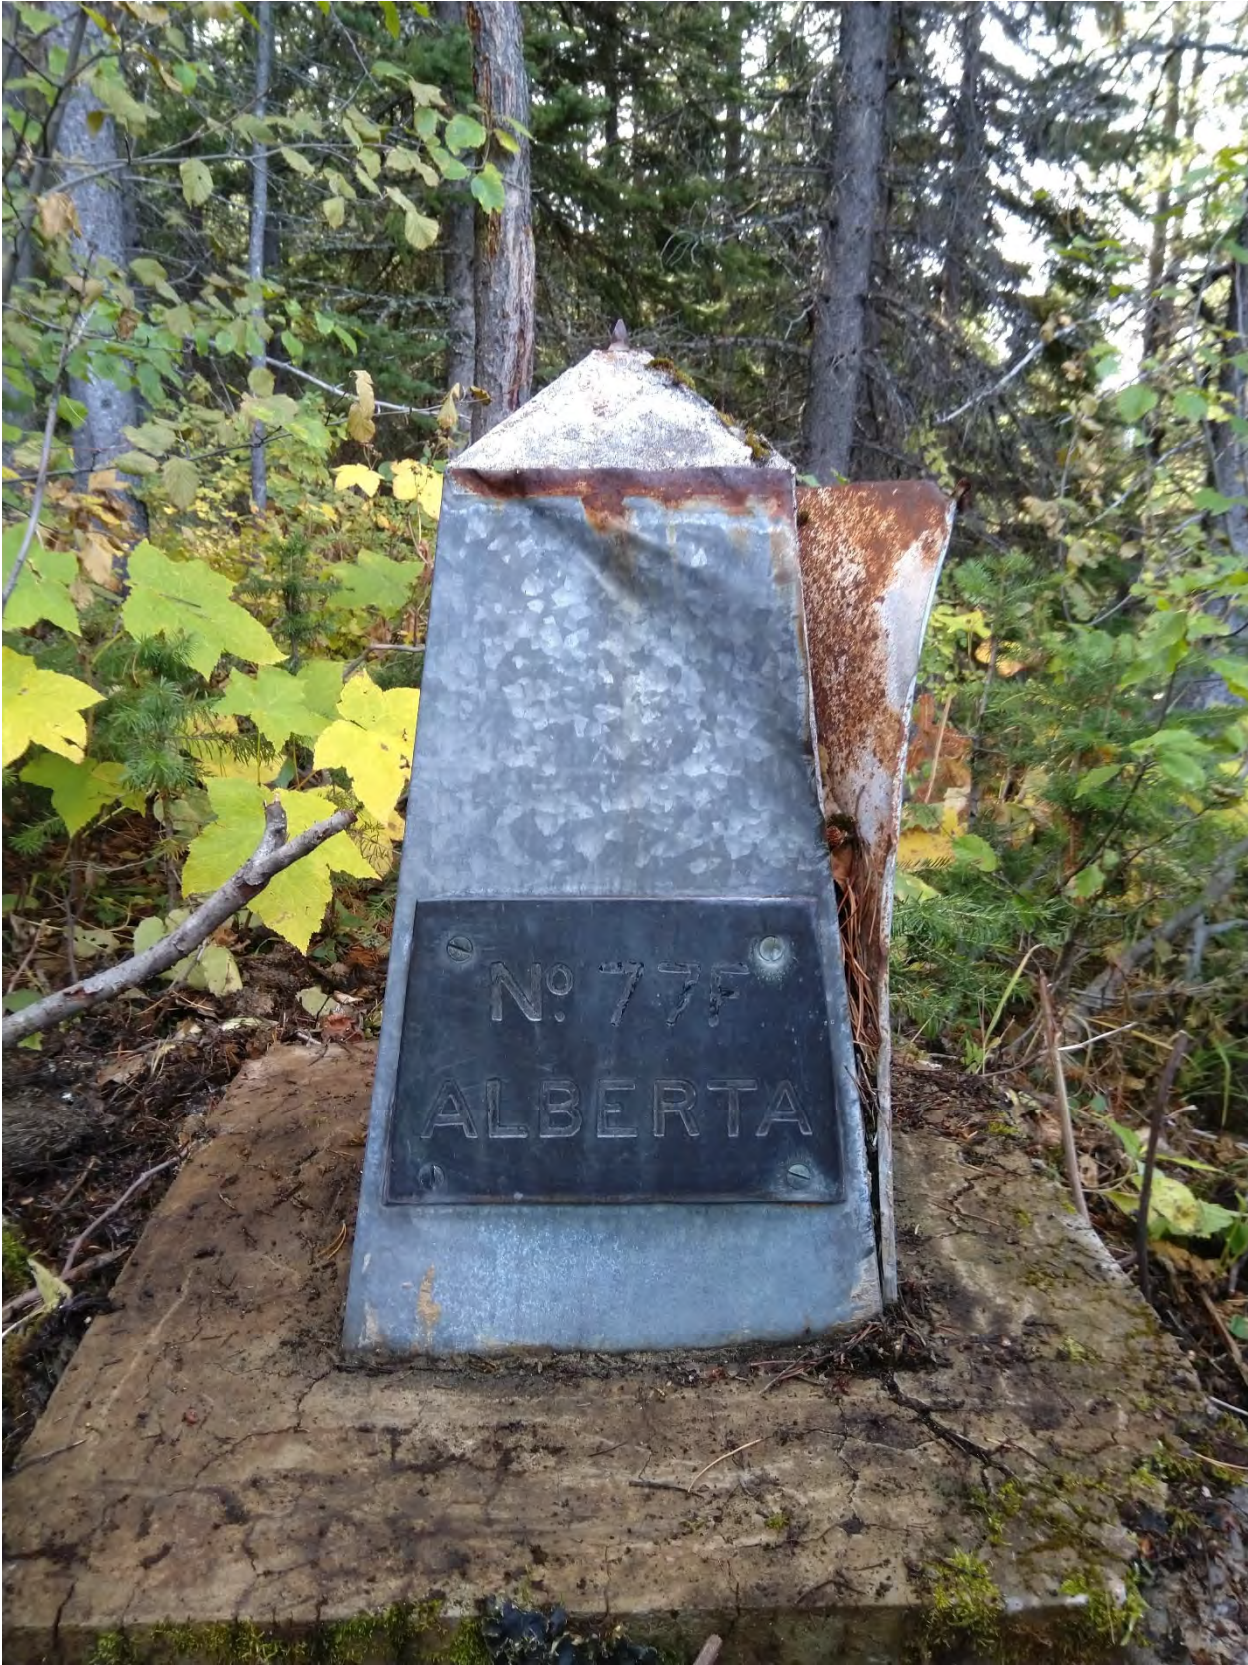
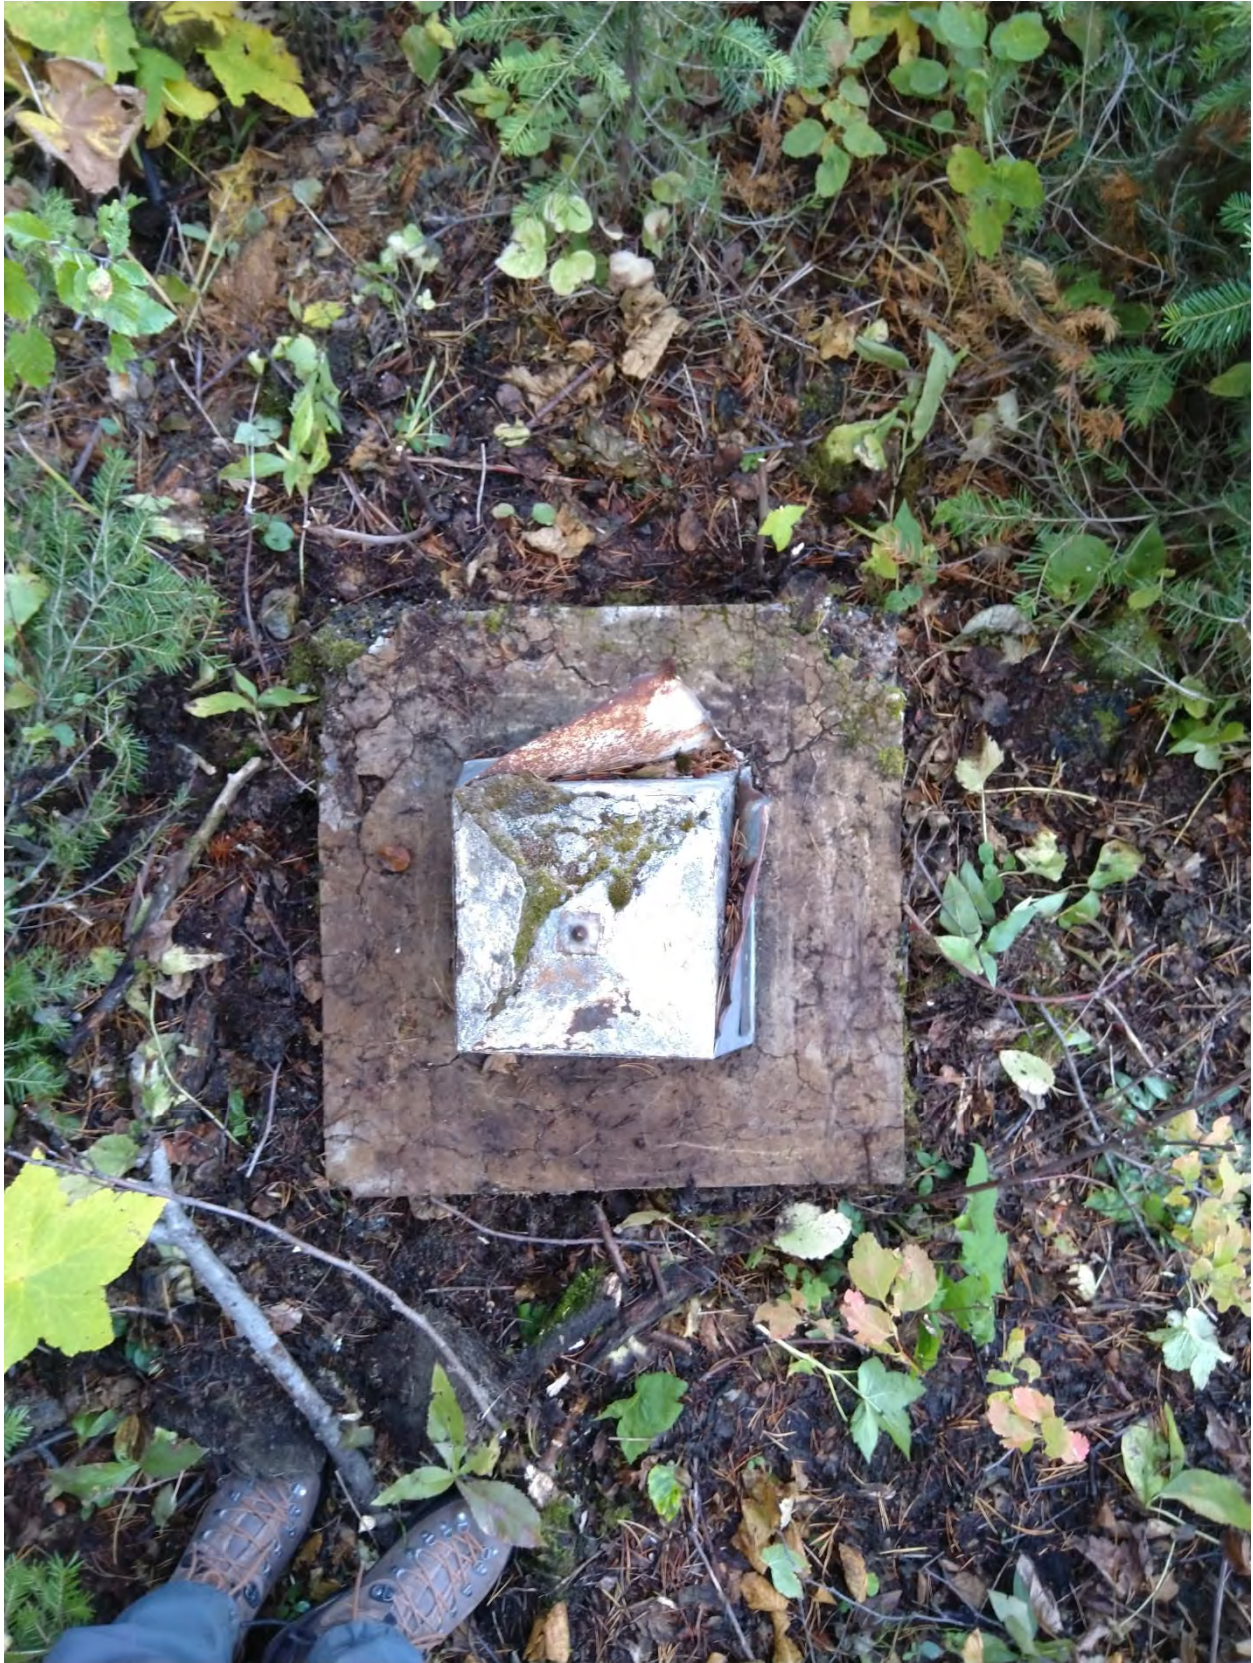
- Access Comments:** This monument was accessed by walking from 75F. It is possible to cover the distance entirely in old cut block; which travels well on the AB side of the boundary. The monument is tucked in the south west corner of the cut block.
- Position Comments:** The boundary position can be determined through the bolt on the monument.
- Base Condition:** The base of the monument is reasonable condition. It has some cracks and a couple of the tops of the corners are knocked off.
- Pillar Condition:** The metal cladding on the pillar is peeling back.
- Plate Condition:** Both plates are attached to the pillar.
- GPS Suitability:** This monument is in the corner of a cut block with 50cm diameter trees nearby. GPS views are marginal, and this monument would be better surveyed by establishing temporary points in the cut block and conventionally surveying to the monument.

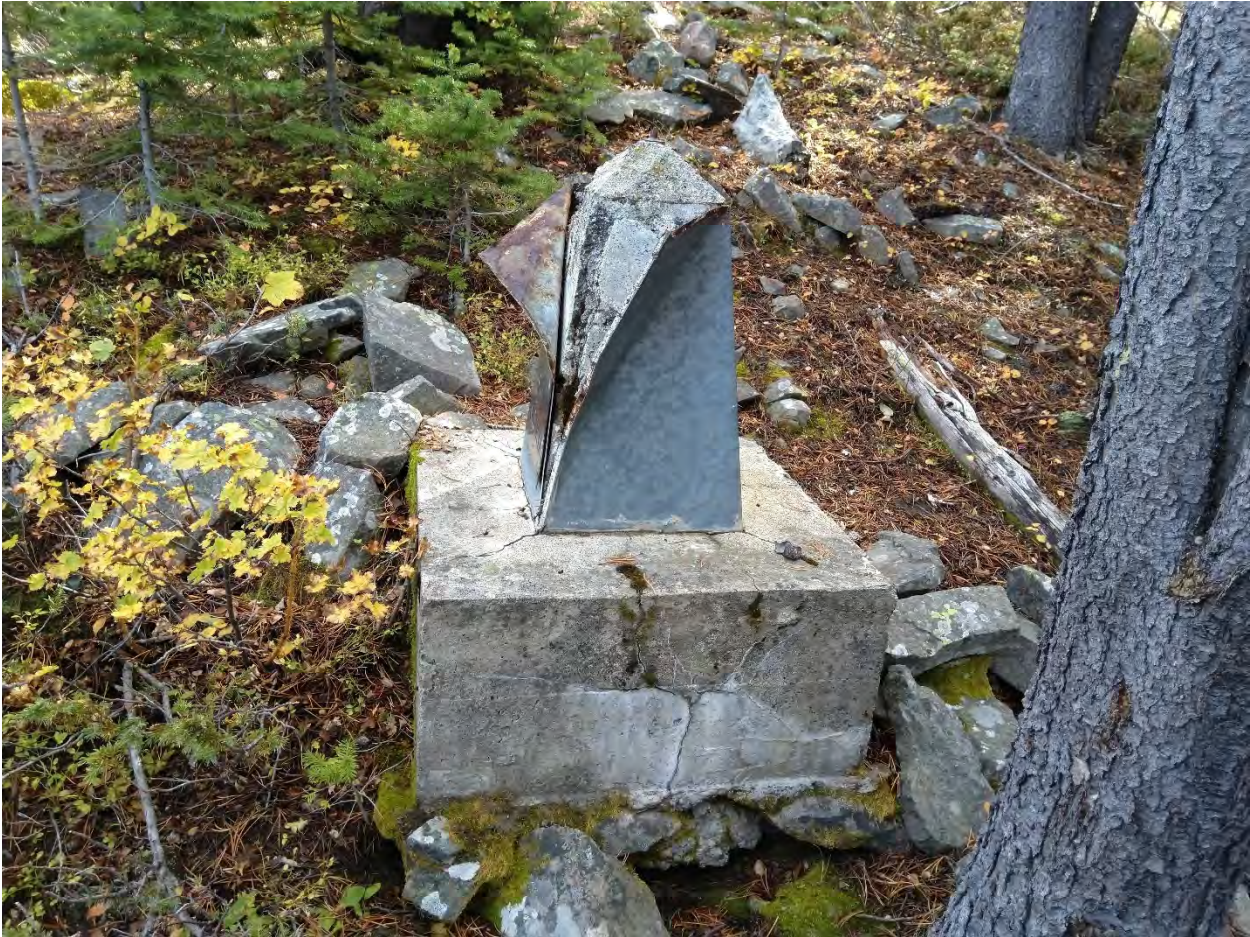
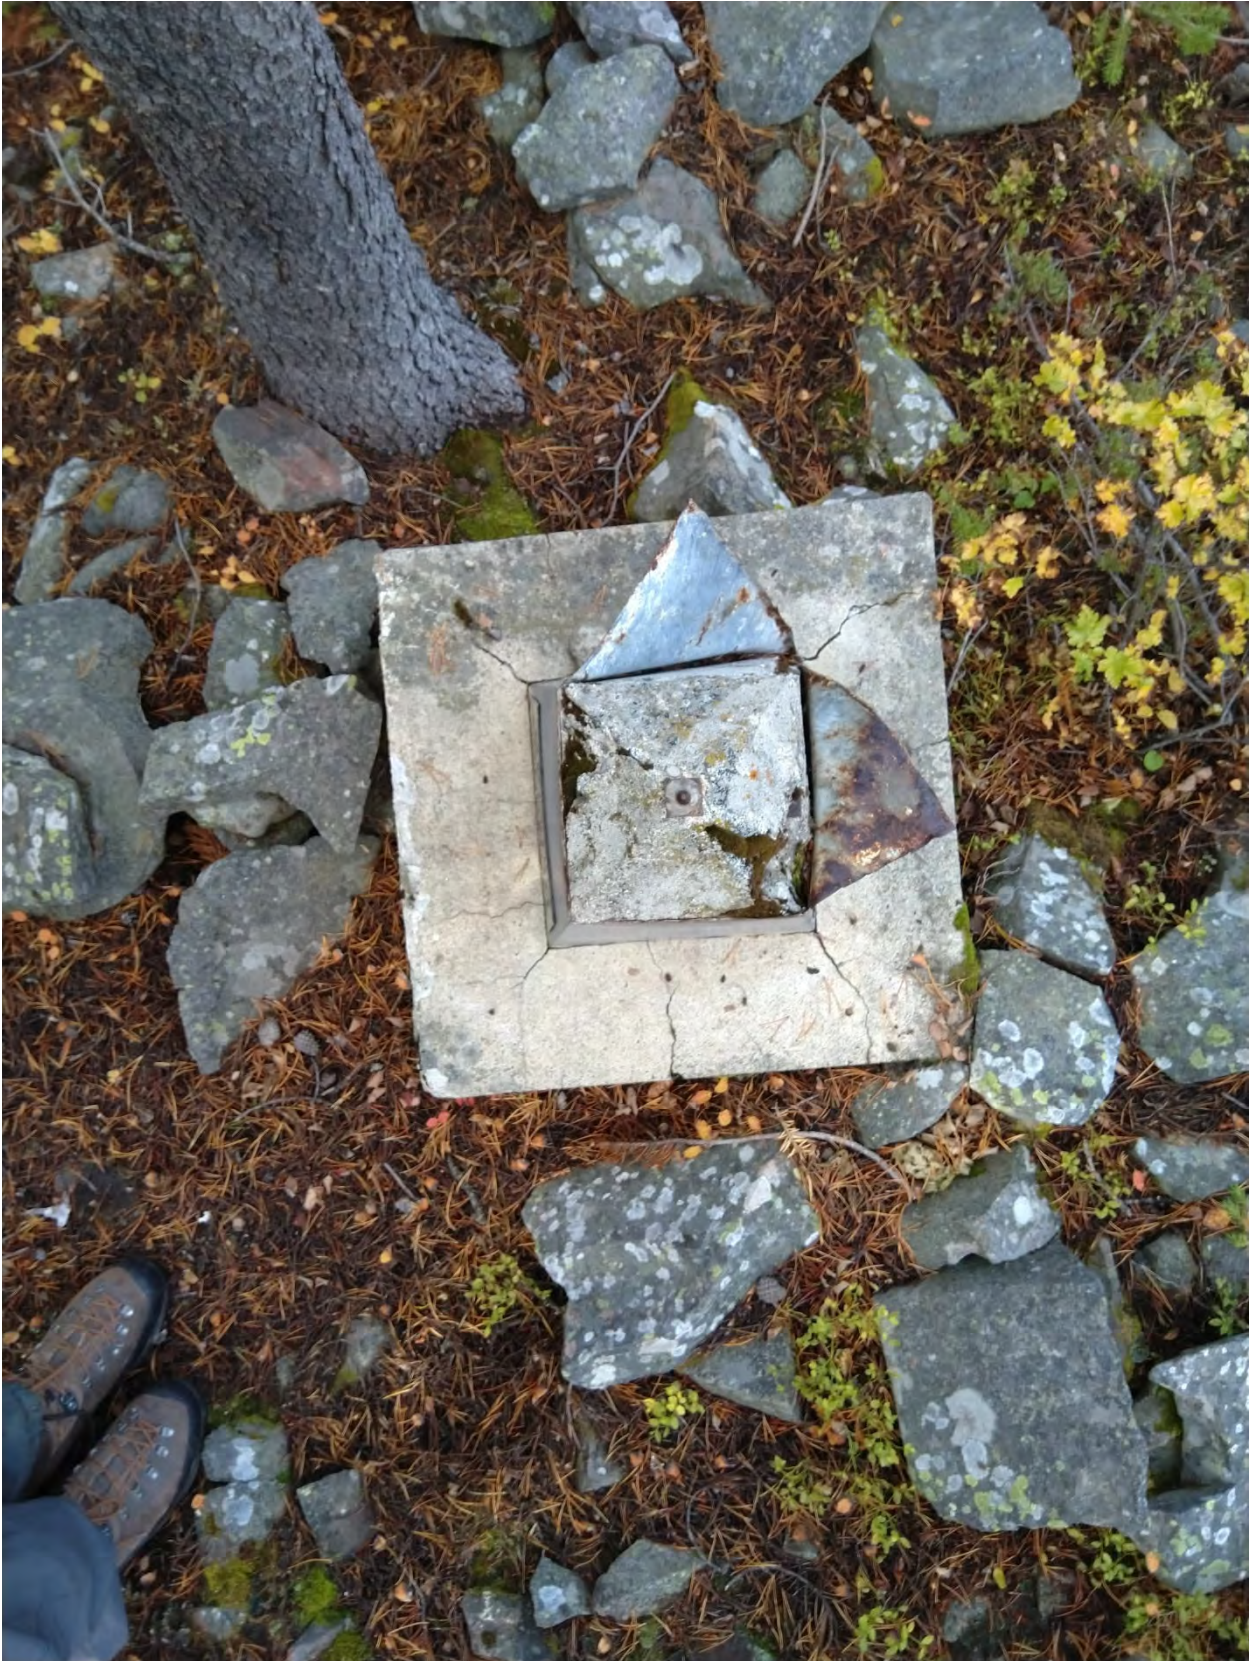
- Access Comments:** This monument was accessed by hiking uphill from 77F. Most of the hiking is through large forest with little undergrowth. One open area with rocks was hiked through.
- Position Comments:** The boundary position can be determined through the bolt on the monument.
- Base Condition:** The base of the monument is reasonable condition. It has some cracks and underside the north side has been eroded under the base.
- Pillar Condition:** The metal cladding on the pillar is peeling back.
- Plate Condition:** Both plates are attached to the pillar.
- GPS Suitability:** This monument is in on the edge of ridge that defines the AB-BC boundary. There are some sky views to the east. About a dozen trees with 10cm diameter would need to be cut to obtain enough GPS window to survey this location. Opportunities for conventional survey and traverse are limited.

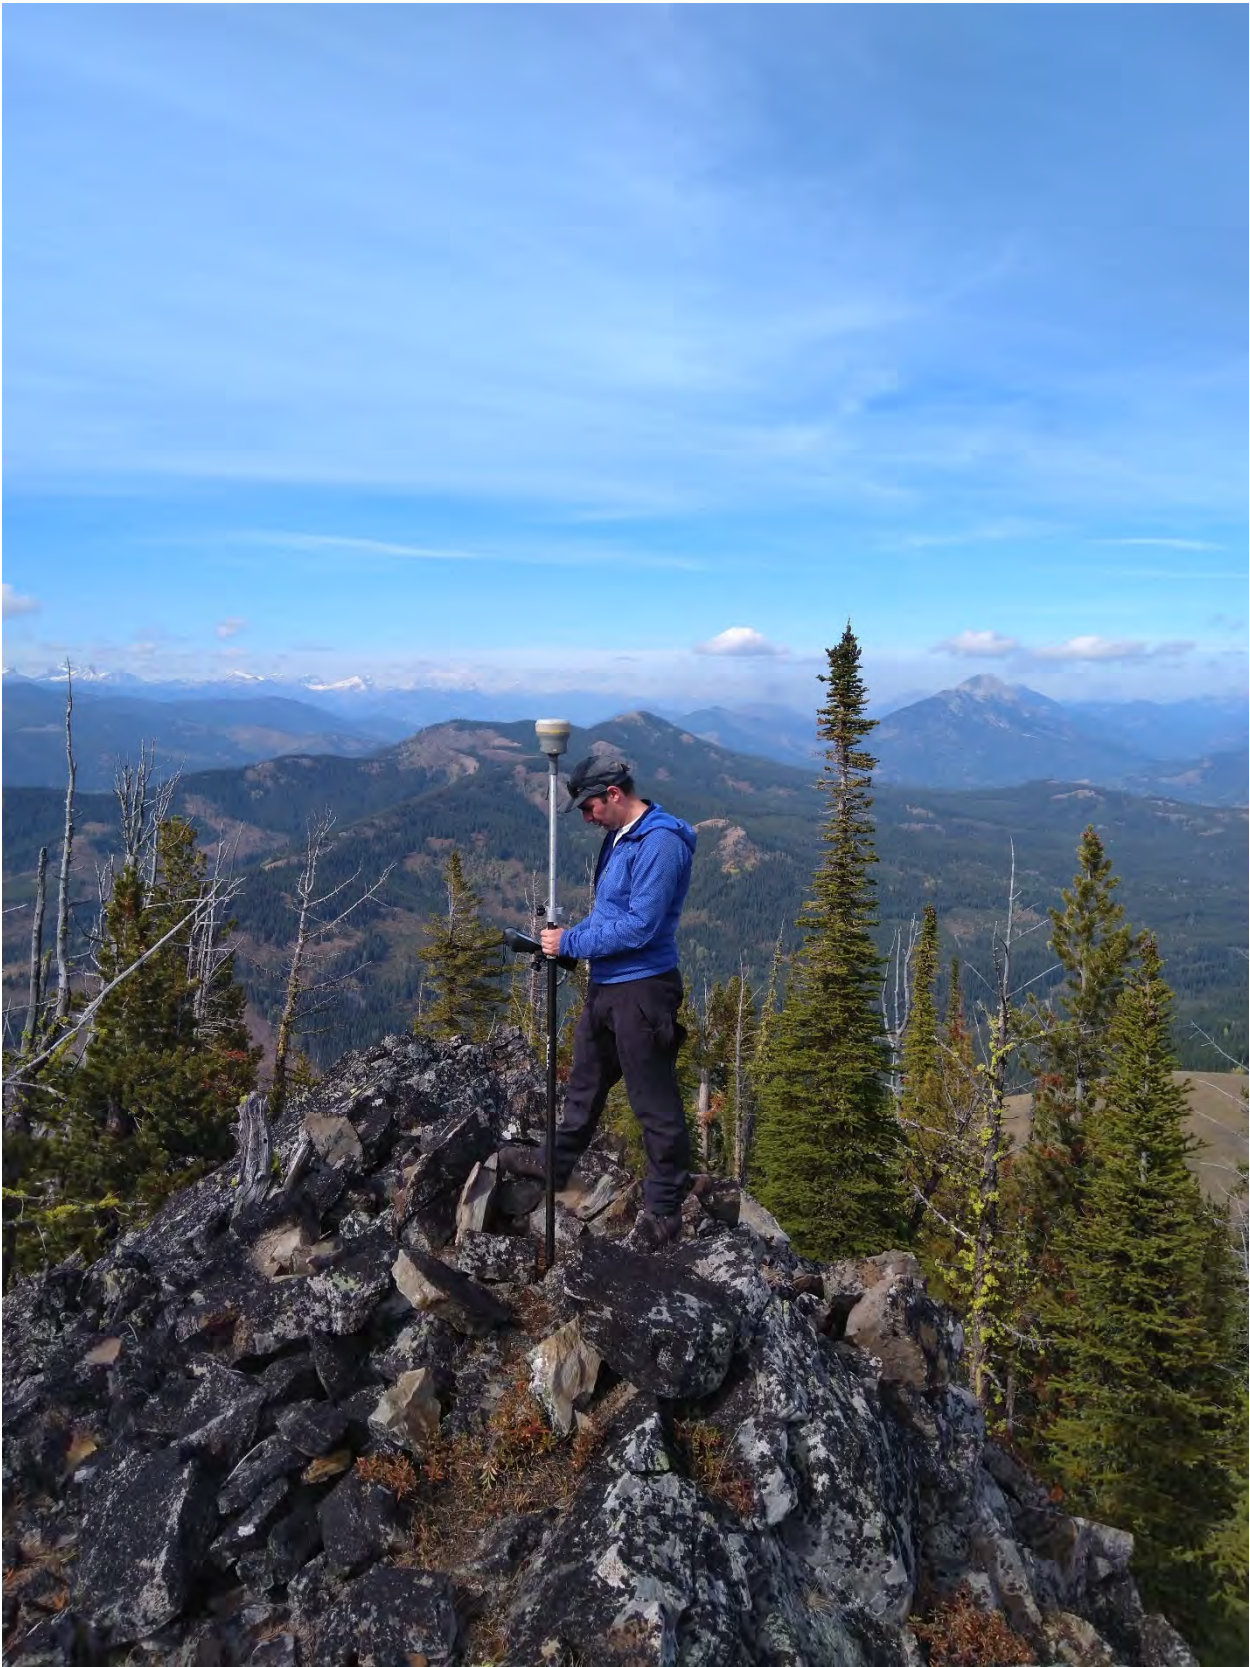
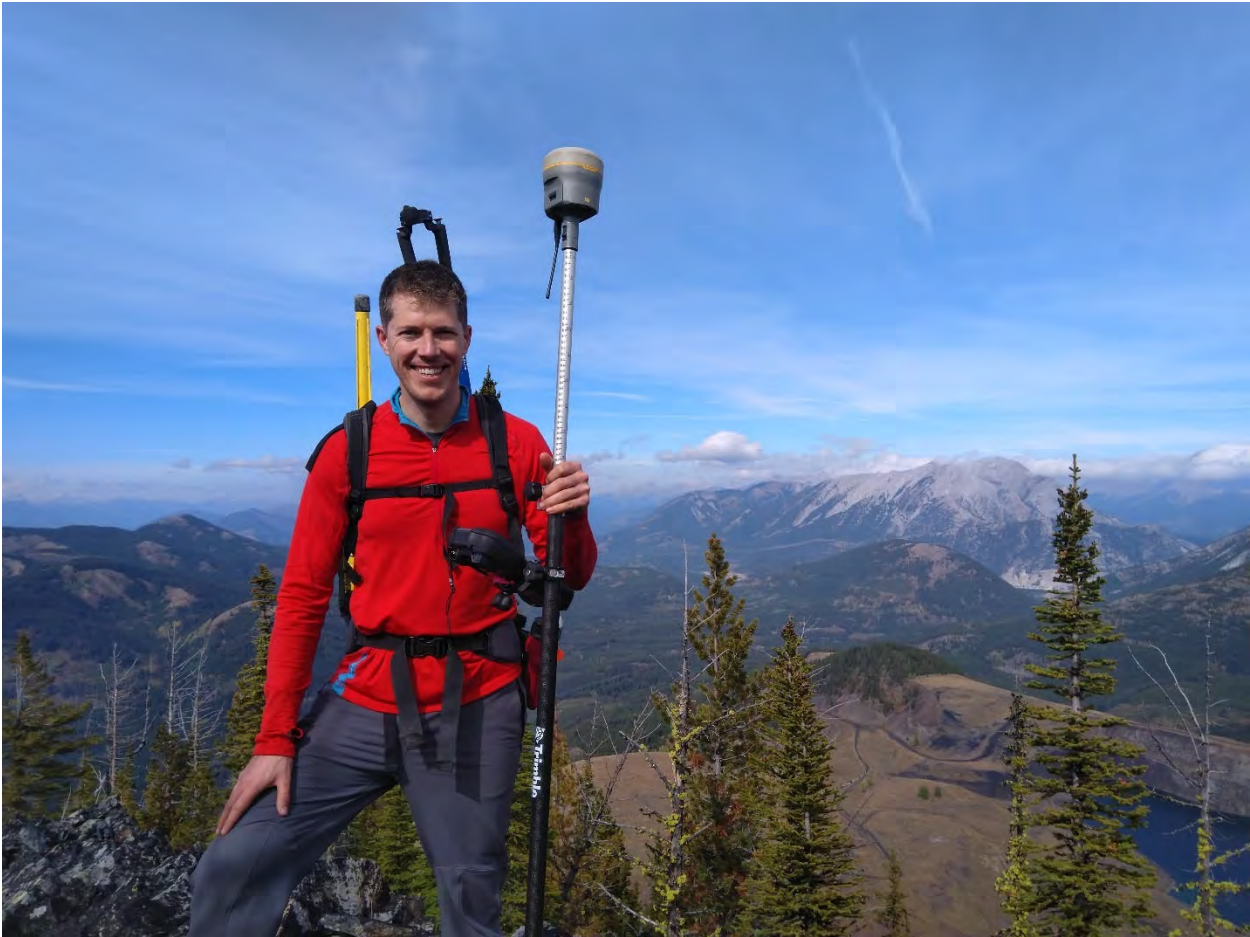
Monument 81F – Approximate Location

After completing 79F we proceeded steeply uphill to 81F. 81F is not part of the scope of work required for this contract. However, 81F is an A.O Wheeler original monument. Conrad Kain participated with A.O Wheeler on his 1914 trip to the Crowsnest Pass and it is possible he was involved with the original survey. Much to our disappointment no trace of 81F was found on the ridge.
