Alberta – British Columbia Boundary Commission

Survey Report

Yellowhead Pass Boundary Monument Project

Survey of Restoration of Survey Monuments S, 1S to 31S (Inclusively), and 33S Along a Portion of the Alberta – British Columbia Boundary

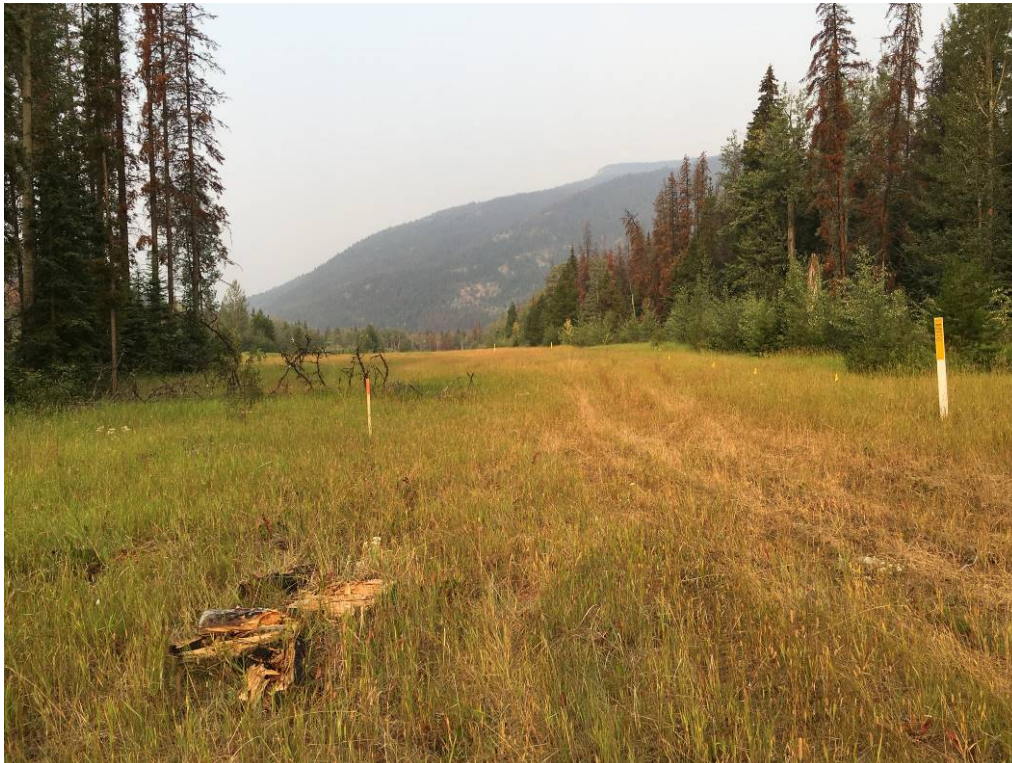
There was no evidence of Monument S on the ground due to ongoing maintenance of the utility right-of-way. There is a distinct cutline heading northwest to Monument 2S and southeast to monument 1S.

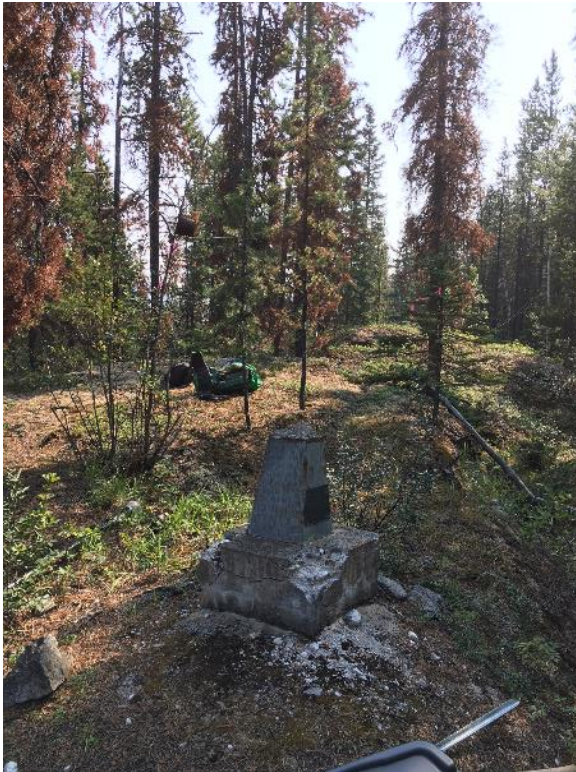
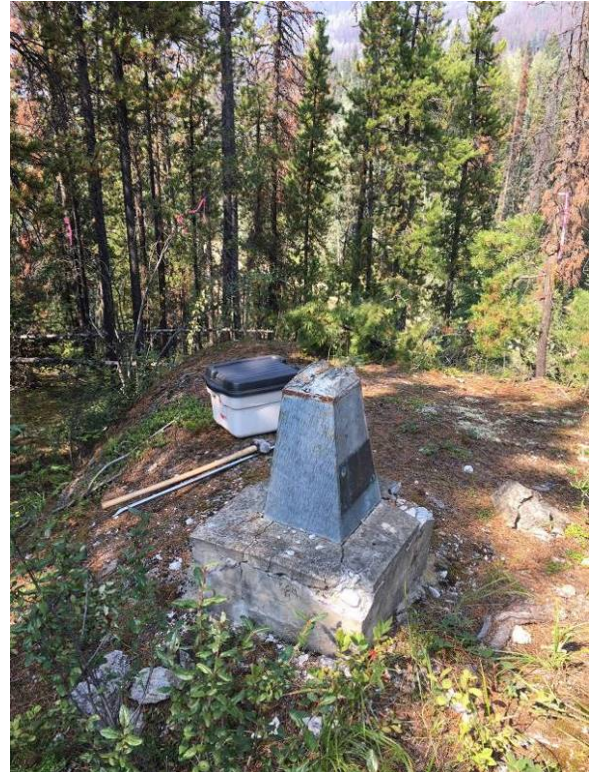
Monument 1S was found in poor condition with both the monolith and base deteriorating. The pillar cap and datum point was missing as well. Upon further inspection, all concrete easily broke off in large pieces and the removal of the monolith caused further deterioration and peeling of the concrete base. There is a distinct cutline northwest to monuments S and 2S and a hint of a cutline to 3S.

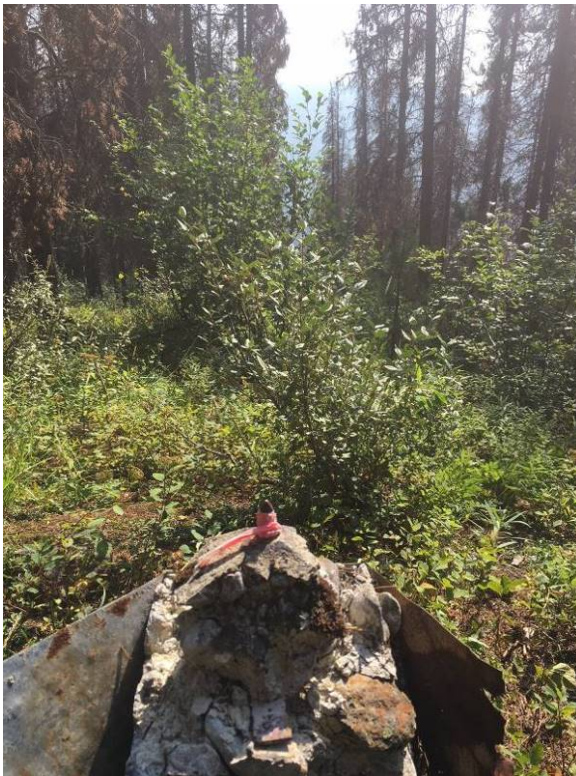
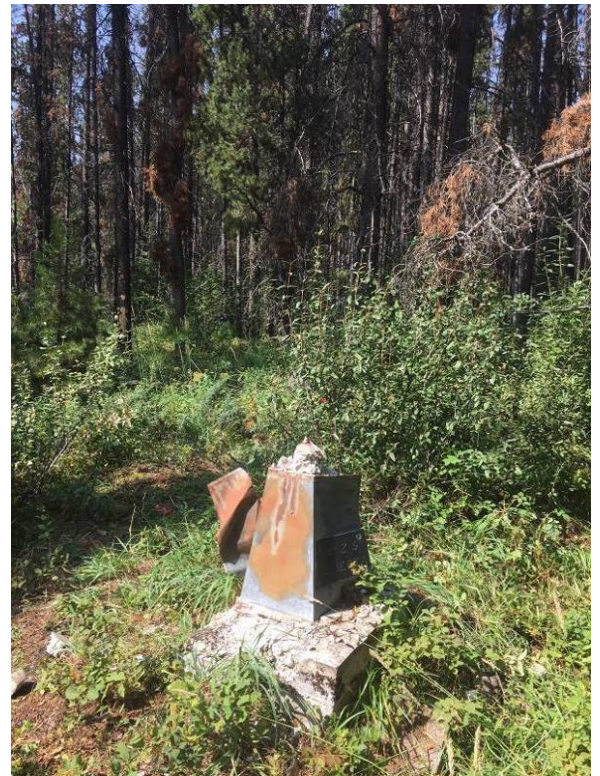
Monument 2S was found in poor condition with both the monolith and base deteriorating. The top of the pillar was missing but the datum point was still in place. Upon further inspection, all concrete easily broke off due to large cracks in the base and the removal of the monolith caused further deterioration of the concrete base. There was a faint cutline visible to the southeast towards S, but no visible cutline to 4S.

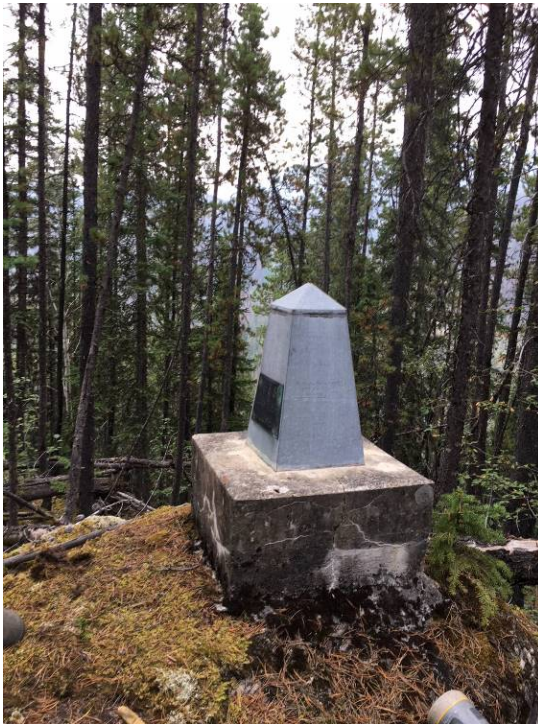
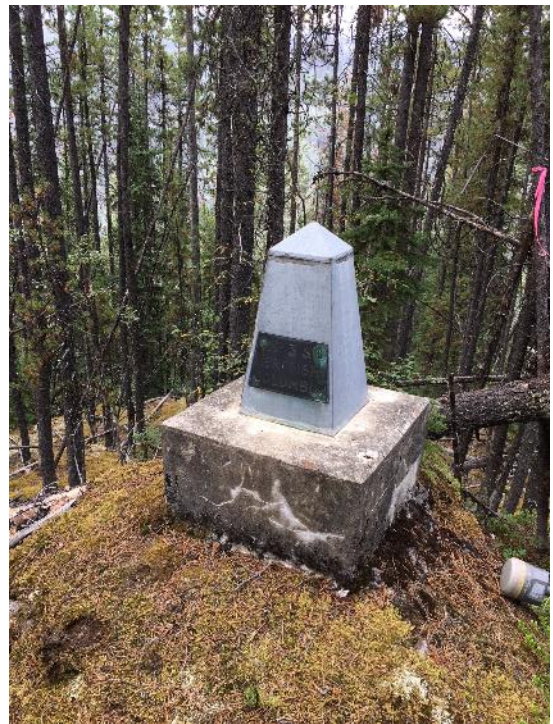
Monument 3S was found in excellent condition, with both the monolith and base still in place and no deterioration found. Minor cracks were observed in the base and one corner of the monolith was split open from the datum point to the base. There were no visible cutlines in either direction.

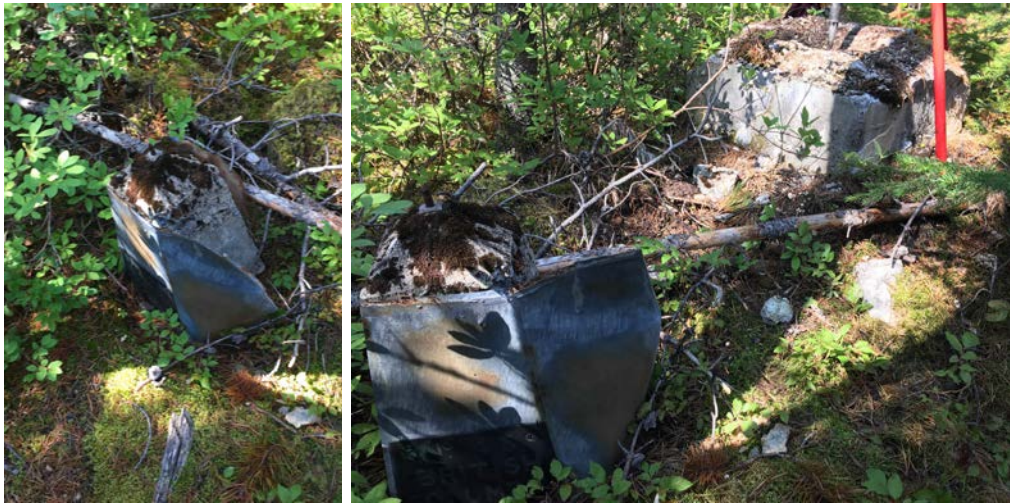
Monument 4S was found in poor condition with the monolith completely off the base, possibly knocked off by a downed tree. Upon further inspection, the concrete base easily broke apart due to damage from surrounding trees, weather, and moss. There were no visible cutlines to either 2S or 6S.

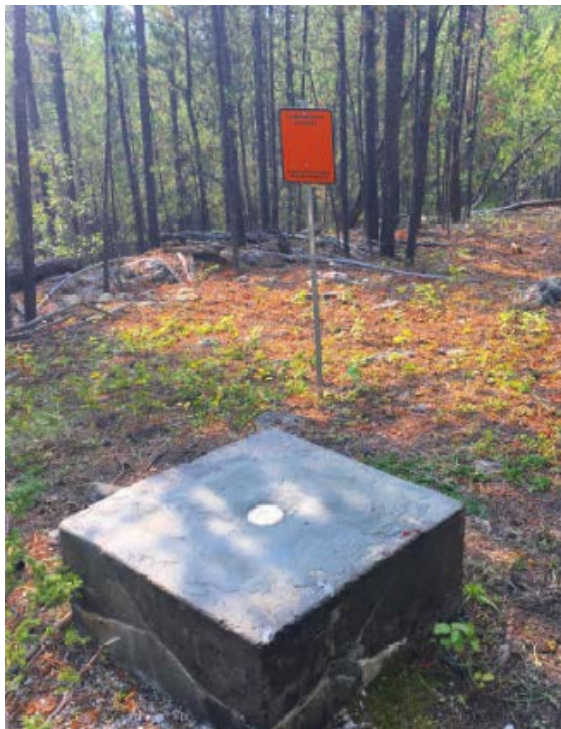
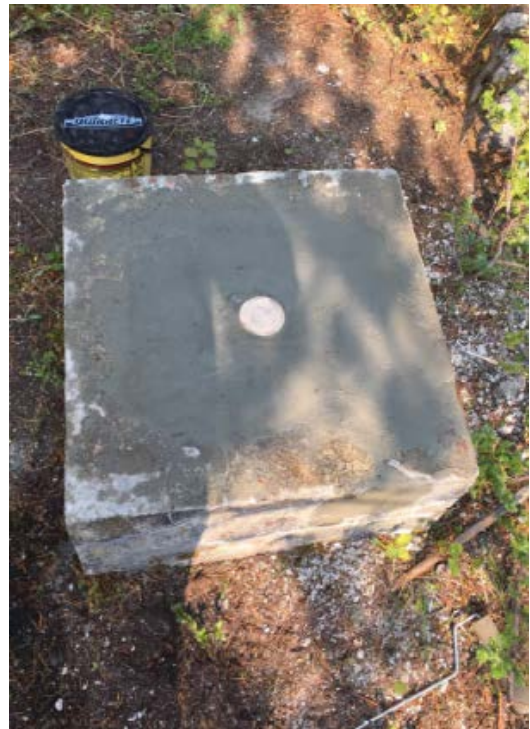
Monument 5S was found in fair condition with the monolith severely deteriorating and no datum point visible. The base had deeper cracks but the majority of it was still intact. There were prominent cutlines towards 7S and 3S. There was a number recorded below the tin plates on the monolith ('903-170814').

Monument 5S was surveyed using GNSS RTK methods from a base station set-up nearby on the highway. The monolith was carefully removed and the base was repaired by sealing the cracks and filling in where the pillar was removed. A standard rock post was set in the new concrete using the previous RTK measurement and measuring between the four corners for restoration. The entire base was sealed to mitigate erosion. A reference post was placed 1.5m northwest of the monument.

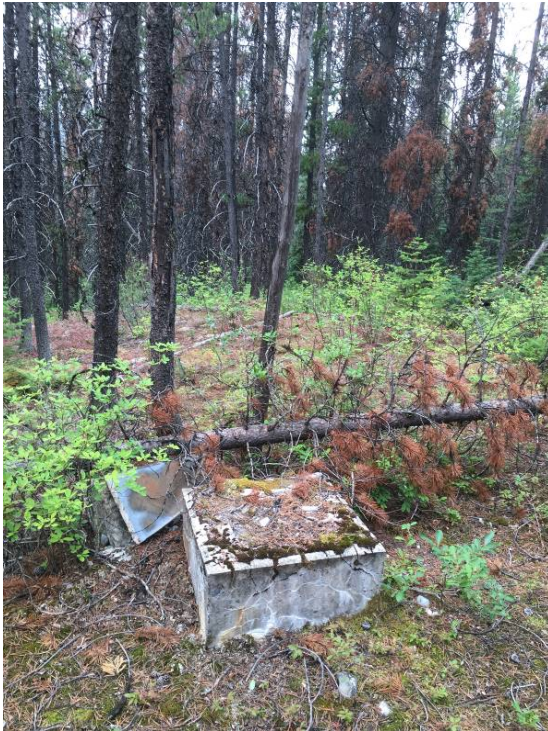
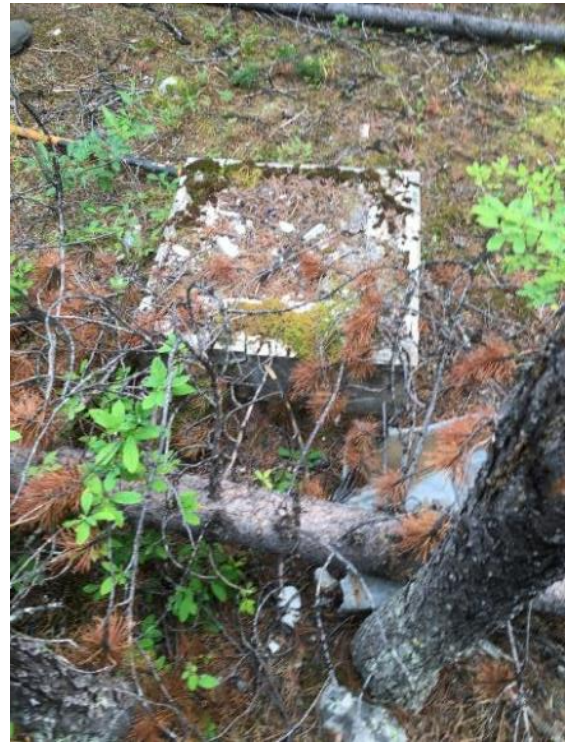
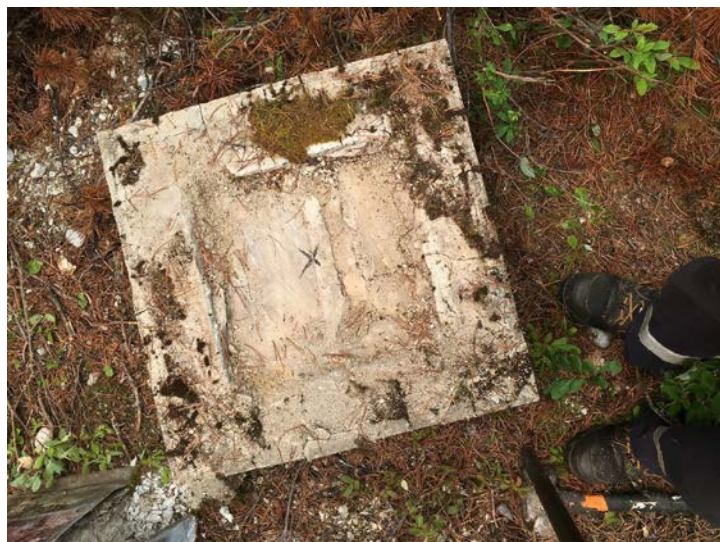
Monument 6S was found in poor condition with the monolith completely off the base and the base severely deteriorating. Upon clearing the vegetation and moss from the base, all the concrete of the base easily fell apart and restoring it was not an option. There were no visible cutlines in either direction.

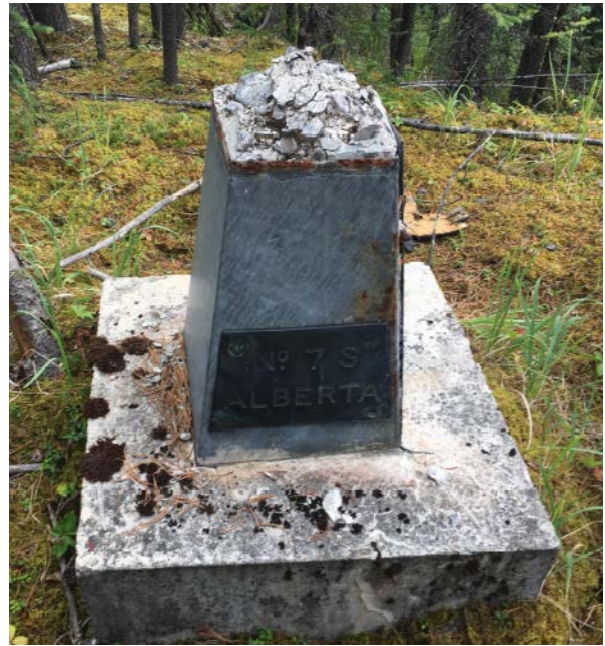
Monument 7S was found in poor condition with both the monolith and base deteriorating. The top of the pillar was completely missing but the datum point was still in place within the weathered concrete. Upon further inspection, the “minor cracks” in the concrete easily broke apart and the removal of the monolith caused further breaking of the concrete base. There was a prominent cutline towards 5S, but no visible cutline to 9S.

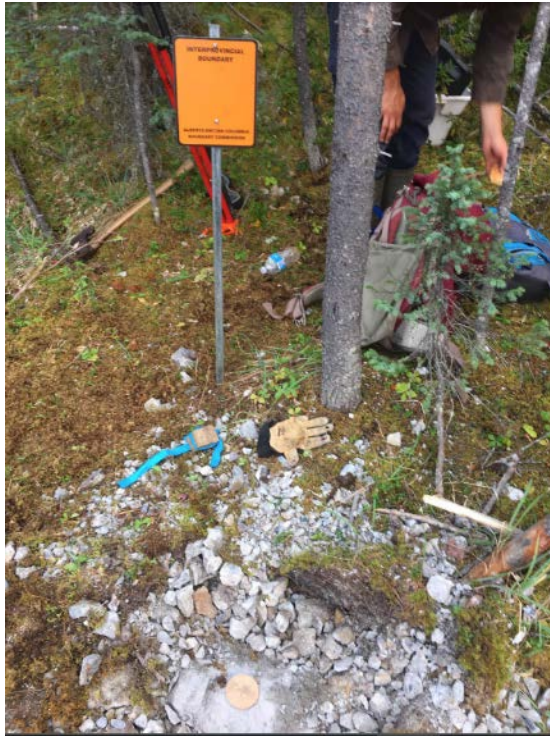
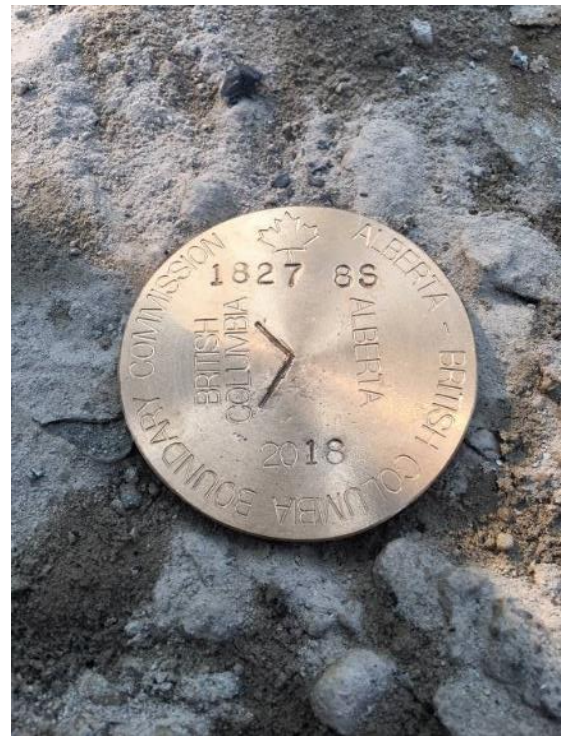
Monument 8S was found in fair condition with both the monolith and base deteriorating. The top of the pillar and the datum point were still in place but the tin on the monolith was peeling. This caused weather damage to the concrete inside. Upon further inspection of the minor cracks reported on the base, all of the concrete easily broke apart and the removal of the monolith caused further deterioration of the concrete base. There was a prominent cutline towards 5S, but no visible cutline to 9S.

Reference spikes were placed around the datum point in order to restore the centre of the monument upon demolition. The entire monument was then demolished to ground level and a standard rock post was set using a construction adhesive. A reference post was placed north of the monument. Two control points were established in a nearby clearing via GNSS RTK methods, as shown in the field notes sketch. Monument 8S was surveyed by traversing from control points set in a nearby clearing.

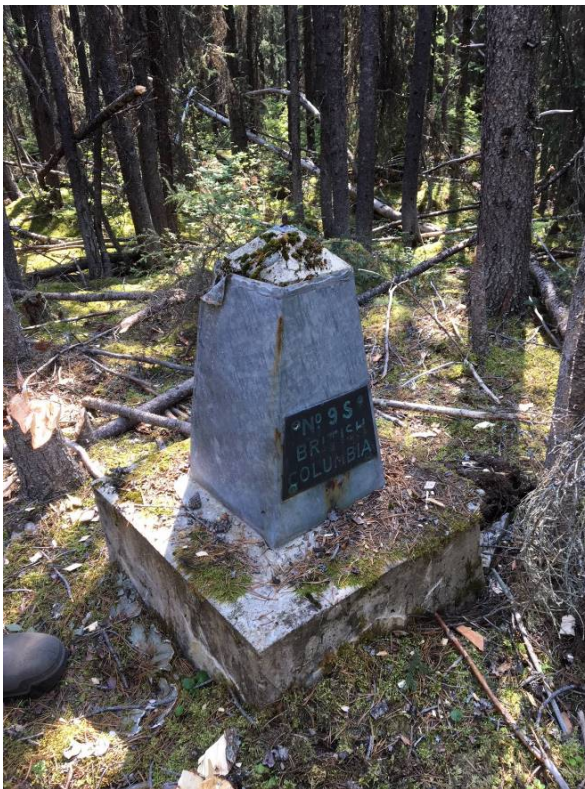
Monument 9S was found in poor condition with both the monolith and base severely deteriorating. The peeling tin on the monolith has introduced water damage within the concrete which required the entire structure to be removed. The removal of the monolith caused further deterioration of the concrete base and the small cracks in the base quickly gave way to large pieces of concrete breaking off, as shown in the photographs. There were no visible cutlines in either direction.

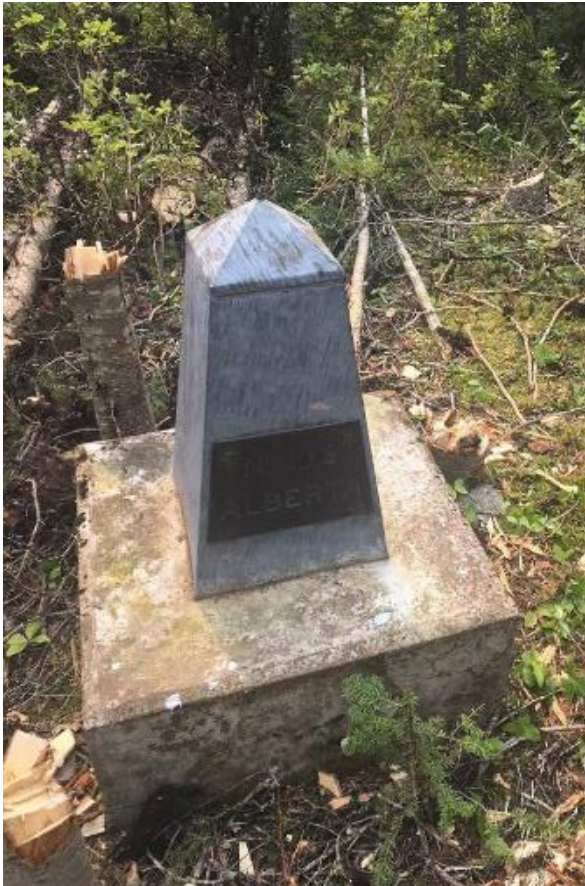
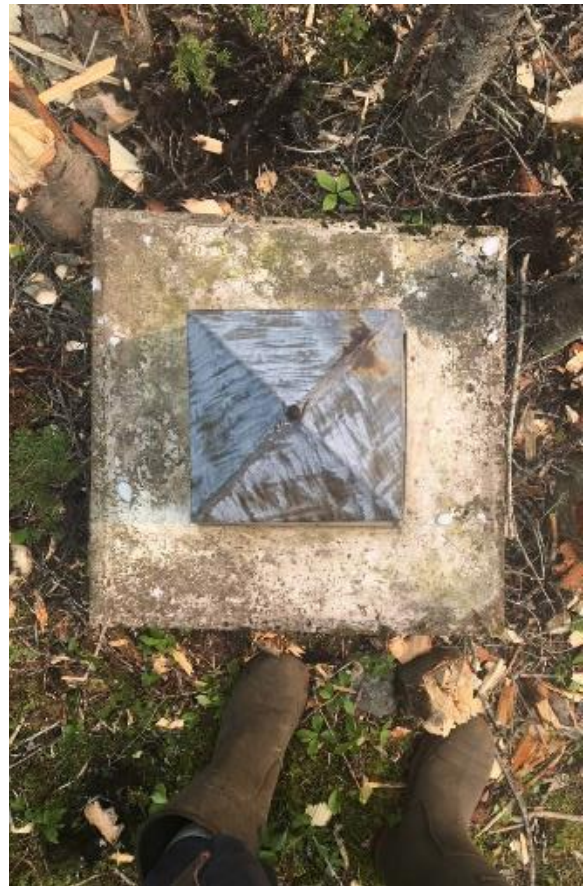
Monument 10S was found in excellent condition with both the monolith and base still in place and no deterioration found. There were minor cracks in the concrete base but nothing affecting the structural integrity. There was no visible cutline to 8S; however, there was a slight cutline visible uphill to 12S.

The cracks in the concrete base were sealed and the entire base was coated with a waterproof sealant. Monument 10S was surveyed using static GNSS observations and a marker post was set nearby.

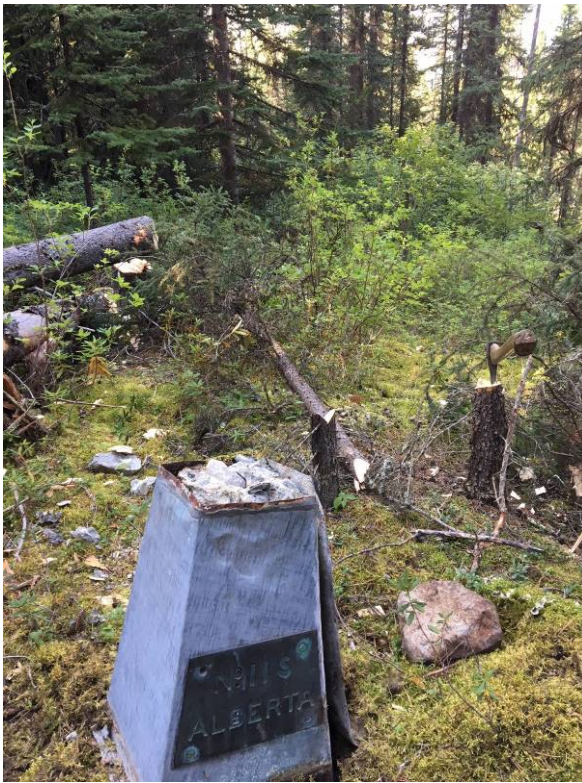
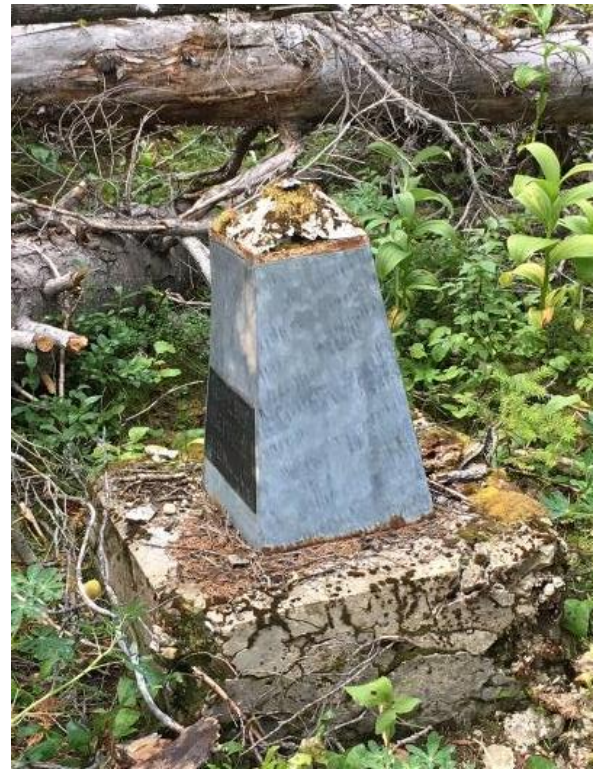
Monument 11S was found in poor condition with both the monolith and base severely deteriorating. The pillar top was missing but the datum point remained in place. The monolith was not salvagable and the subsequent removal caused further deterioration of the concrete base. The base was not salvagable due to the amount of vegetation growing in the cracks. There were no visible cutlines in either direction.

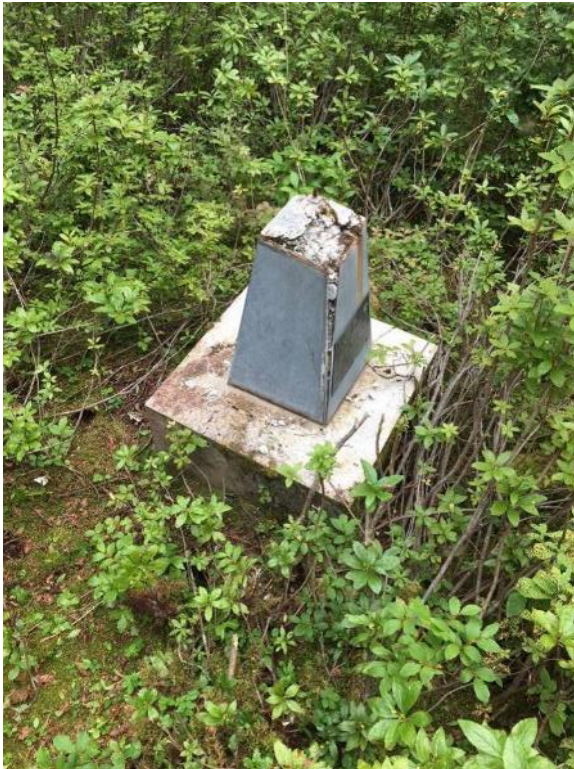
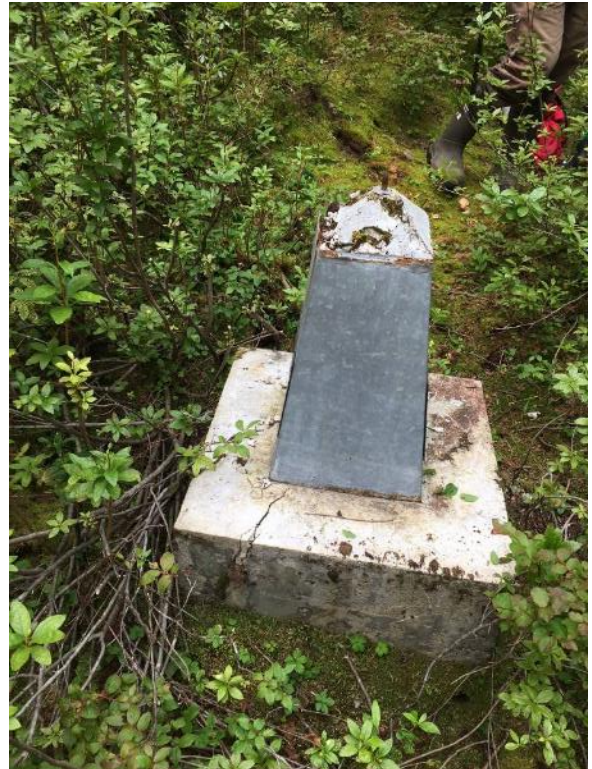
Monument 12S was found in fair condition with both the monolith and base deteriorating. The pillar top was partially missing but the datum point remained in place. Peeling tin on the monolith has caused heavy weathering of the concrete inside. Upon further inspection, all concrete easily broke off and the removal of the monolith caused further deterioration of the concrete base. There was no visible cutline to 10S; however, a prominent cutline towards 14S was observed.

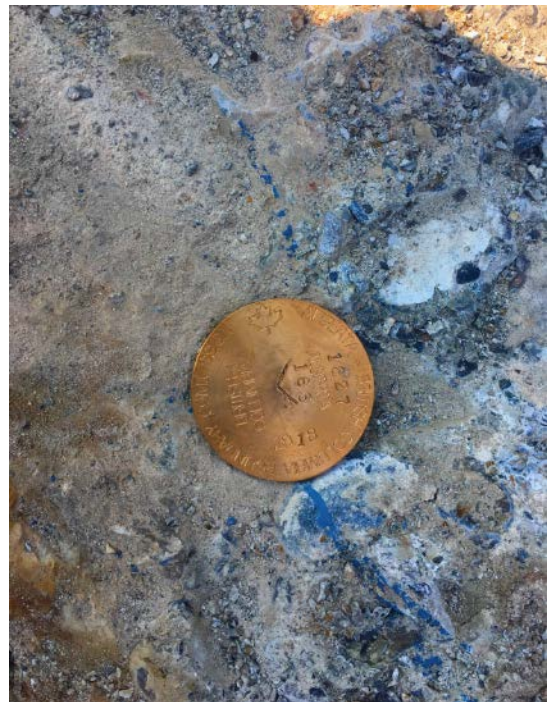
Monument 16S was found in poor condition with both the monolith and base deteriorating. The pillar top was off centre but the datum point remained in place. Upon further inspection, all concrete easily broke off and the removal of the monolith caused further deterioration of the concrete base. There were prominent cutlines to both monuments 14S and 18S.

Monument 16S was surveyed using static GNSS observations. Reference spikes were placed around the datum point in order to restore the centre of the monument upon demolition. The entire monument was then demolished to ground level and a standard rock post was drilled in the existing concrete and set using construction adhesive. A reference post was placed 0.95m north.

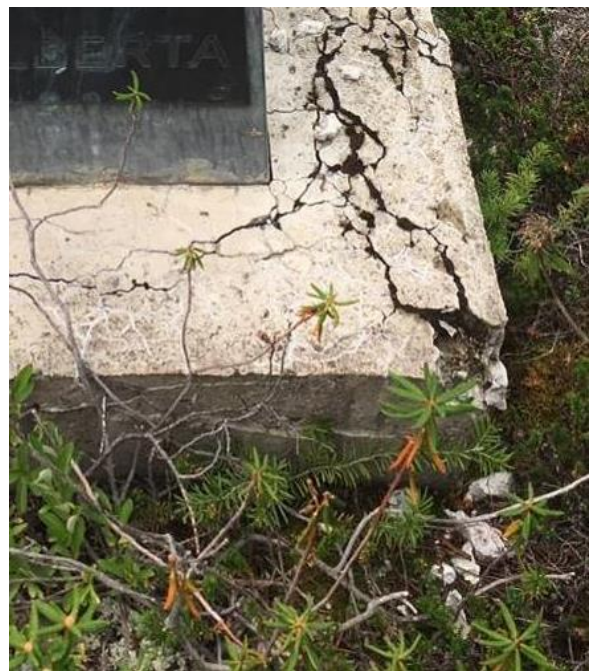
Monument 19S was found in poor condition with both the monolith and base deteriorating. The pillar top and datum point were missing. Upon further inspection, most concrete easily broke off and the removal of the monolith caused further deterioration of the concrete base. There was a clear cutline to 17S but nothing visible downhill to 21S.

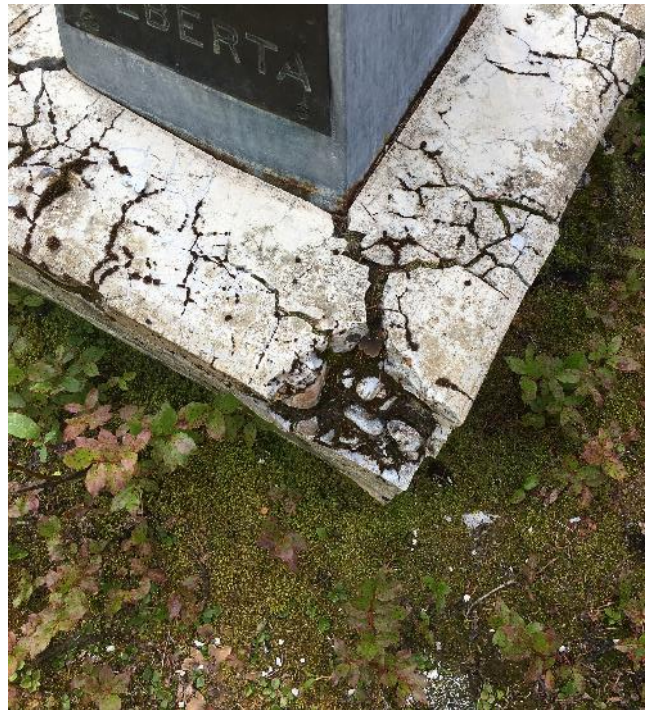
Monument 20S was found in poor condition with both the monolith and base deteriorating. The pillar top was missing but the datum point remained in place. Upon further inspection, all concrete easily broke off and the removal of the monolith caused further deterioration of the concrete base. There were faint cutlines to both monuments 18S and 22S.

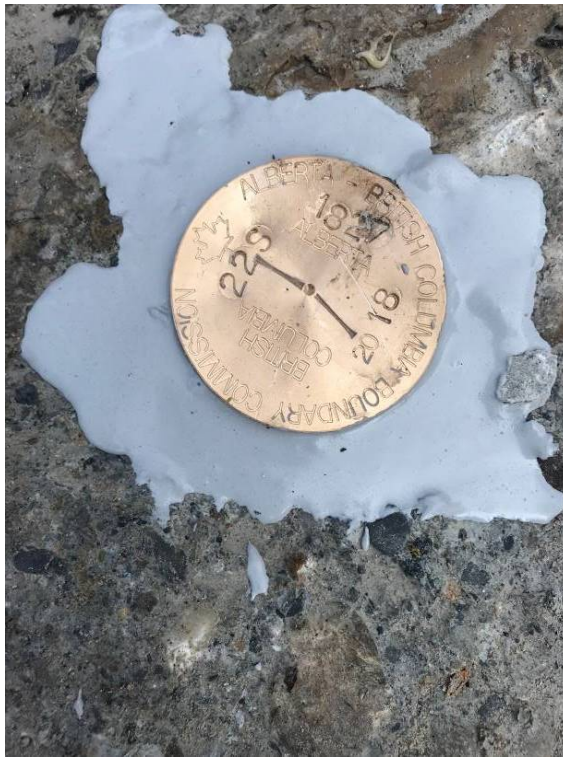
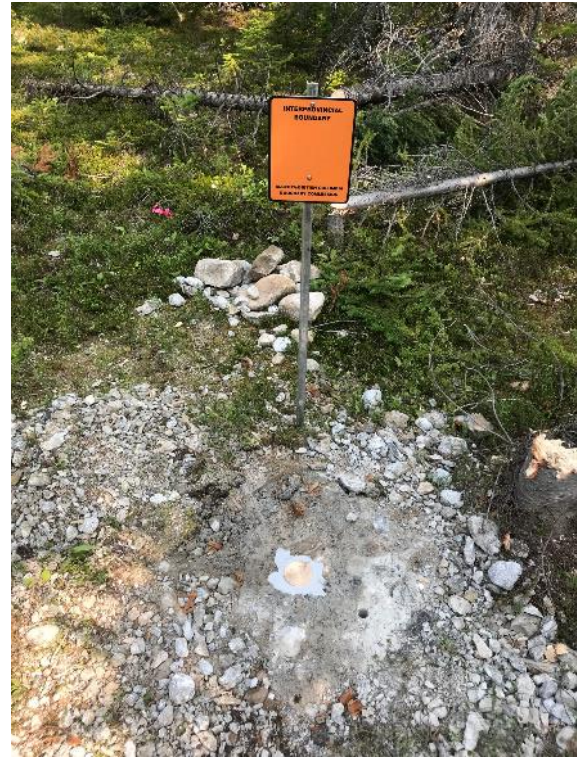
Monument 22S was found in poor condition with both the monolith and base severely deteriorating. The pillar top was partially missing but the datum point remains in place. Upon further inspection, all concrete easily crumbled and the removal of the monolith caused further deterioration of the concrete base. There was a visible cutline leading to 24S but nothing prominent to 20S.

Monument 22S was surveyed using static GNSS observations. Reference spikes were placed around the datum point in order to restore the centre of the monument upon demolition. The entire monument was then demolished to ground level and a standard rock post was drilled in the existing concrete and set using construction adhesive. A reference post was placed 0.55m north.

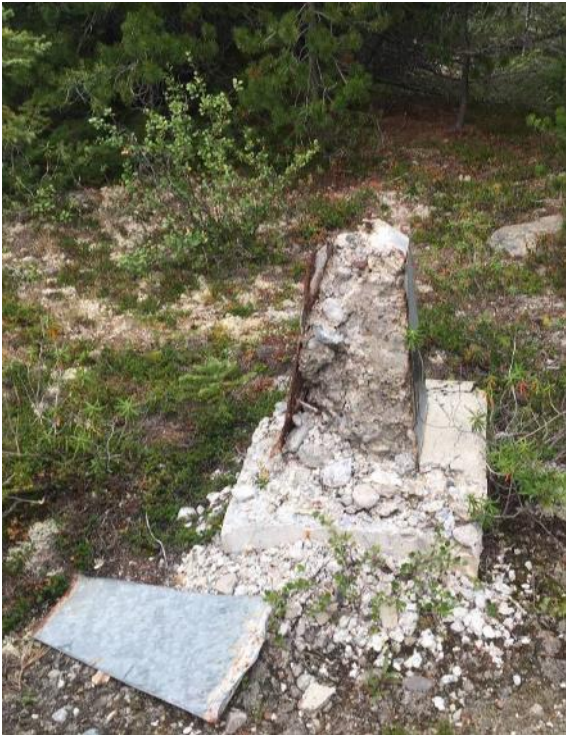
Monument 23S was found in poor condition with both the monolith and base deteriorating. The pillar top was missing but the datum point was still in place. Upon further inspection, all concrete easily broke off and the removal of the monolith caused further deterioration of the concrete base. There were no visible cutlines in either direction.

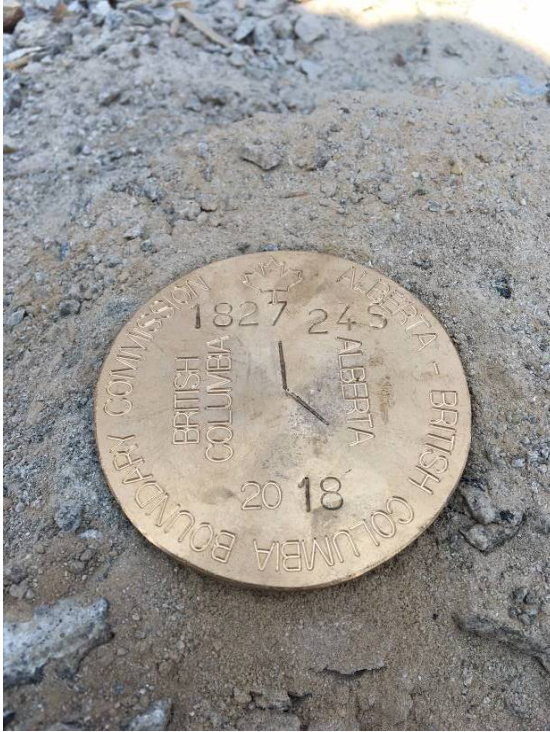
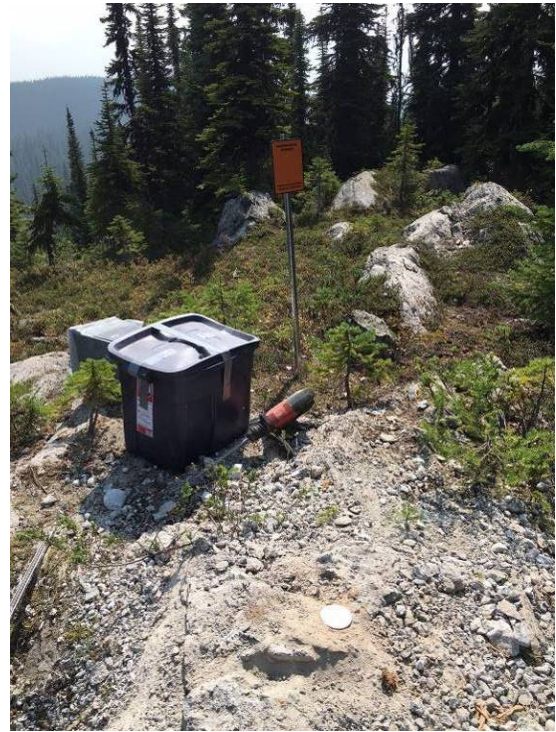
Monument 24S was found in poor condition with both the monolith and base severely deteriorating. The pillar top was partially missing but the datum point was still in place. Upon further inspection, all concrete easily broke off and the removal of the monolith caused further deterioration of the concrete base. There was a prominent cutline to 26S but nothing visible to 22S.

Reference spikes were placed around the datum point in order to restore the centre of the monument upon demolition. The entire monument was then demolished to ground level and a standard rock post was drilled in the existing concrete and set using construction adhesive. A reference post was placed nearby. Monument 24S was surveyed using static GNSS observations.

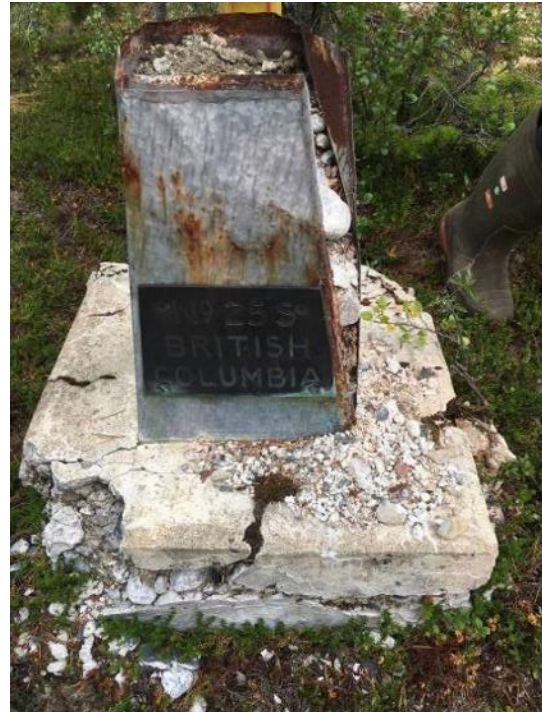
Monument 25S was found in poor condition with both the monolith and base severely deteriorating. The pillar top was missing but the datum point was still in place. Upon further inspection, all concrete easily broke off and the removal of the monolith caused further deterioration of the concrete base. There are no visible cutlines in either direction.

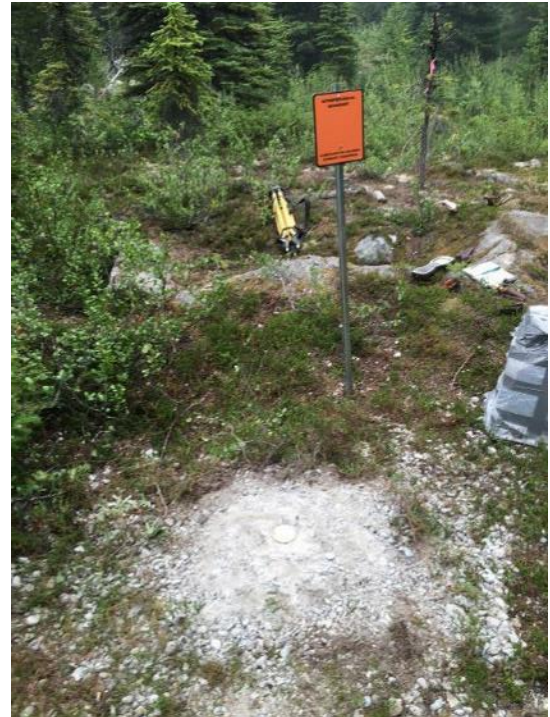
Monument 26S was found in fair condition with both the monolith and base deteriorating. The pillar top was off centre but the datum point was still in place. Upon further inspection, all concrete easily broke off and the removal of the monolith caused further deterioration of the concrete base due to large cracks already in place. There were visible cutlines in either direction.

Monument 26S was surveyed using static GNSS observations. Reference spikes were placed around the datum point in order to restore the centre of the monument upon demolition. The entire monument was then demolished to ground level and a standard rock post was drilled in the existing concrete and set using construction adhesive. A reference post was placed nearby.

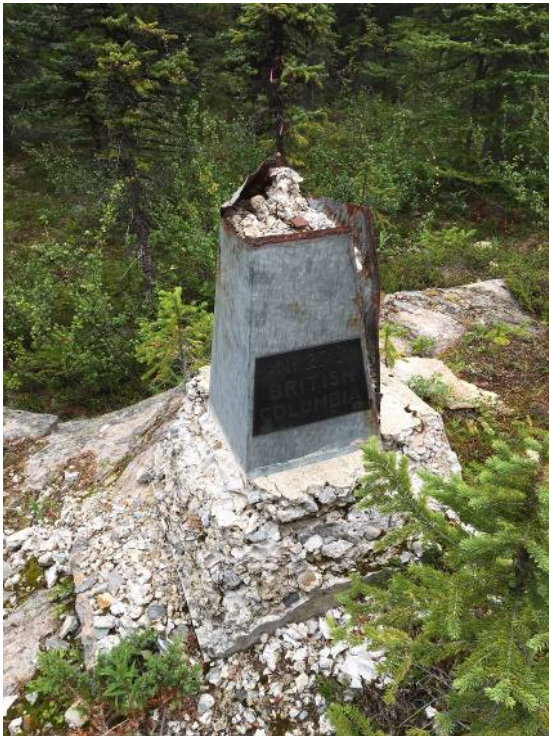
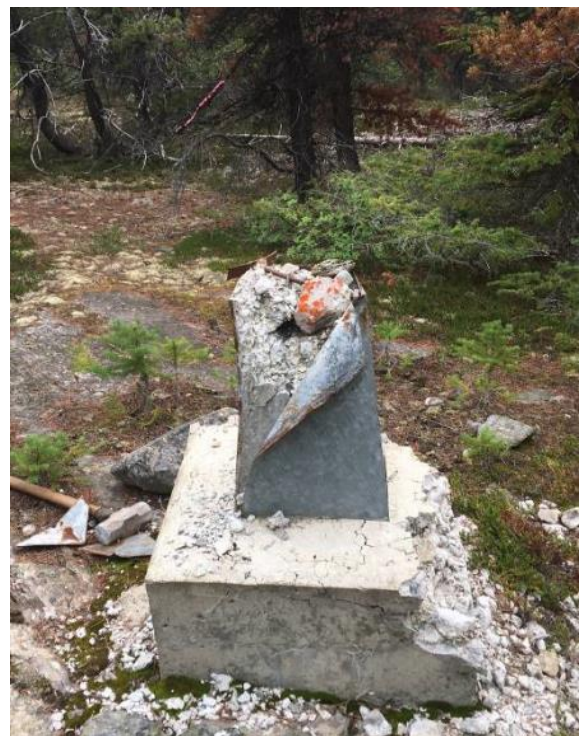
Monument 27S was found in poor condition with both the monolith and base severely deteriorating. The pillar top was partially missing and the datum point was off centre. Upon further inspection, all concrete easily broke off and the removal of the monolith caused further deterioration of the concrete base. There was a faint cutline to 25S but nothing visible to 29S.
