Surveyor General Report: 2021 Lytton Wildfire Cadastral Preservation

Cristin Schlossberger, Surveyor General
Peter Haas, Deputy Surveyor General

Date: February 14, 2025

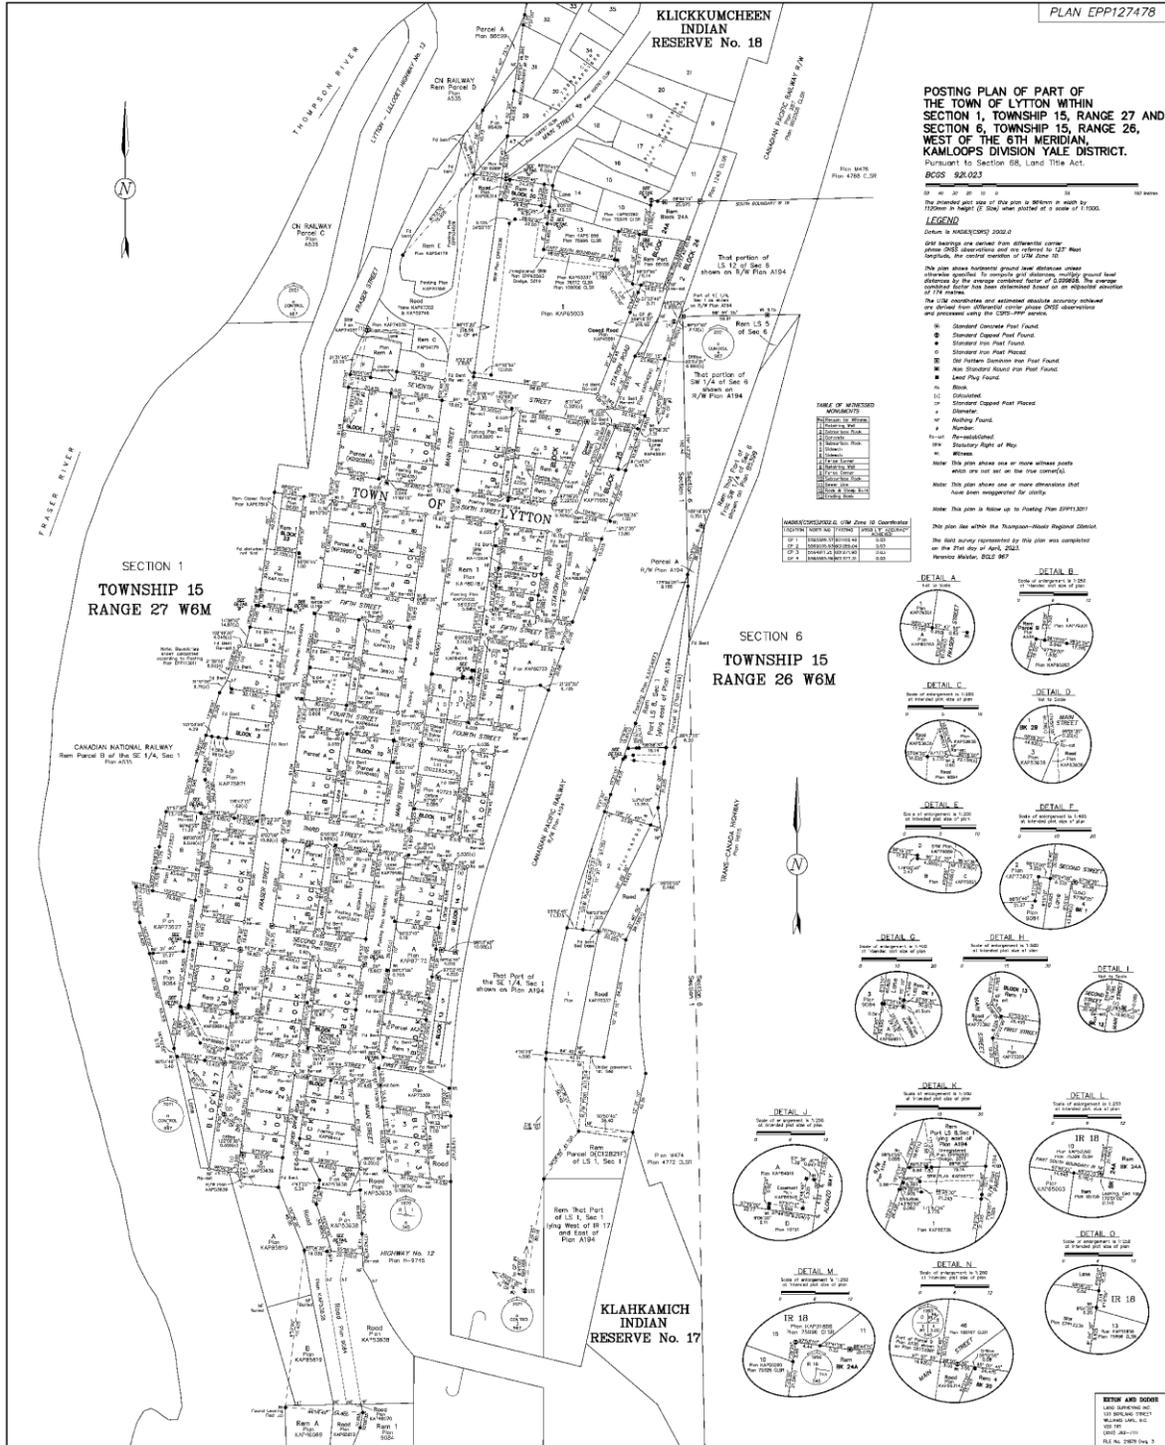
GeoBC Ortho Imagery
– Cadastral Overlays Prepared by Office of SG – Keyplan

The LTSA provided land title documents and survey plans free of charge, in the public interest, to support the surveyors on the ground. The LTSA produced a cadastral overlay⁴ of ParcelMap BC fabric with high resolution Orthophotos from GeoBC; this overlay was shared with the land surveyors working on site. Following delays due to an extreme weather event that significantly damaged highways across southern BC, the field work, for the initial scope of work, was completed in December 2021.

imagery and terrain models were incorporated to refine the cadastral overlay, improving accuracy for reconstruction planning.
