Alberta – British Columbia Boundary Commission

Survey Report

Yellowhead Pass Boundary Monument Project

Survey of Restoration of Survey Monuments S, 1S to 31S (Inclusively), and 33S Along a Portion of the Alberta – British Columbia Boundary

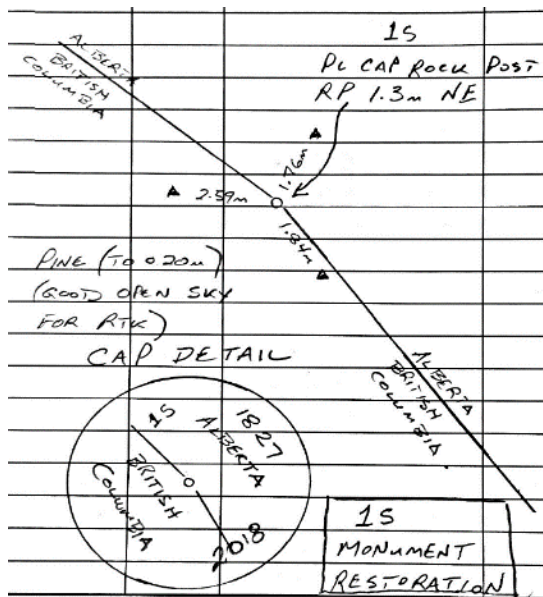
Monument 1S was found in poor condition with both the monolith and base deteriorating. The pillar cap and datum point was missing as well. Upon further inspection, all concrete easily broke off in large pieces and the removal of the monolith caused further deterioration and peeling of the concrete base. There is a distinct cutline northwest to monuments S and 2S and a hint of a cutline to 3S.

15 MONUMENT RESTORATION		
FOUND MONUMENT IN POOR CONDITION SHOT MONUMENT TIP W/ATK (SEE PG 4). ALSO MEASURED IN 3 REFERENCE SPIKES. FOR A SECONDARY CHECK (SEE SKETCH ON PAGE 5). REMOVED MONUMENT AND BASE. PLACED CAPPED ROCK POST TO RTK POSITION. CHECKED TO REF SPIKES. PHOTOS ATTACHED W/ TODAY'S DATA.		
10015(-) 148	PL CAP ROCK POST - 2.0m (2.3m)	RP 1.3 m NE

Reference spikes were placed around the datum point in order to restore the centre of the monument upon demolition. The entire monument was then demolished to ground level and a standard rock post was set in the centre using a construction adhesive. A reference post was placed 1.3m northeast. 1S was surveyed in using GNSS RTK methods, with a base station set-up nearby on the highway. Although the photograph does not clearly show it, the cap has 'Alberta' and 'British Columbia' stamped on the correct sides.

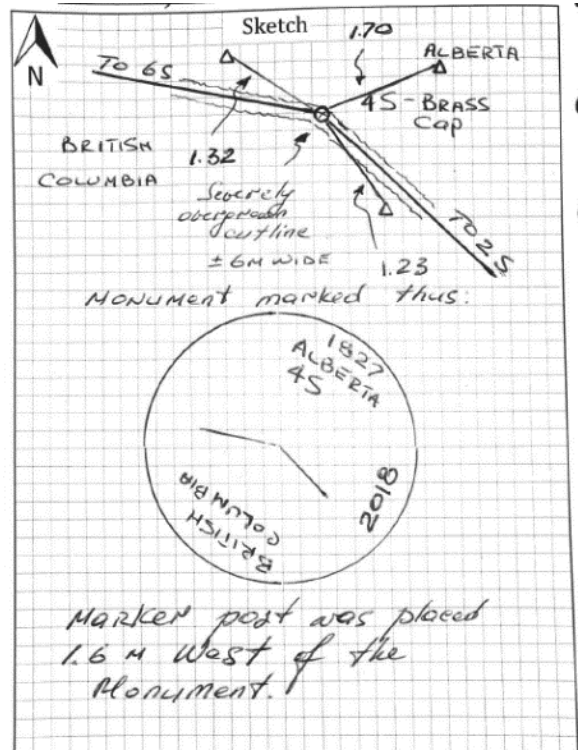
Monument 4S was found in poor condition with the monolith completely off the base, possibly knocked off by a downed tree. Upon further inspection, the concrete base easily broke apart due to damage from surrounding trees, weather, and moss. There were no visible cutlines to either 2S or 6S.

Point No.	Code	Description	Height
①	Check TO SRS 4 BY S.		
		Snowden on Aug 19, 2018	
	SRS 4 112	CHK	2.00
		Alt = 0.019 ΔV = -0.029	
②	Monument 45.		
		Found monument 45, top monoliths been knocked off, the base is in poor condition. Measured the centre of the base with a tape, placed 3 reference spikes: 1.70m, 1.23m, 1.32m. The base was brought down to ground level. The centre was restored and the brass cap was placed in the centre using reference spikes. RTK RTK observations were taken to obtain coordinates.

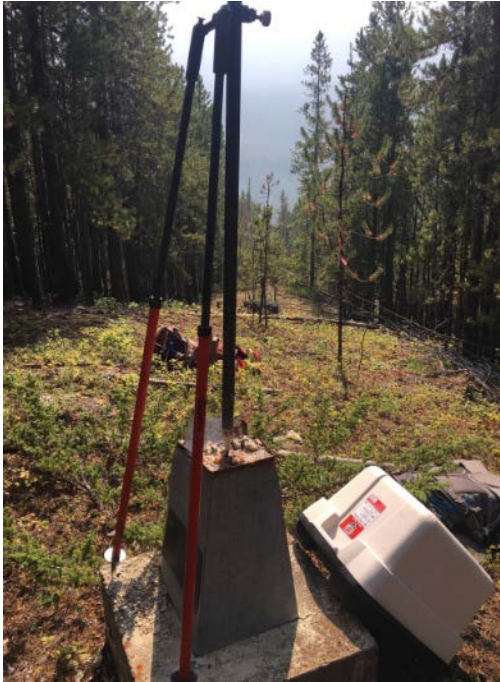
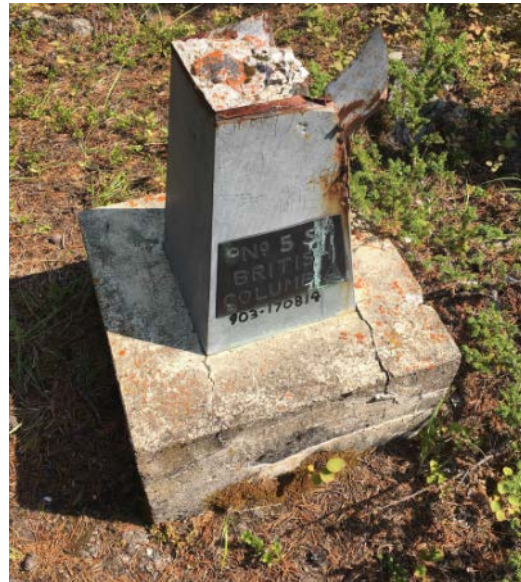
Monument 5S was found in fair condition with the monolith severely deteriorating and no datum point visible. The base had deeper cracks but the majority of it was still intact. There were prominent cutlines towards 7S and 3S. There was a number recorded below the tin plates on the monolith ('903-170814').

Monument 5S was surveyed using GNSS RTK methods from a base station set-up nearby on the highway. The monolith was carefully removed and the base was repaired by sealing the cracks and filling in where the pillar was removed. A standard rock post was set in the new concrete using the previous RTK measurement and measuring between the four corners for restoration. The entire base was sealed to mitigate erosion. A reference post was placed 1.5m northwest of the monument.

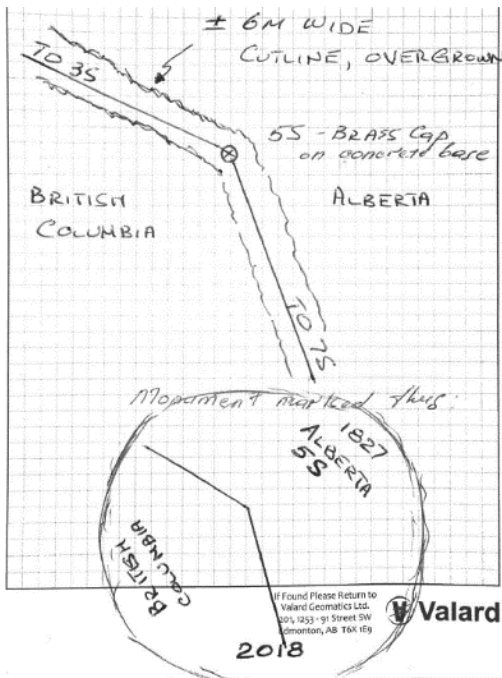
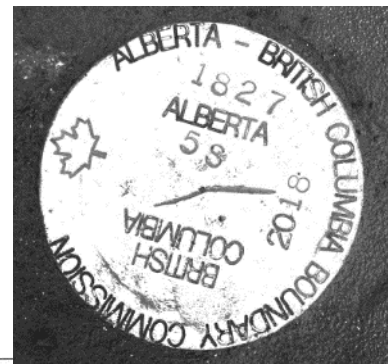
Found monument 55 monolith top in poor condition, the base is repairable. Observed the centre of the top monolith and removed it, prepared the base, cleaned up of a debris, filled up with concrete and bonding adhesive. Staked the centre of the monument to its previously observed position. MARKER post placed 1.5 m NW of the monument.

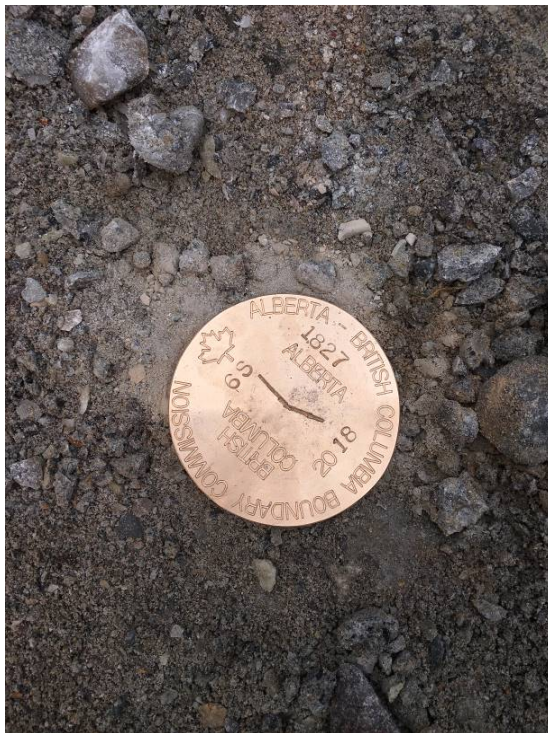
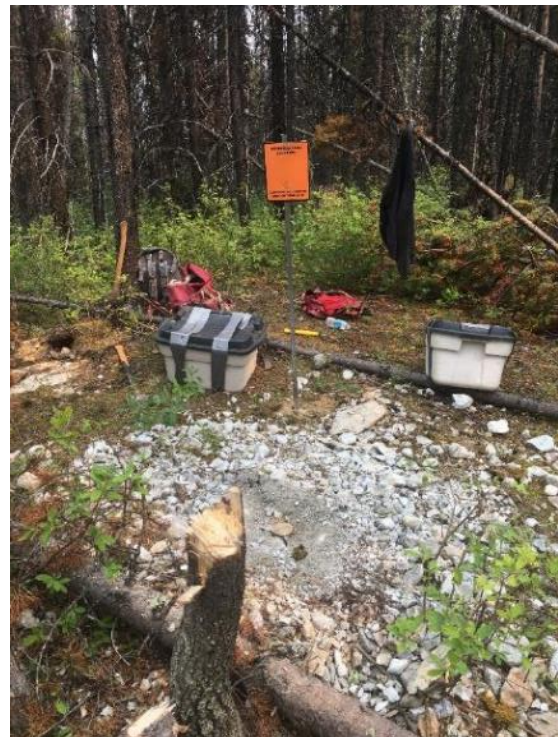
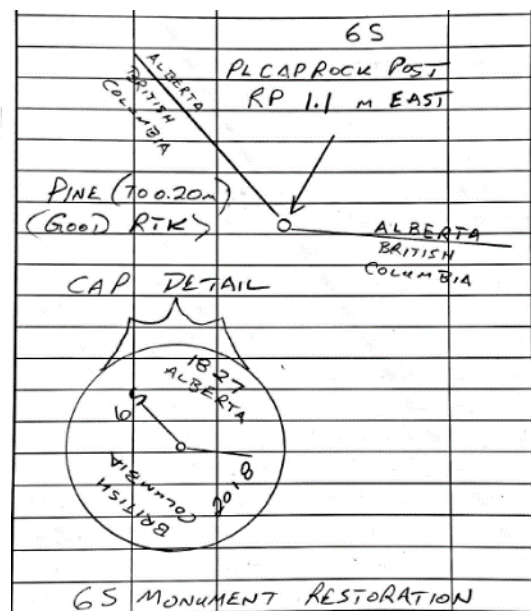
Monument 6S was found in poor condition with the monolith completely off the base and the base severely deteriorating. Upon clearing the vegetation and moss from the base, all the concrete of the base easily fell apart and restoring it was not an option. There were no visible cutlines in either direction.

BASE PT #	SRS 3	H.I.	1.890m
START CHECK PT #	SRS 4		2.000m
		ΔH 2mm ΔV 1mm	
106 S(-1)	157	6S FD CONCRETE	1.80m (2.10m)
		BASE - CTR (INTERSECTION OF CORNERS)	
FD CONCRETE BASE OF 6S. PILLAR WAS LAYING ON THE GROUND. MEASURED CTR OF BASE BY INTERSECTION OF CORNERS. SHOT w/ RTK (106S(-1)). REMOVED BASE. PL CAPPED ROCK POST TO 106 S.			
106S(-1)	148	PL CAP ROCK POST	2.0m (2.3m)
		RP 1.1m EAST

The centre of the base was measured using the four corners of the base, rather than reference spikes. The entire monument was then demolished to ground level and a standard rock post was set using a construction adhesive. A reference post was placed 1.1m east. Monument 6S was surveyed using GNSS RTK methods.

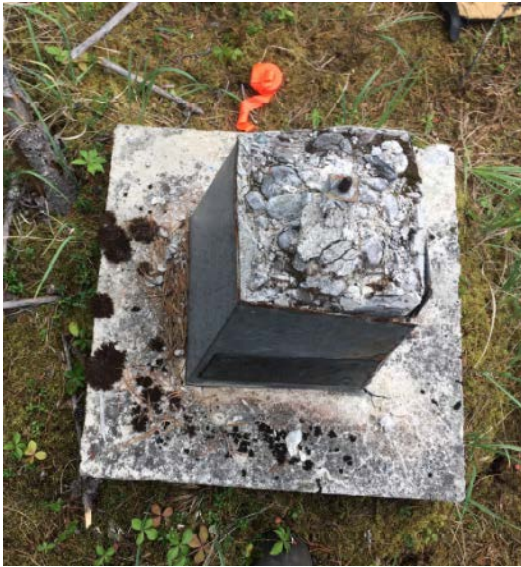
Monument 7S was found in poor condition with both the monolith and base deteriorating. The top of the pillar was completely missing but the datum point was still in place within the weathered concrete. Upon further inspection, the “minor cracks” in the concrete easily broke apart and the removal of the monolith caused further breaking of the concrete base. There was a prominent cutline towards 5S, but no visible cutline to 9S.

Monument 7S was georeferenced by taking a GNSS RTK measurement on the datum point in order to restore the centre of the monument upon demolition. Therefore, no reference spikes were used. The entire monument was then demolished to ground level and a standard rock post was set using a construction adhesive. A reference post was placed south of the monument.

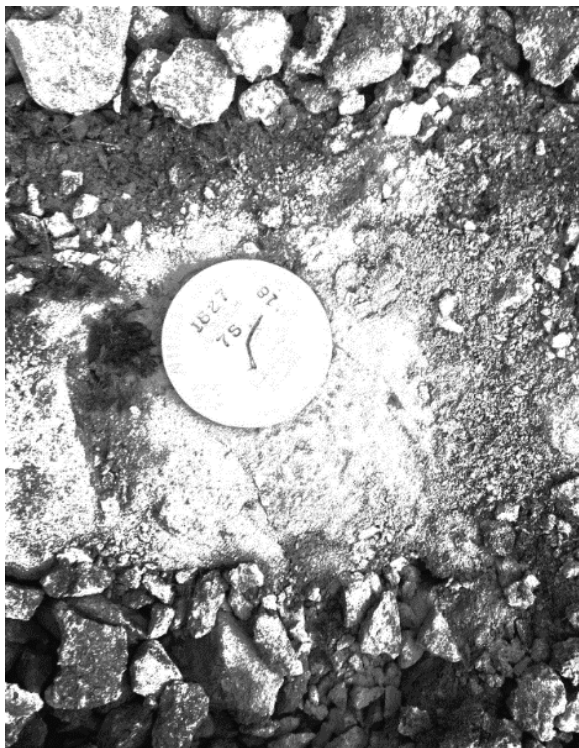
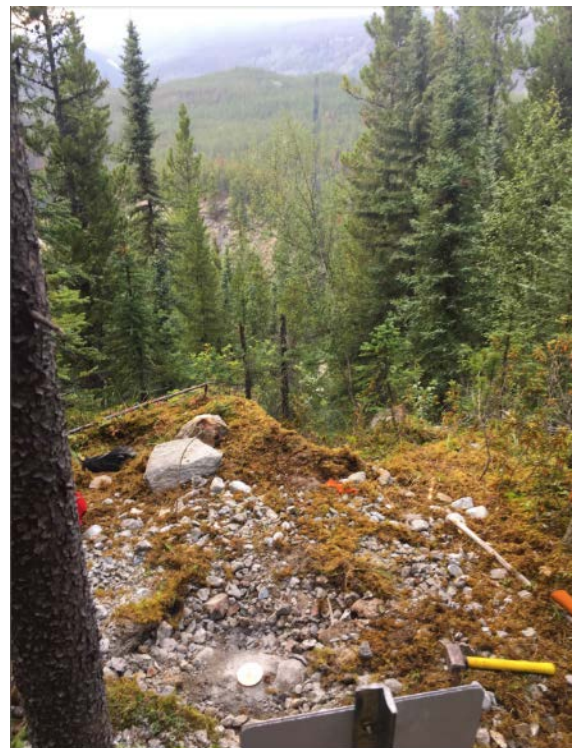
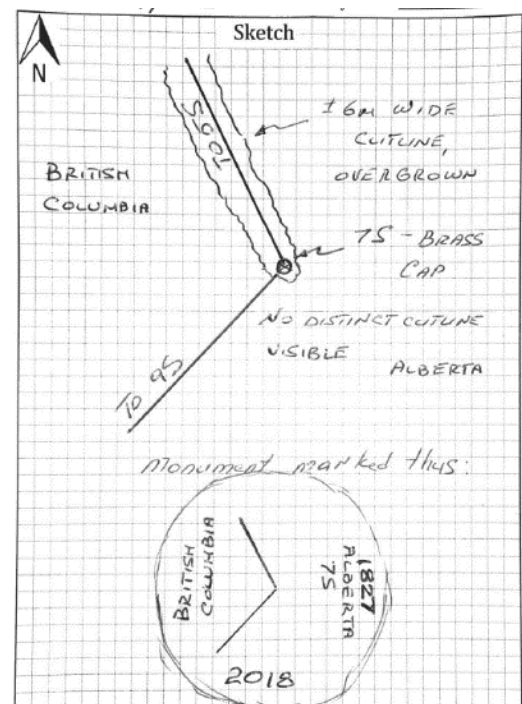
Note: the description of restoration to monument 7S mentions 5S rather than 7S. This is a blunder in the field notes and should read 7S.

7S
(3) Monument 55 . Found Monument 55 of top monolith part of the monument in poor condition, base with cracks. Observed the top monument centre. Top monolith part was removed and the base was brought down to ground level. Marked the previously observed position of the centre of the monument into its original position. Placed rock Brass cap in the rock.

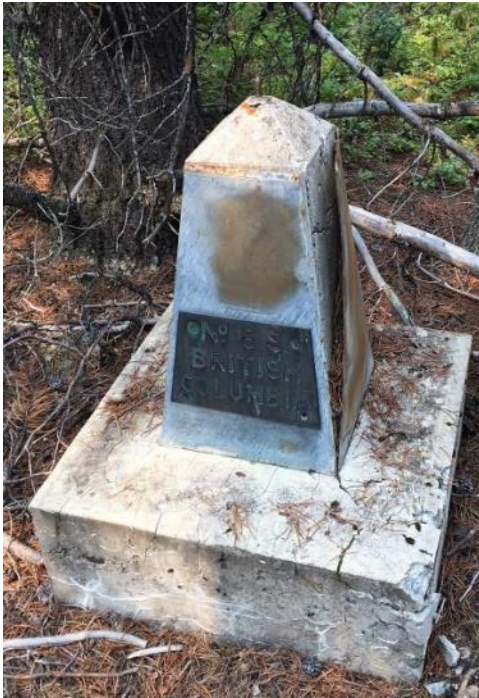
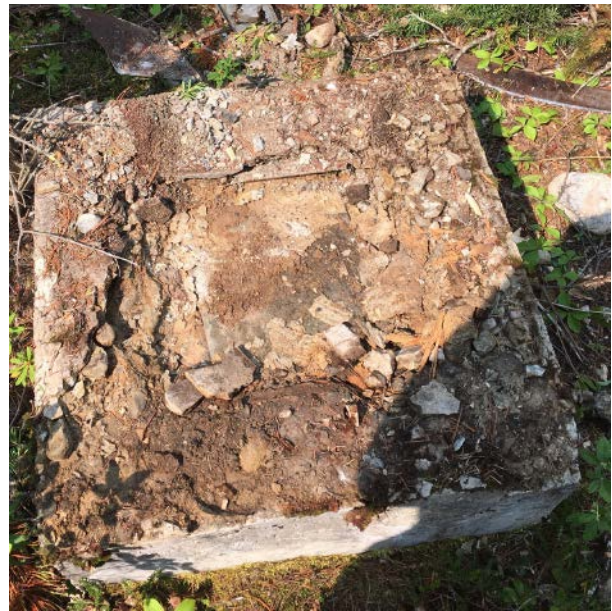
Monument 8S was found in fair condition with both the monolith and base deteriorating. The top of the pillar and the datum point were still in place but the tin on the monolith was peeling. This caused weather damage to the concrete inside. Upon further inspection of the minor cracks reported on the base, all of the concrete easily broke apart and the removal of the monolith caused further deterioration of the concrete base. There was a prominent cutline towards 5S, but no visible cutline to 9S.

Reference spikes were placed around the datum point in order to restore the centre of the monument upon demolition. The entire monument was then demolished to ground level and a standard rock post was set using a construction adhesive. A reference post was placed north of the monument. Two control points were established in a nearby clearing via GNSS RTK methods, as shown in the field notes sketch. Monument 8S was surveyed by traversing from control points set in a nearby clearing.

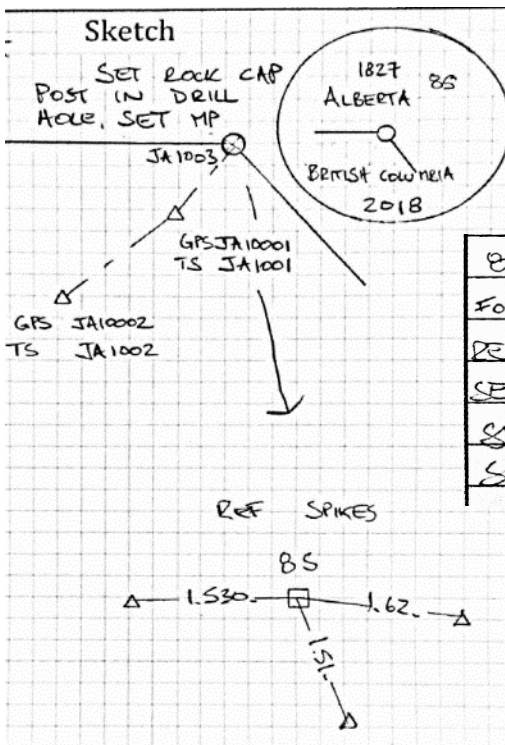
BS			
FOUND OLD MONUMENT, MONUMENT & BASE DETERIORATING.			
RE-ESTABLISHED CENTRE USING REMAINING MONUMENT.			
SET THREE REFERENCE SPIKES, REFER TO SKETCH			
UNABLE TO OCCUPY DUE TO CANOPY			
SET 2 CONTROL POINTS, TIED CONVENIENTLY

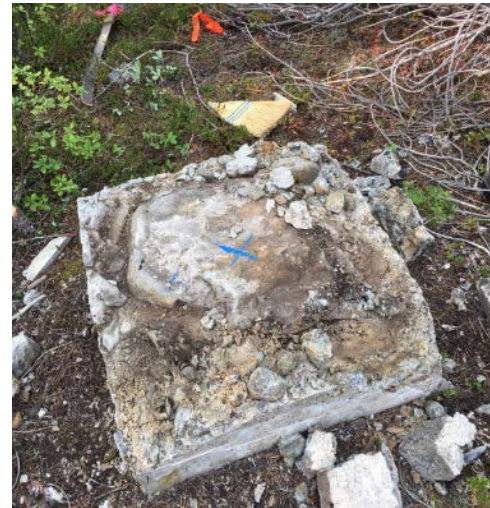
Monument 9S was found in poor condition with both the monolith and base severely deteriorating. The peeling tin on the monolith has introduced water damage within the concrete which required the entire structure to be removed. The removal of the monolith caused further deterioration of the concrete base and the small cracks in the base quickly gave way to large pieces of concrete breaking off, as shown in the photographs. There were no visible cutlines in either direction.

Monument 9S was georeferenced by GNSS RTK ties to the datum point in order to restore the centre of the monolith upon demolition. Therefore, reference spikes were not required to restore this monument. The entire monument was then demolished to ground level and a standard rock post was set using a construction adhesive. A reference post was placed 1.5m south.

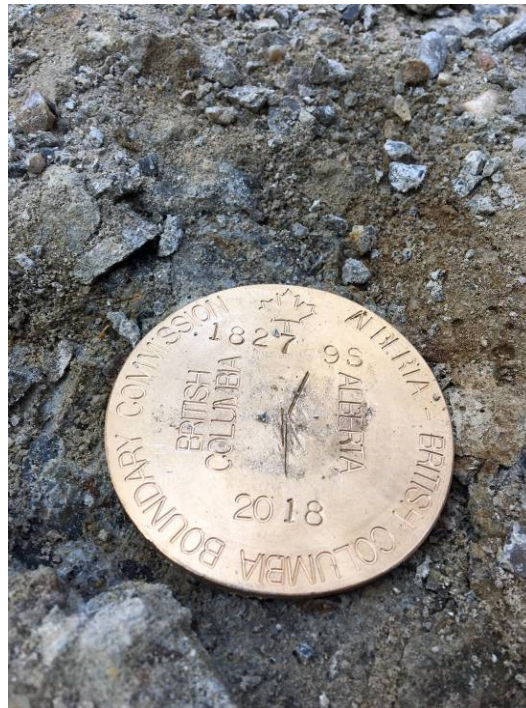
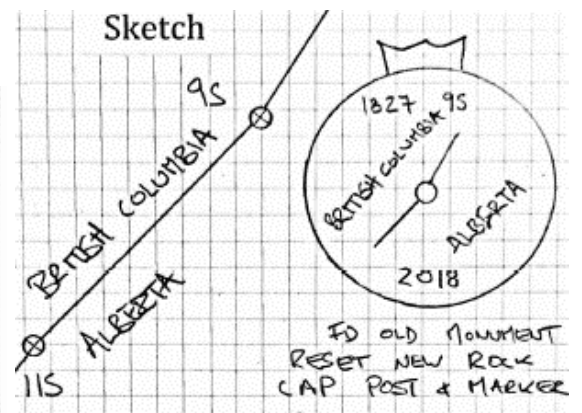
95			
FOUND OLD MONUMENT		BASE & MONOLITH DETERIORATING	
SHOT TOP	REMOVED	BASE & MONOLITH. RESET ROCK	
CAP POST & MARKER		POST 1/8 1.50- SOUTH	
JA1004	95	TOP OF OLD MONOLITH	2.30-
JA1004C1	95	CHK	2.47-
JA1005	95	RESET ROCK CAP POST	2.47-
JA1005C1	95	CHK	2.47-

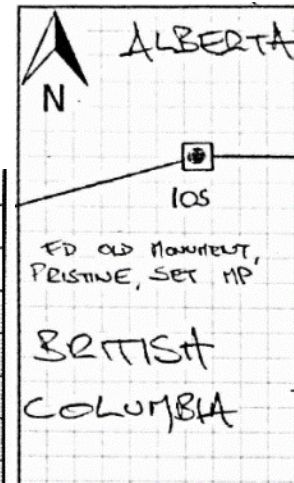
Monument 10S was found in excellent condition with both the monolith and base still in place and no deterioration found. There were minor cracks in the concrete base but nothing affecting the structural integrity. There was no visible cutline to 8S; however, there was a slight cutline visible uphill to 12S.

IOS		
FOUND OLD MONUMENT, CONDITION IS PRISTINE.		
SEALED FEW MINOR CRACKS ON BASE. APPLIED		
SEALANT SET MARKER POST		
LOGGED STATION @ IOS, EXISTING MONUMENT		
START TIME: 12:36		HT: 0.55-
END TIME 13:55

The cracks in the concrete base were sealed and the entire base was coated with a waterproof sealant. Monument 10S was surveyed using static GNSS observations and a marker post was set nearby.

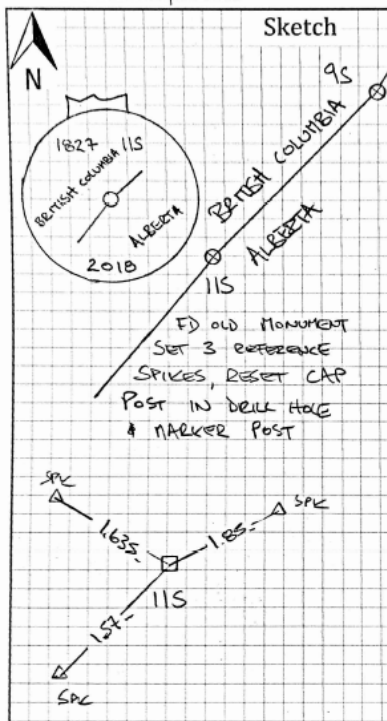
Monument 11S was found in poor condition with both the monolith and base severely deteriorating. The pillar top was missing but the datum point remained in place. The monolith was not salvagable and the subsequent removal caused further deterioration of the concrete base. The base was not salvagable due to the amount of vegetation growing in the cracks. There were no visible cutlines in either direction.

11S		
FOUND OLD MONUMENT, BASE & MONOLITH DETERMINATION		
SET 3 REFERENCE SPIKES, REMOVED BASE & MONOLITH		
RESET CAP POST IN DRILL HOLE MP 1/8 1.70m NORTH		
JA1006	11S	2.90-
JA10061	11S	3.20-

The tree that had fallen across the base was easily removed. Reference spikes were placed around the datum point in order to restore the centre of the monument upon demolition. The entire monument was then demolished to ground level and a standard capped post was drilled in the existing concrete. A reference post was placed 1.2m north. Monument 11S was surveyed using static GNSS methods.

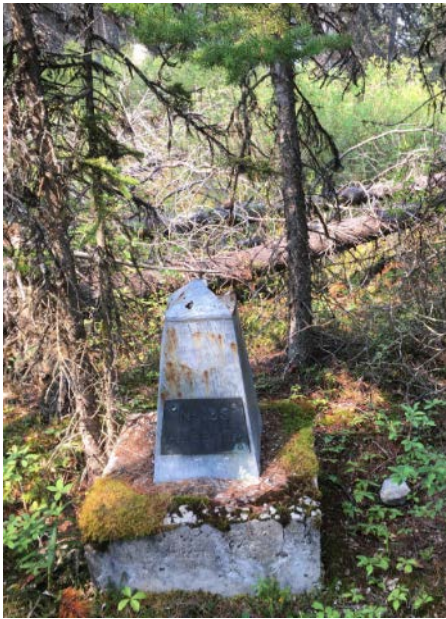
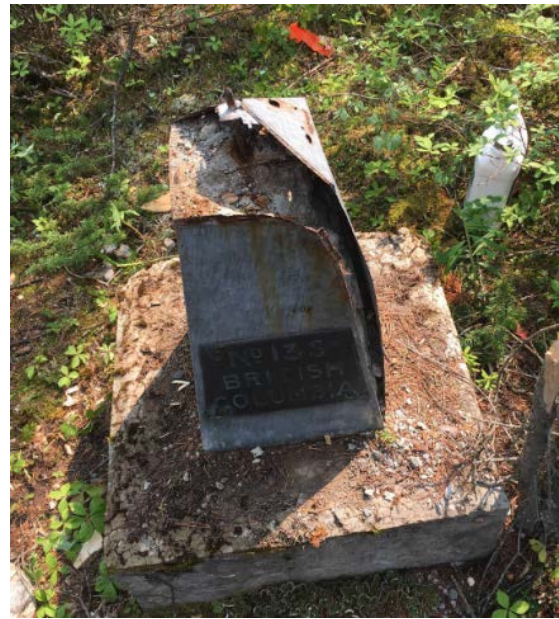
Monument 13S was found in poor condition with both the monolith and base deteriorating. The pillar top was partially missing but the datum point remained in place. Upon further inspection of the minor cracks in the base, all concrete easily broke off in large pieces and the removal of the monolith caused further deterioration of the concrete base. There was a visible cutline to 15S; however, no visible cutline towards 11S was observed.

Reference spikes were placed around the datum point in order to restore the centre of the monument upon demolition. The entire monument was then demolished to ground level and a standard capped post was drilled in the existing concrete. A reference post was placed 0.7m north. Monument 3S was surveyed using a long GNSS static occupation due to the surrounding tree cover.

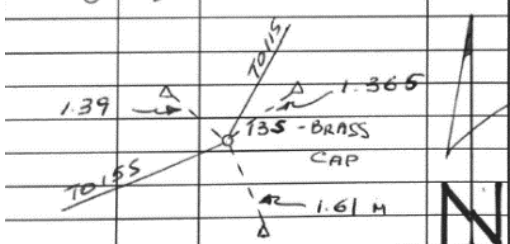
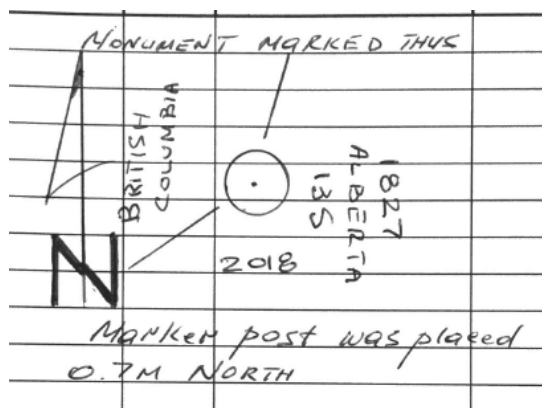
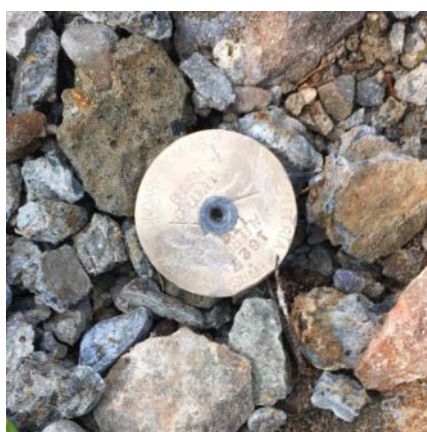
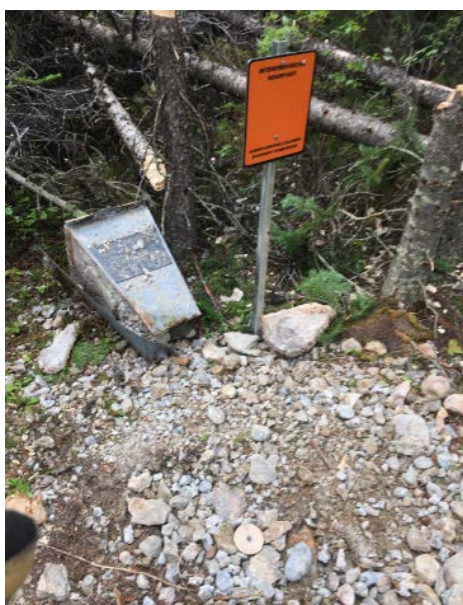
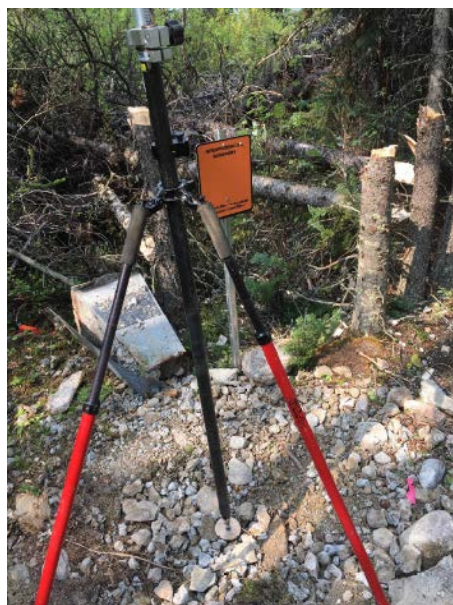
② Monument 13S.
Found monument 13S.
Monolith pyramid is on the base, showing signs of significant deterioration. Base is square with signs of deterioration. The pyramid top was removed - unable to restore, that revealed significantly deteriorating base underneath. Prior to removal of the top

pyramid its centre was referenced with 3 spikes 1.365 M, 1.38 M, and 1.61 M.
The base was brought down to the ground level. A rebar was put in the ground with a brass cap using reference spikes.

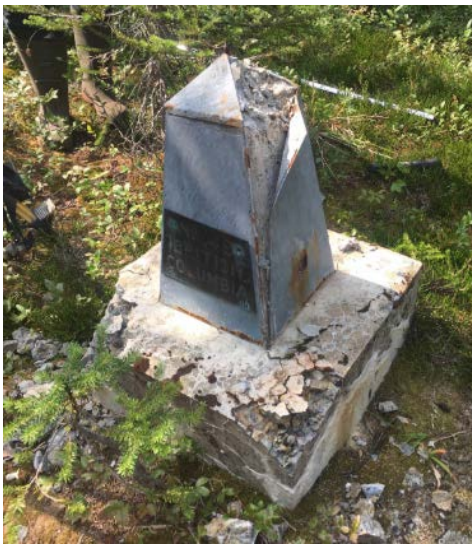
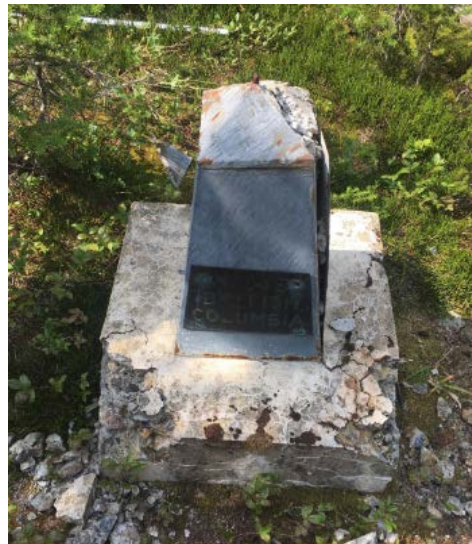
Monument 14S was found in poor condition with both the monolith and base heavily deteriorating. The majority of the tin on the monolith was peeling away, revealing heavily weathered concrete inside. The pillar top was partially missing but the datum point remained in place. Upon further inspection, all concrete easily broke off in large pieces and the removal of the monolith caused further deterioration of the severely cracked concrete base. There are prominent cutlines to both 16S and 12S.

Reference spikes were placed around the datum point in order to restore the centre of the monument upon demolition. The entire monument was then demolished to ground level and a standard capped post was drilled in the existing concrete. A reference post was placed 1.6m northeast. Monument 14S was surveyed using static GNSS methods.

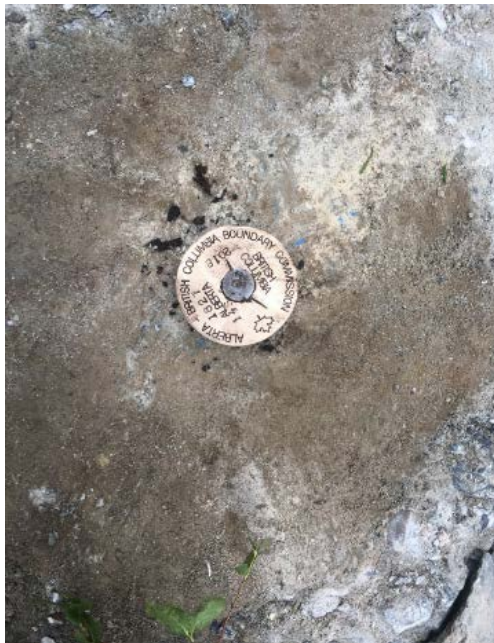
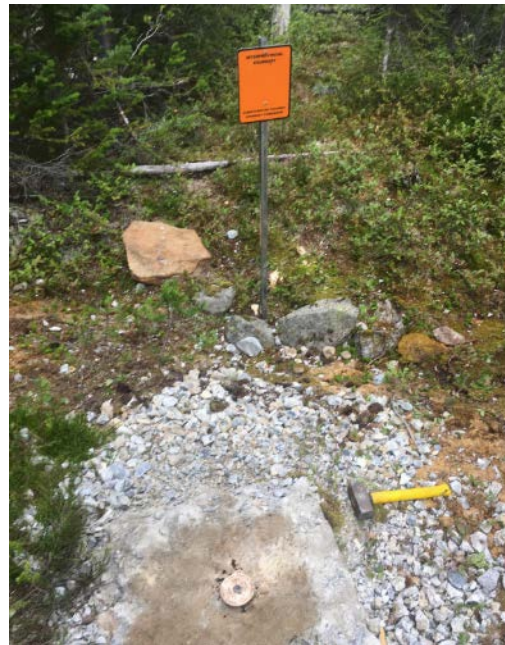
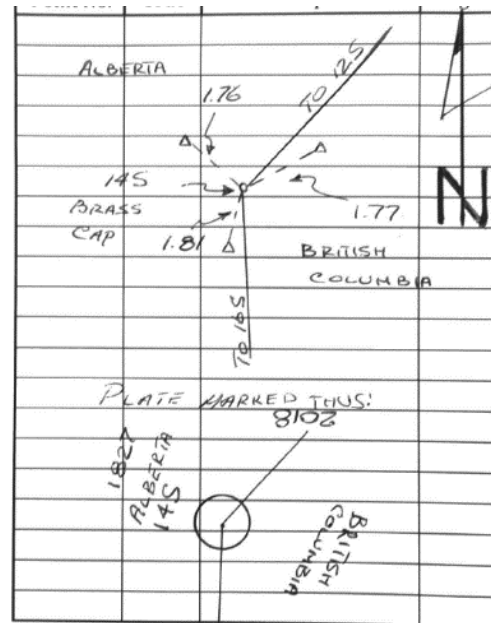
3	④ Monument 145.	
	Found monument 145 in	
	poor condition. Referenced center	
	of the monument with 3	
	spikes: 1.76, 1.77, 1.81 M	
	Removed the top of the	
	monument, brought the base	
	down to the ground level.	
	Re-stored the position of the	
	monument using reference	
	spikes. Placed spikes with brass	
	cap in the re-stored position	
	MP placed 1.6 M NE	
	See Sketch.

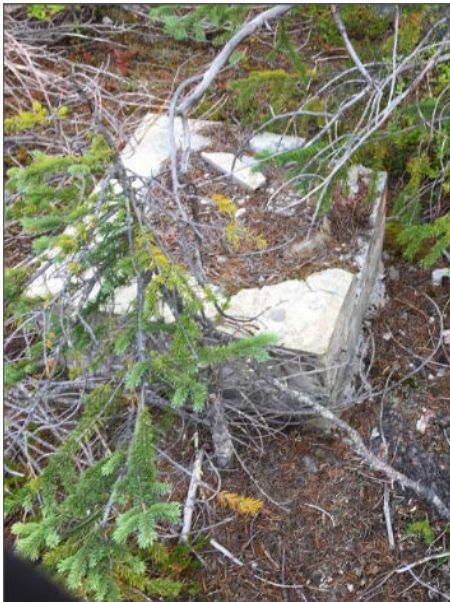
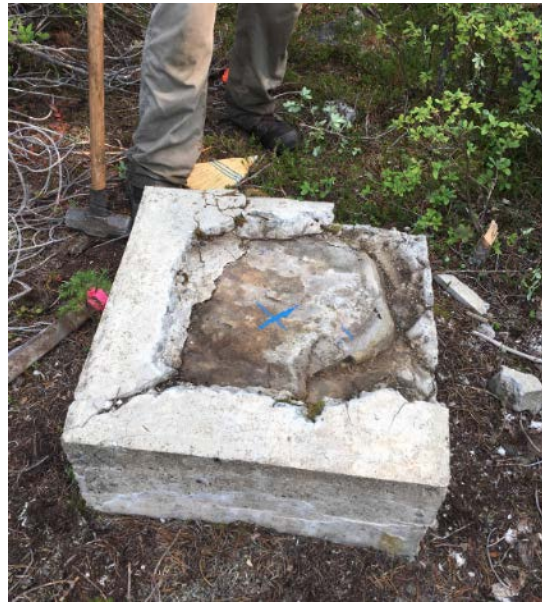
Monument 15S was found in poor condition with the monolith completely sheared off by a nearby dead tree. The base was severely deteriorating but the centre of the base was able to be restored by using the four corners of the base once the vegetation was cleared away. The large cracks in the concrete base prevented it from being restored. There were no visible cutlines in either direction.

Reference spikes were placed around the base in order to restore the centre of the monument upon demolition. The entire base was then demolished to ground level and a standard capped post was drilled in the existing concrete and set using construction adhesive to hold it in place. A reference post was placed 0.6m north. Monument 15S was surveyed using GNSS static observations.

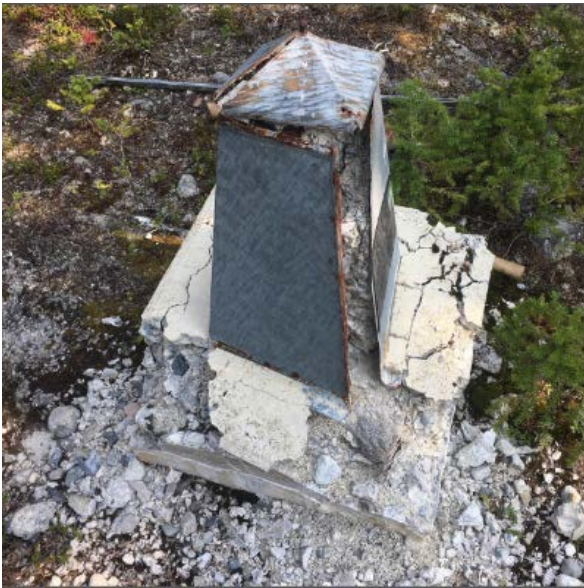
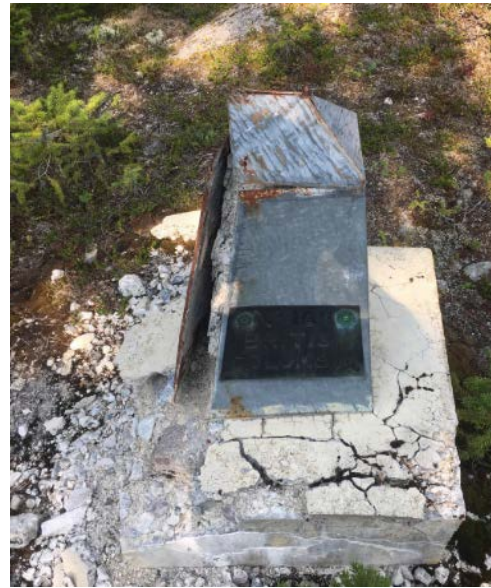
Monument 16S was found in poor condition with both the monolith and base deteriorating. The pillar top was off centre but the datum point remained in place. Upon further inspection, all concrete easily broke off and the removal of the monolith caused further deterioration of the concrete base. There were prominent cutlines to both monuments 14S and 18S.

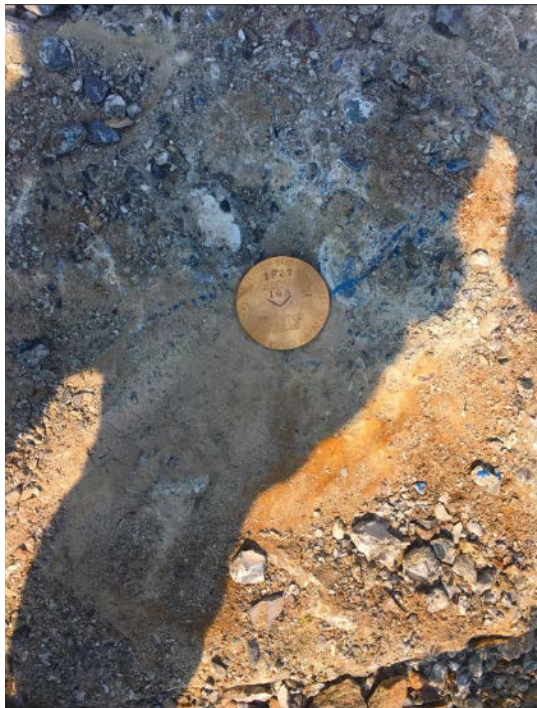
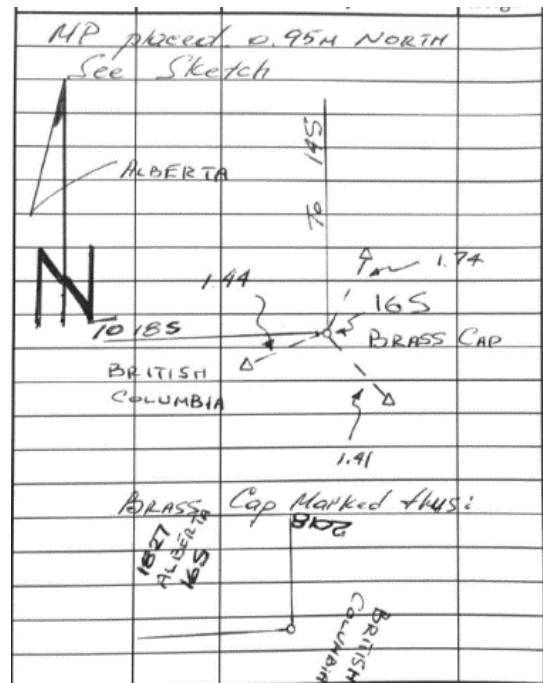
(3) Monument 16S
 Found Monument 16S,
 base and pyramid monolith in
 poor condition. Referenced
 the position of the monument's
 centre with 3 spikes: 1.41,
 1.44, 1.74. Removed the top
 monolith part of the monument
 and put the base to the ground
 level. Re-stored the position of
 the monument using the refer-
 ence spikes. Placed ~~cap~~ "rock"
 brass cap in the re-stored position.

Monument 16S was surveyed using static GNSS observations. Reference spikes were placed around the datum point in order to restore the centre of the monument upon demolition. The entire monument was then demolished to ground level and a standard rock post was drilled in the existing concrete and set using construction adhesive. A reference post was placed 0.95m north.

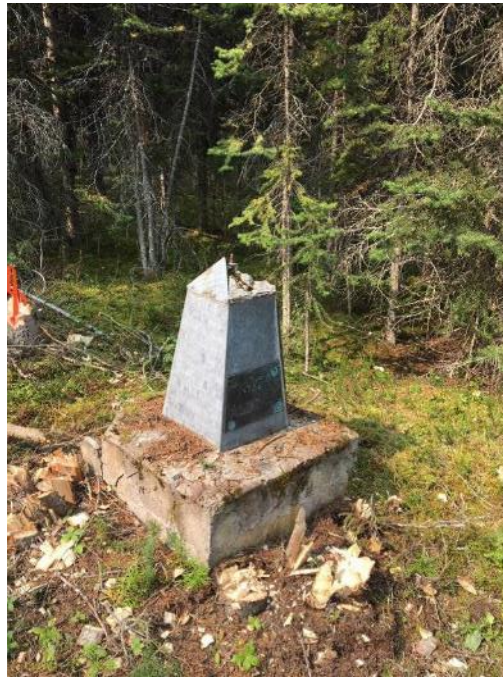
Monument 17S was found in poor condition with both the monolith and base deteriorating. The pillar top was partially missing but the datum point remained in place. Upon removal of the monolith, all concrete easily broke off in large pieces. There were prominent cutlines to both monuments 15S and 19S.

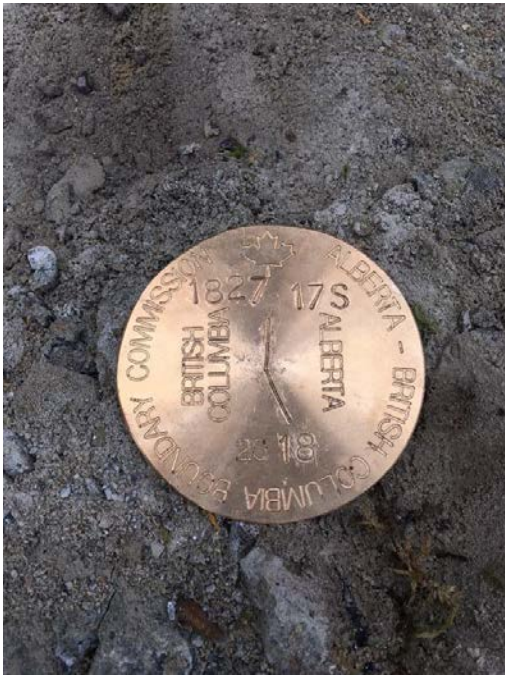
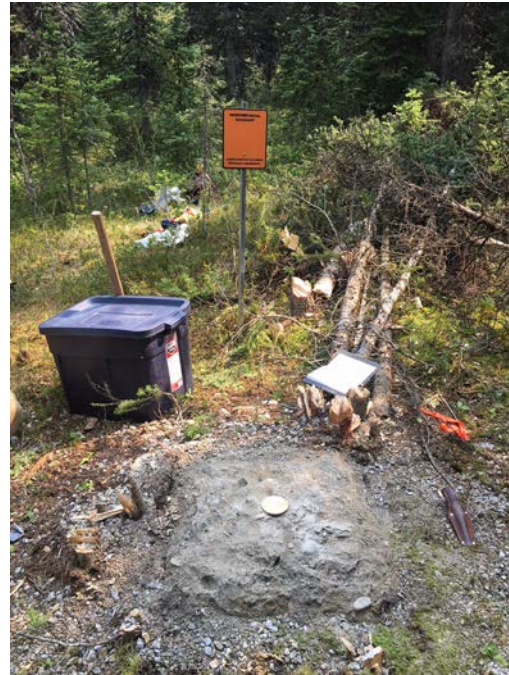
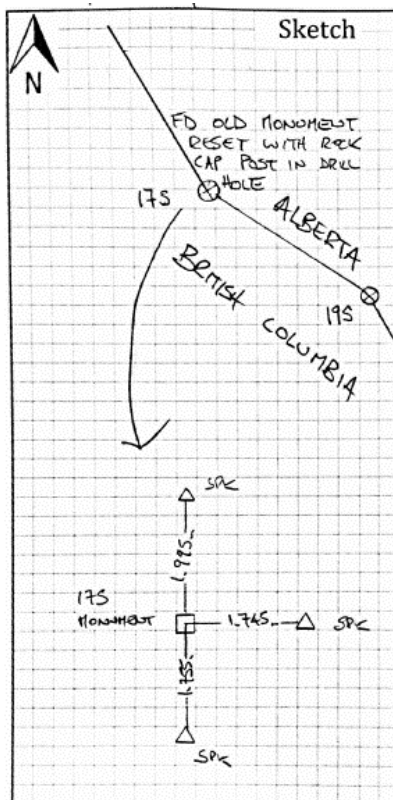
17S			
FOUND OLD MONUMENT, MONUMENT & BASE DETERIORATING.			
RE-ESTABLISHED CENTRE USING REMAINING MONUMENT			
SET THREE REFERENCE SPIKES, REFER TO SKETCH			
SET ROCK CAP POST IN DRILL HOLE			
LOGGED STATIC @ 17S ROCK CAP POST			
START TIME 11:55		HT 1.473	
END TIME 13:03

The 10-20cm diameter pine trees surrounding the monument were cut to allow for a static occupation and ensure visibility of the border. Reference spikes were placed around the datum point in order to restore the centre of the monument upon demolition. The entire monument was then demolished to ground level and a standard rock post was drilled in the existing concrete and set using construction adhesive. A reference post was placed nearby. Monument 17S was surveyed using a static GNSS observation.

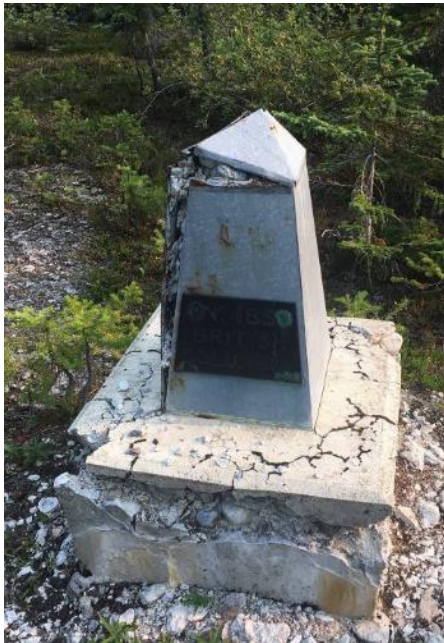
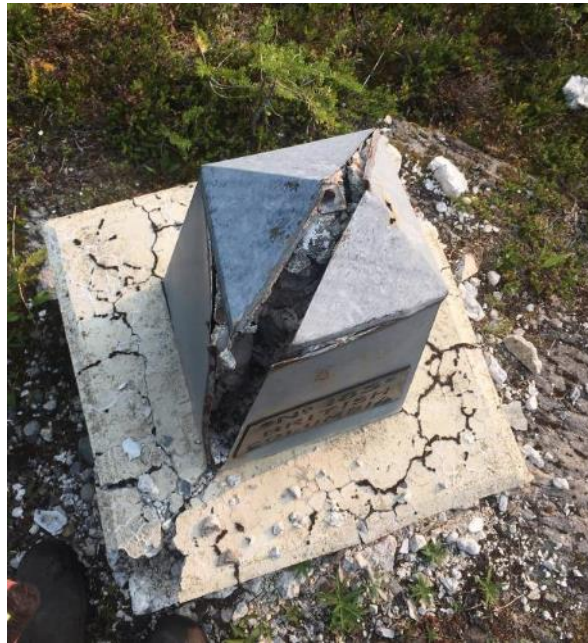
Monument 18S was found in poor condition with both the monolith and base deteriorating. The pillar top was splitting apart but the datum point remained in place. Upon further inspection, all concrete easily broke off and the removal of the monolith caused further deterioration of the concrete base. There were prominent cutlines to both monuments 16S and 20S.

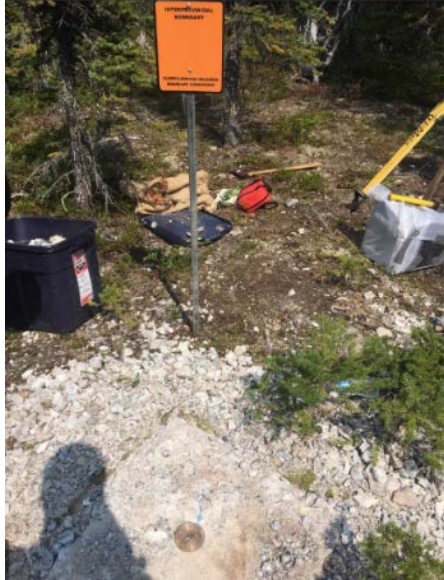
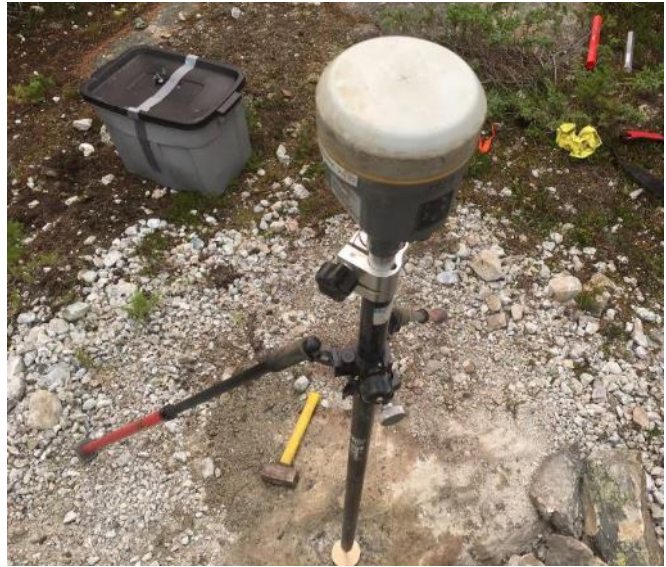
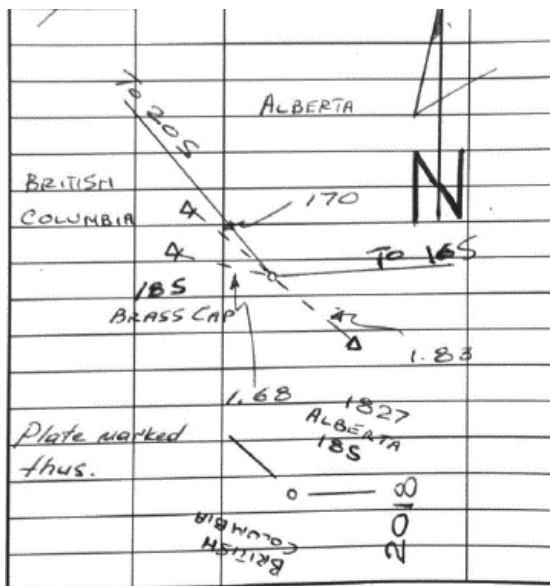
(2) Monument 185
 Found monument 185, base and monolith pyramid in a poor condition. Referenced the centre of the monolith with 3 spikes: 1.68, 1.70 & 1.83 m. Removed the monolith and brought the base to the ground level. Restored position of the monolith using reference spikes. Placed "rock" brass cap in the ~~new~~ restored position. See sketch.

Reference spikes were placed around the datum point in order to restore the centre of the monument upon demolition. The entire monument was then demolished to ground level and a standard rock post was drilled in the existing concrete and set using construction adhesive. A reference post was placed 1.5m east. Monument 18S was surveyed using static GNSS observations.

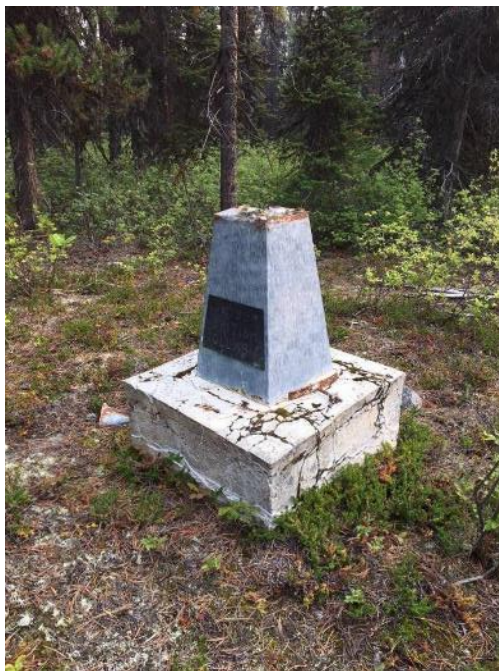
Monument 19S was found in poor condition with both the monolith and base deteriorating. The pillar top and datum point were missing. Upon further inspection, most concrete easily broke off and the removal of the monolith caused further deterioration of the concrete base. There was a clear cutline to 17S but nothing visible downhill to 21S.

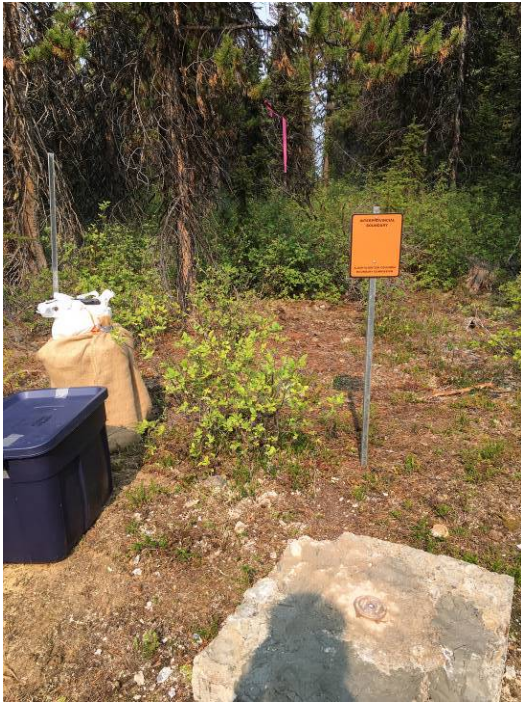
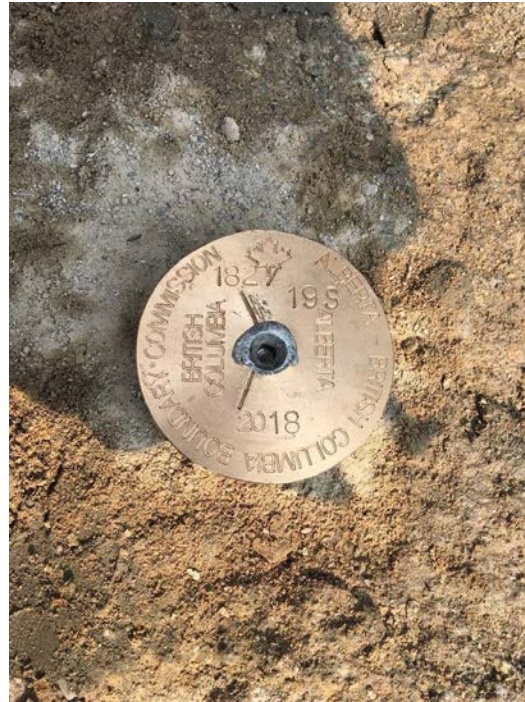
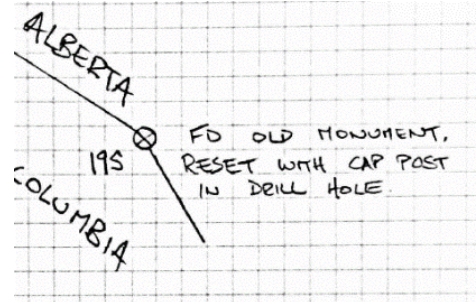
195		
FOUND OLD MONUMENT, MONUMENT DEGRADATING		
REPAIRED CONCRETE BASE, RE-ESTABLISHED CENTER		
WITH REMAINING MONUMENT FOOTPRINT.		
SET CAP POST IN DRILL HOLE		
LOGGED STAK &	195 CAP POST IN DRILL HOLE	
START TIME 08:38	HT: 1.190-	
END TIME 10:22

Reference spikes were placed around the datum point in order to restore the centre of the monument upon demolition. Most of the concrete base was demolished until solid concrete was reached. The remaining concrete was patched and sealed and a standard capped post was drilled in the existing concrete and set using construction adhesive. A reference post was placed nearby. Monument 19S was georeferenced using static GNSS observations.

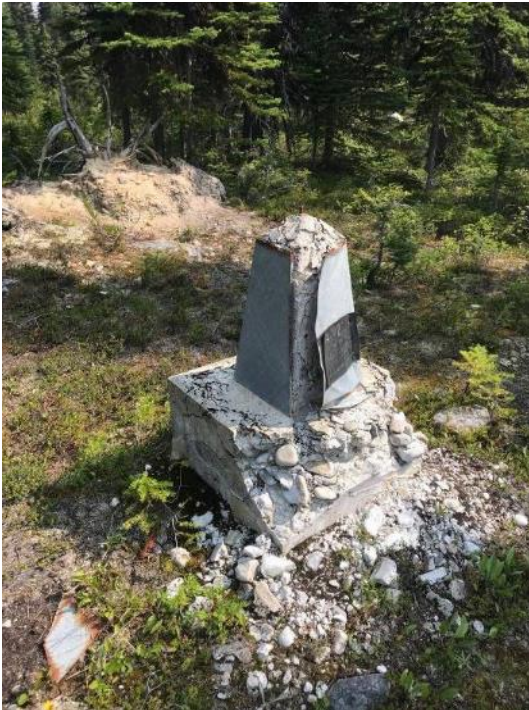
Monument 20S was found in poor condition with both the monolith and base deteriorating. The pillar top was missing but the datum point remained in place. Upon further inspection, all concrete easily broke off and the removal of the monolith caused further deterioration of the concrete base. There were faint cutlines to both monuments 18S and 22S.

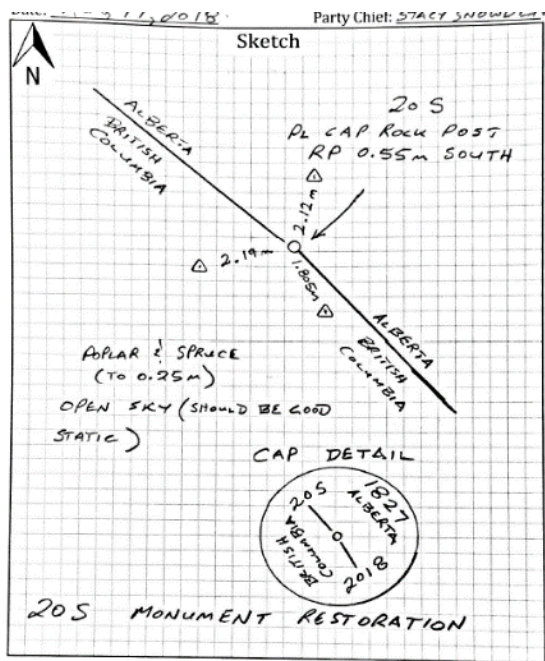
20 S	MONUMENT RESTORATION
FOUND MONOLITH W/ BASE IN POOR CONDITION. MEASURED 3 SPIKES OFF OF MONOLITH AS PER SKETCH ON PAGE 6.	
REMOVED MONOLITH AND BASE. SET CAP ROCK POST OFF OF THE REFERENCE SPIKES. PHOTOS ATTACHED W/ TODAY'S DATA.

Reference spikes were placed around the datum point in order to restore the centre of the monument upon demolition. The entire monument was then demolished to ground level and a standard rock post was drilled in the existing concrete and set using construction adhesive. A reference post was placed 0.55m south. Monument 20S was surveyed using static GNSS observations.

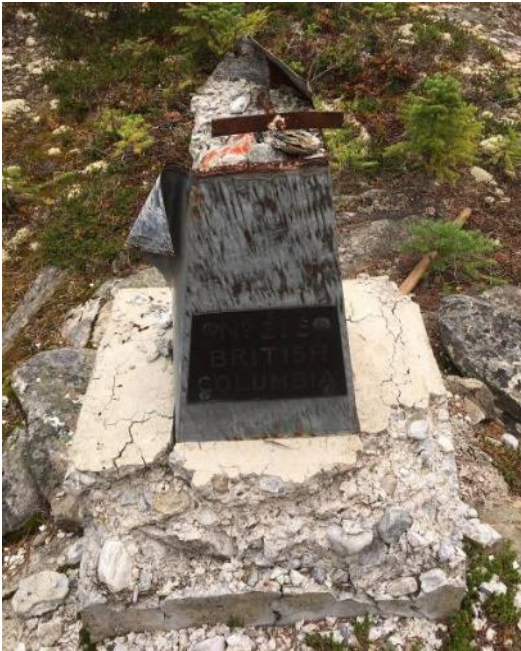
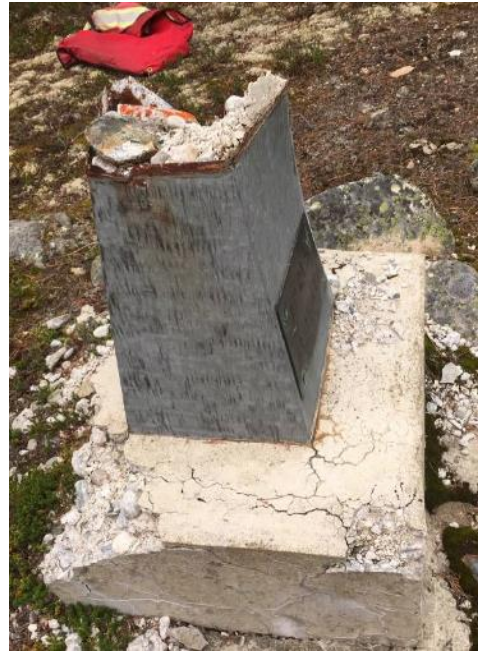
Monument 21S was found in poor condition with both the monolith and base severely deteriorating. The pillar top and datum point were off centre. Upon further inspection, all concrete easily broke off and the removal of the monolith caused further deterioration of the concrete base. There were no visible cutlines in either direction.
