Alberta – British Columbia Boundary Commission

Survey Report

Yellowhead Pass Boundary Monument Project

Survey of Restoration of Survey Monuments S, 1S to 31S (Inclusively), and 33S Along a Portion of the Alberta – British Columbia Boundary

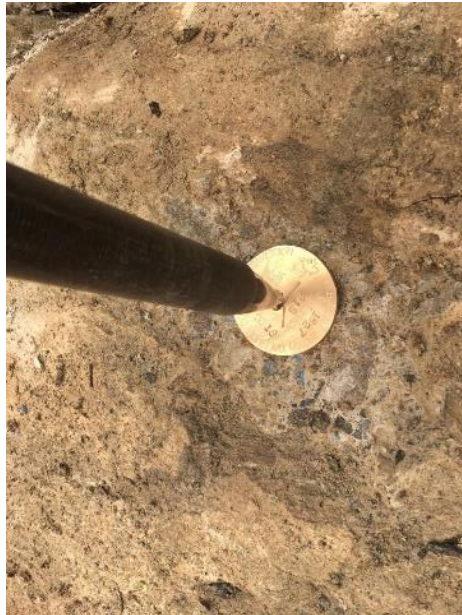
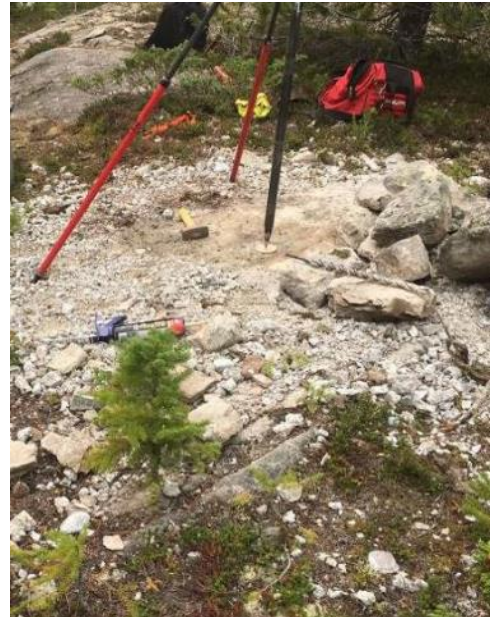
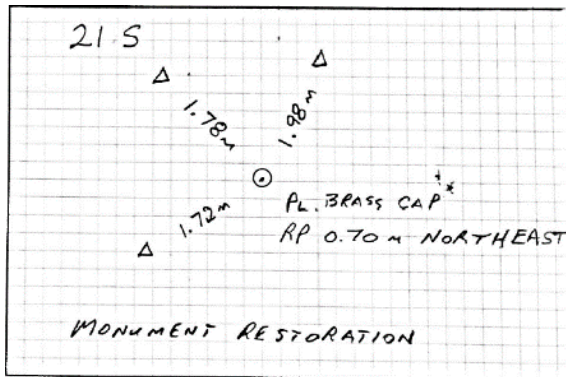
21 S	MONUMENT RESTORATION
FOUND	MONOLITH IN POOR CONDITION.
SET 3	SPIKES OFF OF CTR OF MONOLITH
BROKE	APART MONOLITH AND REMOVED.
SET	BRASS CAP OFF OF THE SPIKES.
SEE	SKETCH ON PAGE 3 AND ATTACHED
PHOTOS	WITH TODAY'S DATA.

Monument 21S was surveyed via static GNSS. Reference spikes were placed around the datum point in order to restore the centre of the monument upon demolition. The entire monument was then demolished to ground level and a standard rock post was drilled in the existing concrete and set using construction adhesive. A reference post was placed 0.7m northeast of the monument.

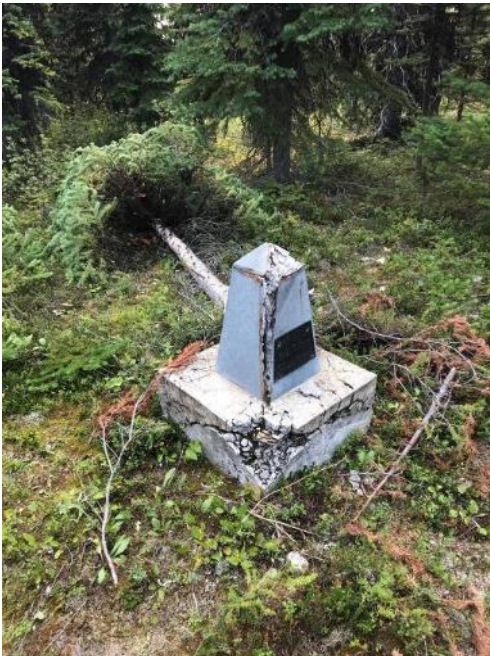
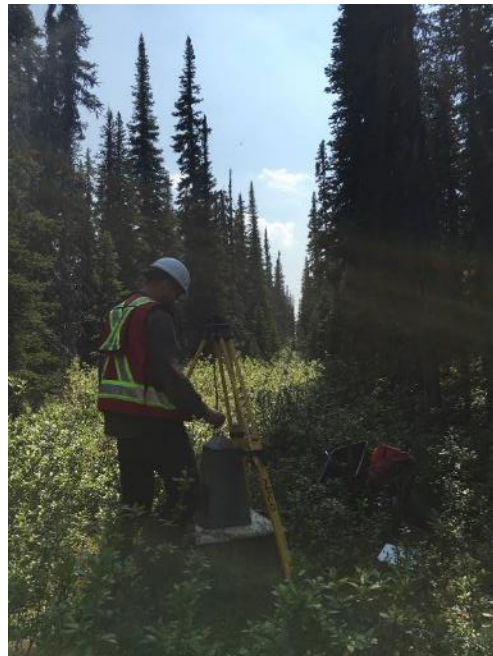
Monument 22S was found in poor condition with both the monolith and base severely deteriorating. The pillar top was partially missing but the datum point remains in place. Upon further inspection, all concrete easily crumbled and the removal of the monolith caused further deterioration of the concrete base. There was a visible cutline leading to 24S but nothing prominent to 20S.

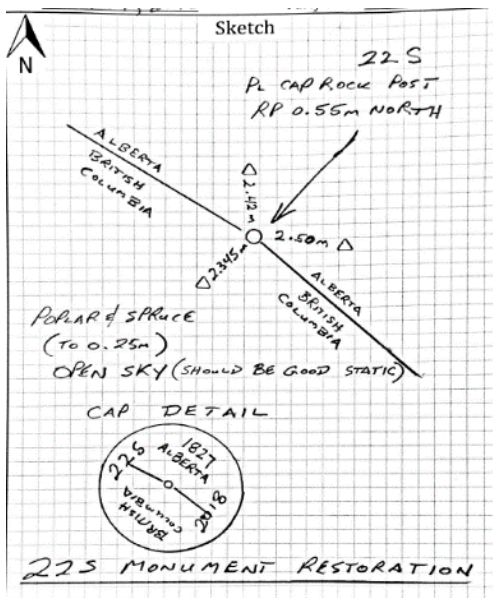
225	MONUMENT RESTORATION.	
	FOUND MONOLITH W/BASE IN POOR/	
	FAIR CONDITION. MEASURED 3 SPIKES	
	OFF OF MONOLITH AS PER SKETCH ON	
	PAGE 3. REMOVED MONOLITH AND BASE	
	SET CAP ROCK POST OFF OF THE	
	REFERENCE SPIKES. PHOTOS	
	ATTACHED W/TODAY'S DATA.

Monument 22S was surveyed using static GNSS observations. Reference spikes were placed around the datum point in order to restore the centre of the monument upon demolition. The entire monument was then demolished to ground level and a standard rock post was drilled in the existing concrete and set using construction adhesive. A reference post was placed 0.55m north.

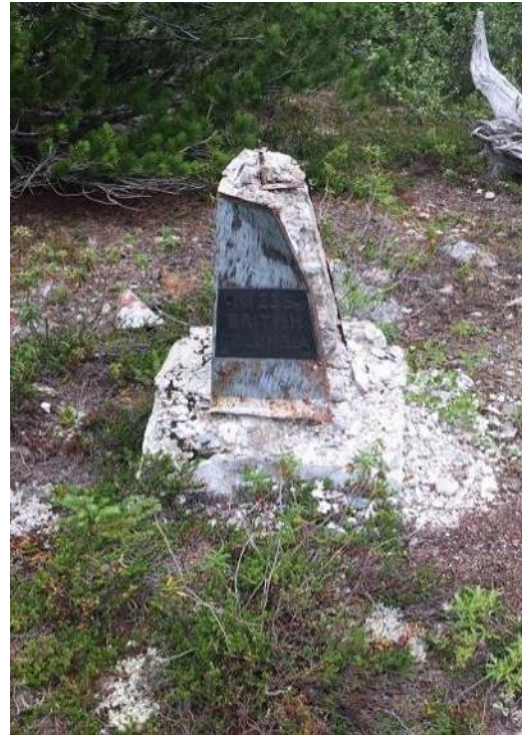
Monument 23S was found in poor condition with both the monolith and base deteriorating. The pillar top was missing but the datum point was still in place. Upon further inspection, all concrete easily broke off and the removal of the monolith caused further deterioration of the concrete base. There were no visible cutlines in either direction.

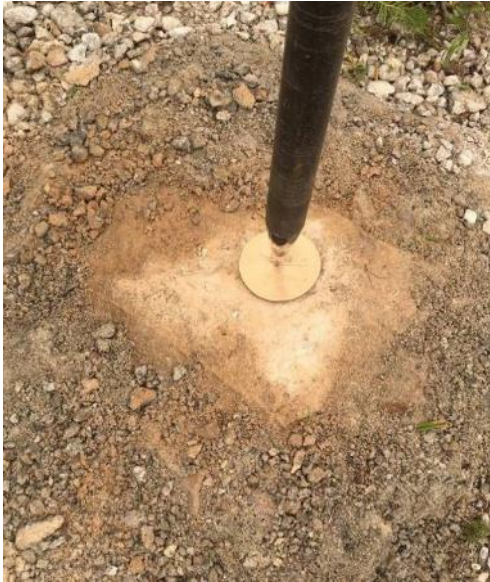
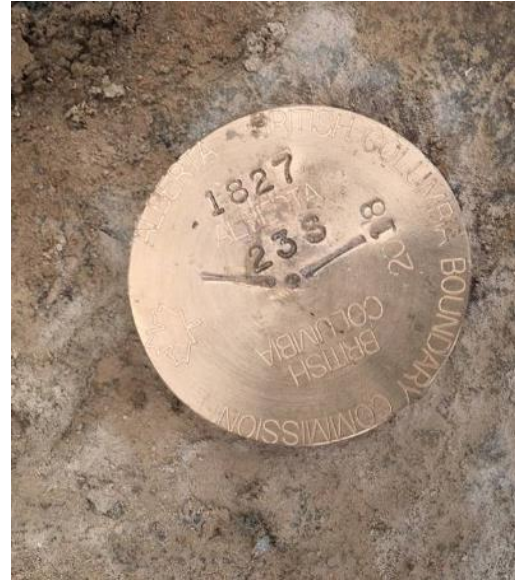
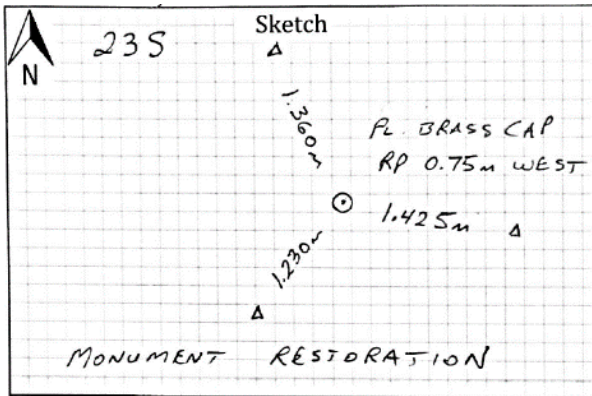
235	MONUMENT RESTORATION.
FOUND	MONOLITH IN POOR CONDITION
SET 3	SPIKES OFF OF CTR OF
MONOLITH.	BROKE APART MONOLITH
AND REMOVED.	SET BRASS CAP
OFF OF THE	SPIKES. SEE SKETCH
ON PAGE 3	AND ATTACHED PHOTOS
WITH TODAY'S	DATA.

Reference spikes were placed around the datum point in order to restore the centre of the monument upon demolition. The entire monument was then demolished to ground level and a standard rock post was drilled in the existing concrete and set using construction adhesive. A reference post was placed 0.75m west. Monument 23S was surveyed using static GNSS methods.

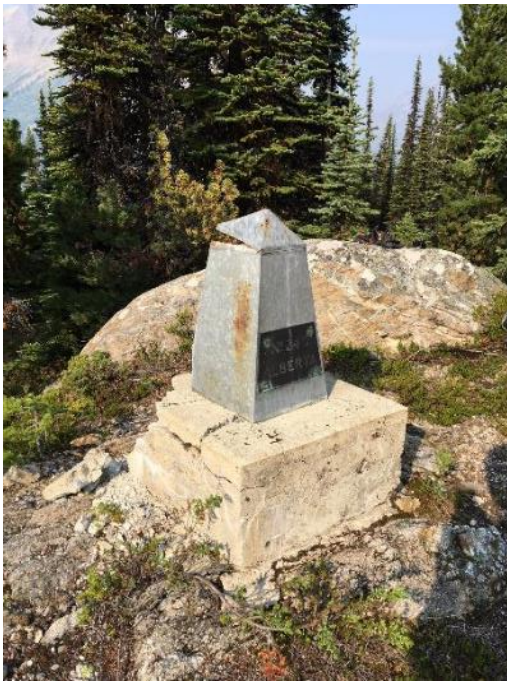
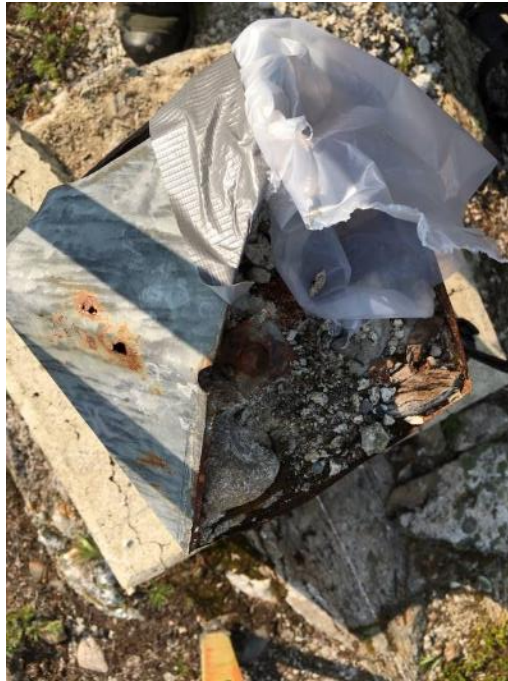
Monument 24S was found in poor condition with both the monolith and base severely deteriorating. The pillar top was partially missing but the datum point was still in place. Upon further inspection, all concrete easily broke off and the removal of the monolith caused further deterioration of the concrete base. There was a prominent cutline to 26S but nothing visible to 22S.

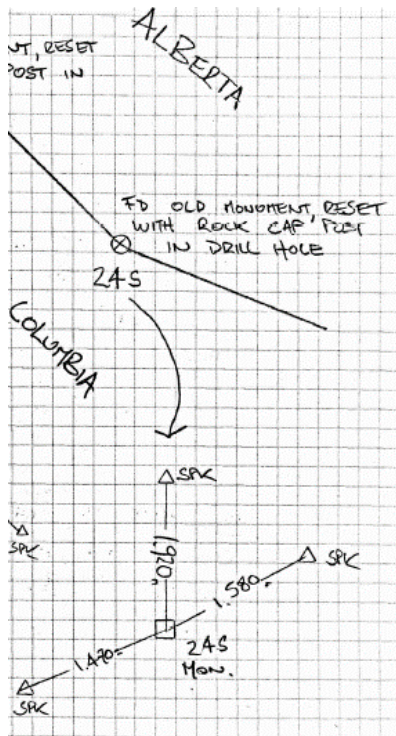
24S			
FOUND OLD MONUMENT, MONOLITH & BASE DETERIORATING			
RE-ESTABLISHED CENTRE WITH REMAINING MONOLITH			
FOOTPRINT. SET 3 REFERENCE SPIKES, REFER TO SKETCH. SET ROCK CAP POST IN DRILL HOLE

Reference spikes were placed around the datum point in order to restore the centre of the monument upon demolition. The entire monument was then demolished to ground level and a standard rock post was drilled in the existing concrete and set using construction adhesive. A reference post was placed nearby. Monument 24S was surveyed using static GNSS observations.

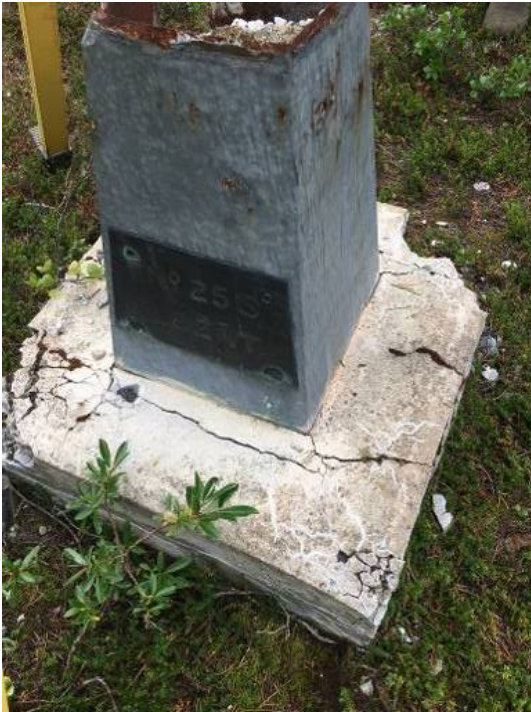
Monument 25S was found in poor condition with both the monolith and base severely deteriorating. The pillar top was missing but the datum point was still in place. Upon further inspection, all concrete easily broke off and the removal of the monolith caused further deterioration of the concrete base. There are no visible cutlines in either direction.

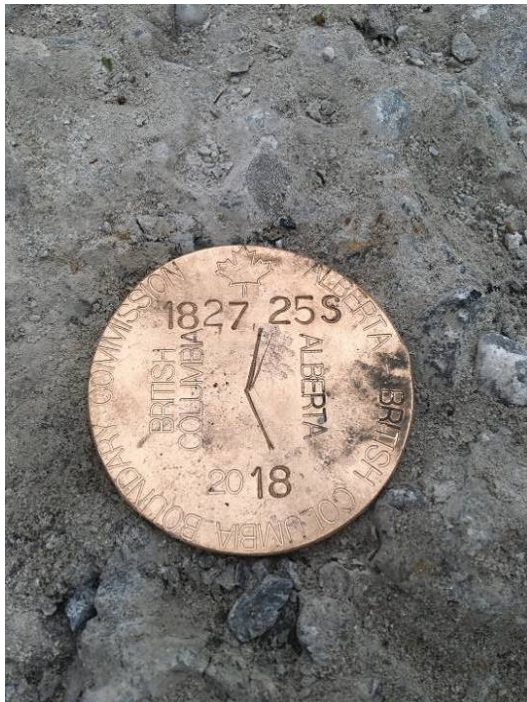
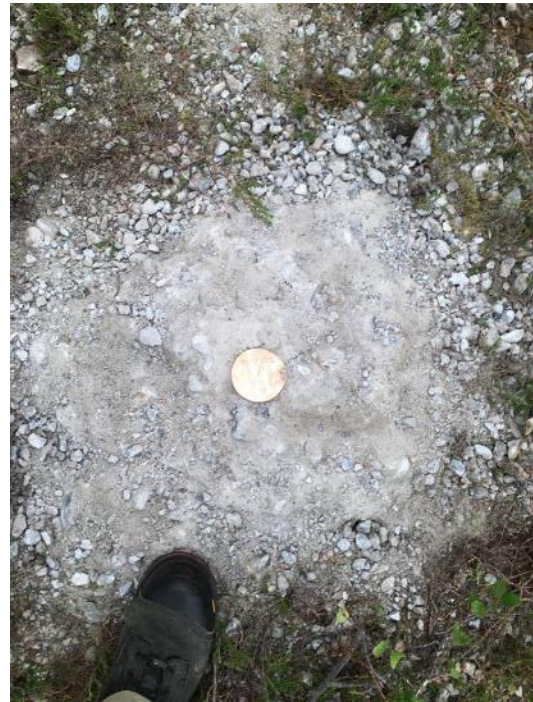
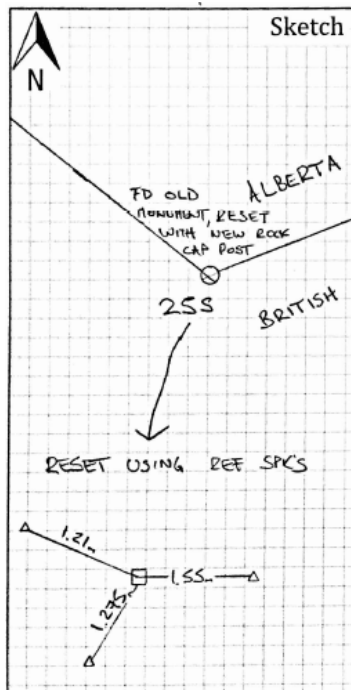
25S			
FOUND OLD MONUMENT, MONOLITH & BASE DETERMINING.			
RE-ESTABLISHED CENTRE WITH REMAINING MONOLITH			
SET THREE REFERENCE SPIKES, REFER TO SKETCH			
SET ROCK CAP POST IN DRILL HOLE			
LOGGED STATIC @ 25S ROCK CAP POST			
START TIME: 13:22		HT: 1.530m	
END TIME: 14:32

Reference spikes were placed around the datum point in order to restore the centre of the monument upon demolition. The entire monument was then demolished to ground level and a standard rock post was drilled in the existing concrete and set using construction adhesive. A reference post was placed nearby. Monument 25S was surveyed using static GNSS methods.

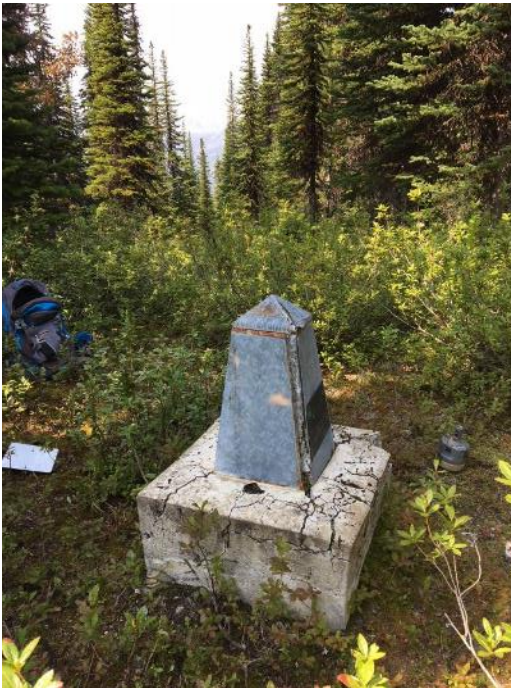
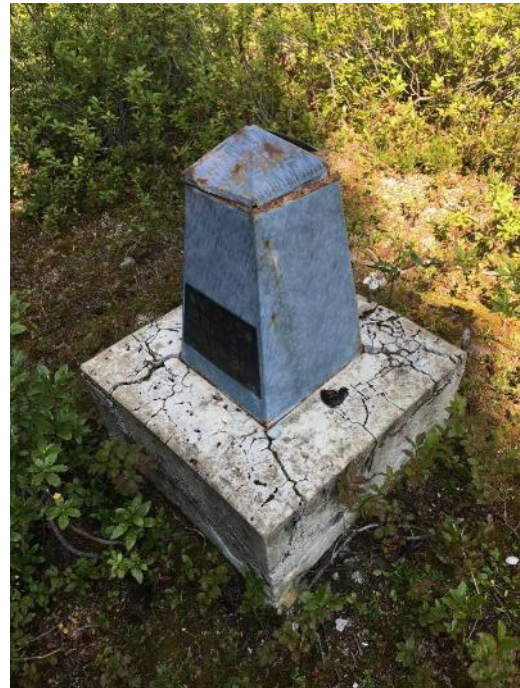
Monument 26S was found in fair condition with both the monolith and base deteriorating. The pillar top was off centre but the datum point was still in place. Upon further inspection, all concrete easily broke off and the removal of the monolith caused further deterioration of the concrete base due to large cracks already in place. There were visible cutlines in either direction.

Monument 26S was surveyed using static GNSS observations. Reference spikes were placed around the datum point in order to restore the centre of the monument upon demolition. The entire monument was then demolished to ground level and a standard rock post was drilled in the existing concrete and set using construction adhesive. A reference post was placed nearby.

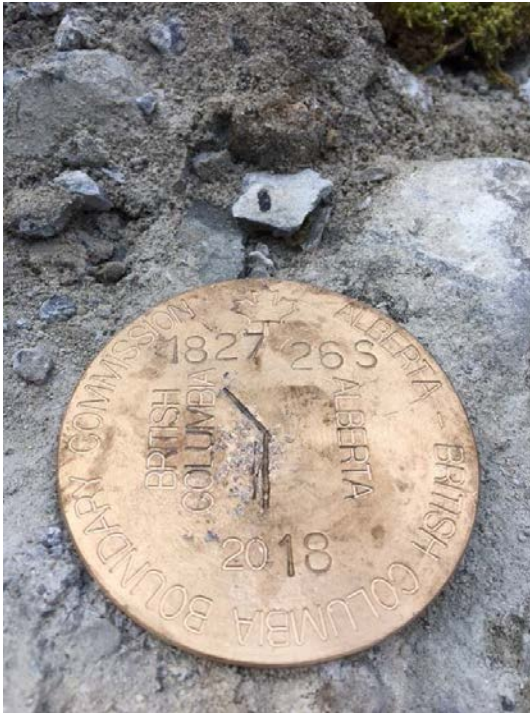
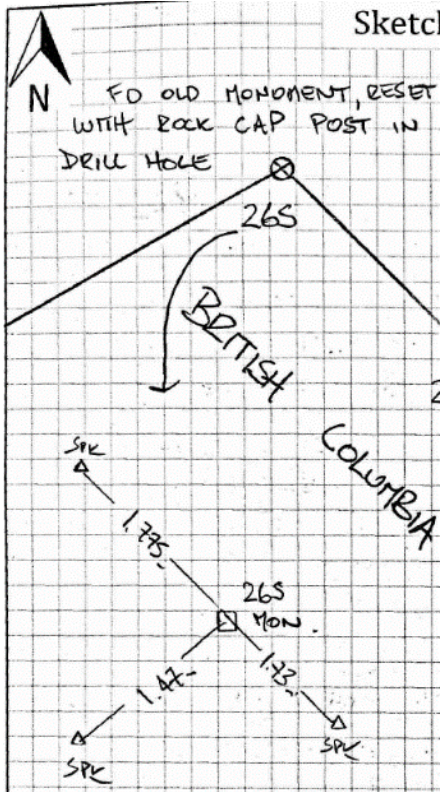
26S			
FOUND OLD MONUMENT, MONUMENT & BASE IN FAIR CONDITION, BUT SIGNS OF DETERIORATION PRESENT.			
RE-ESTABLISHED CENTRE USING EXISTING MONUMENT SET			
3 REFERENCE SPIKES, REFER TO SKETCH.

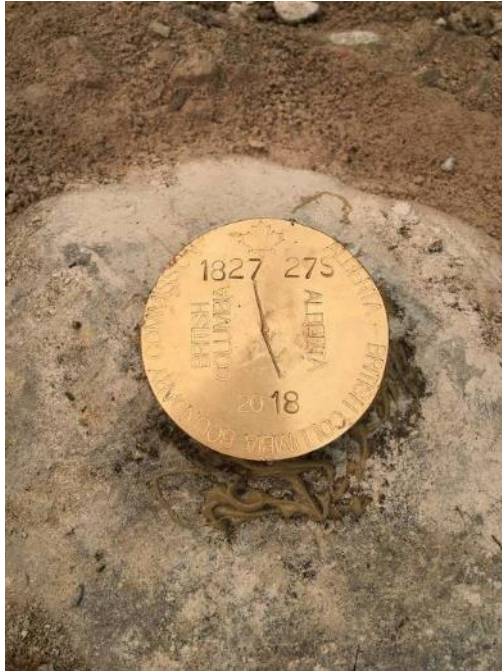
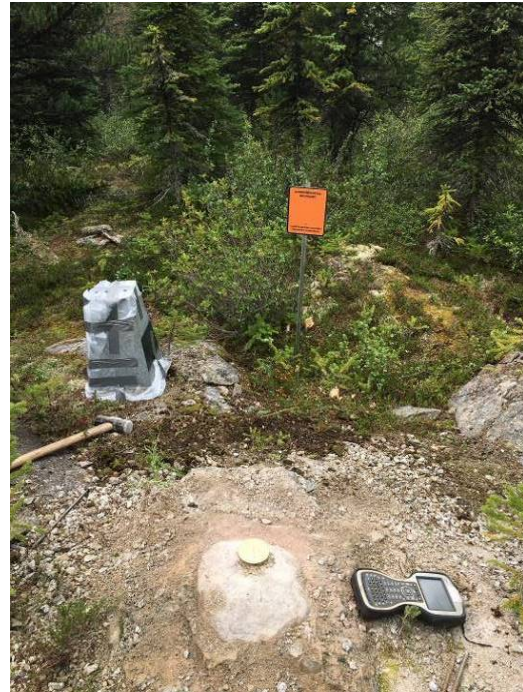
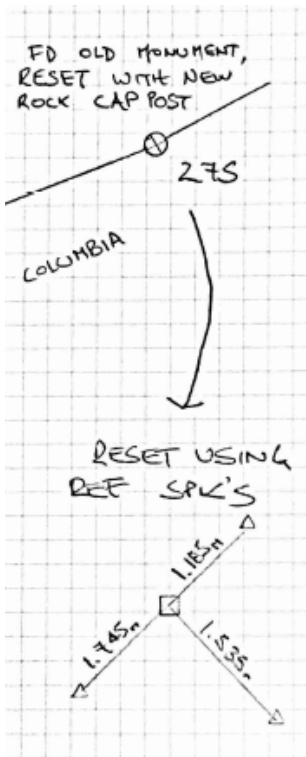
Monument 27S was found in poor condition with both the monolith and base severely deteriorating. The pillar top was partially missing and the datum point was off centre. Upon further inspection, all concrete easily broke off and the removal of the monolith caused further deterioration of the concrete base. There was a faint cutline to 25S but nothing visible to 29S.

275			
FOUND OLD MONUMENT	MONOLITH & BASE DETERIORATING.		
RE-ESTABLISHED CENTRE	WITH REMAINING MONOLITH.		
SET THREE REFERENCE SPKS	REFER TO SKETCH.		
SET ROCK CAP POST	IN DRILL HOLE		
LOGGED STATIC @ 275	ROCK CAP POST		
START TIME:	10:28	HT:	1.665m
END TIME:	11:35

Reference spikes were placed around the datum point in order to restore the centre of the monument upon demolition. The entire monument was then demolished to ground level and a standard rock post was drilled in the existing concrete and set using construction adhesive. A reference post was placed nearby. Monument 27S was surveyed using static GNSS methods.

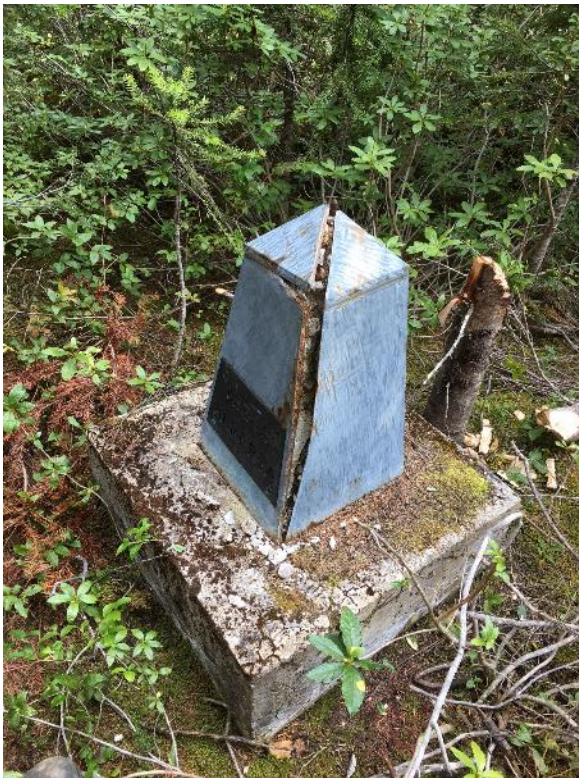
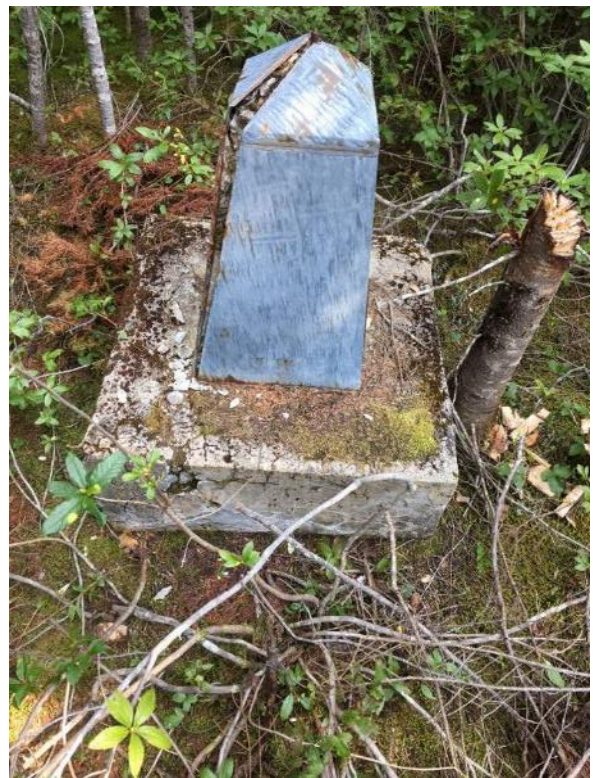
Monument 28S was found in fair condition with both the monolith and base deteriorating. The tin of the monolith had peeled back, revealing heavily weathered concrete. The pillar top and datum point were still in place, although cracking apart significantly. Upon further inspection, all concrete easily broke off and the removal of the monolith caused further deterioration of the heavily cracked concrete base. There is a visible cutline back towards 30S but nothing noticeable to 26S.

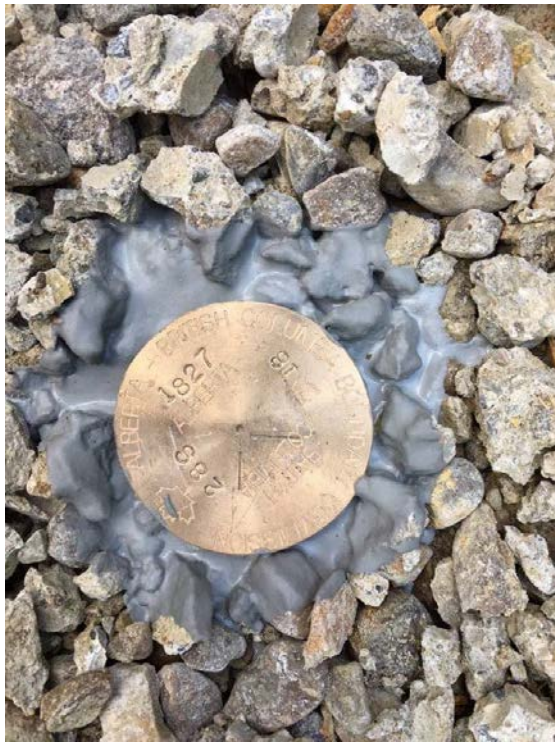
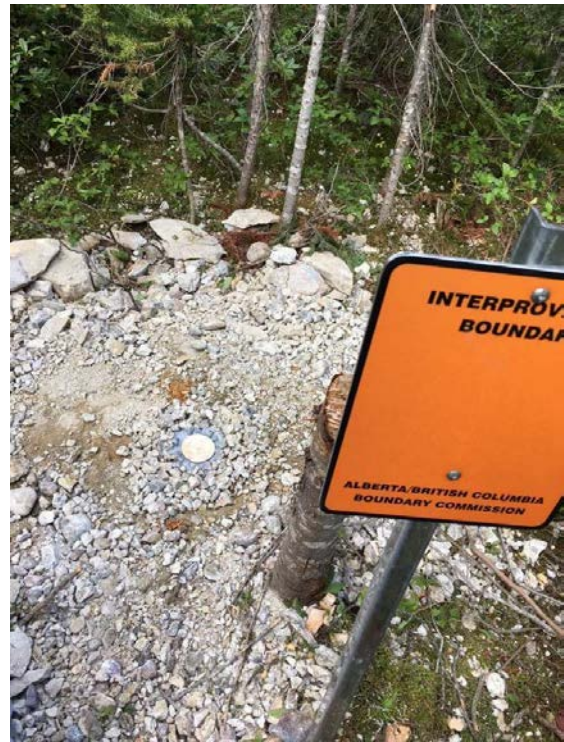
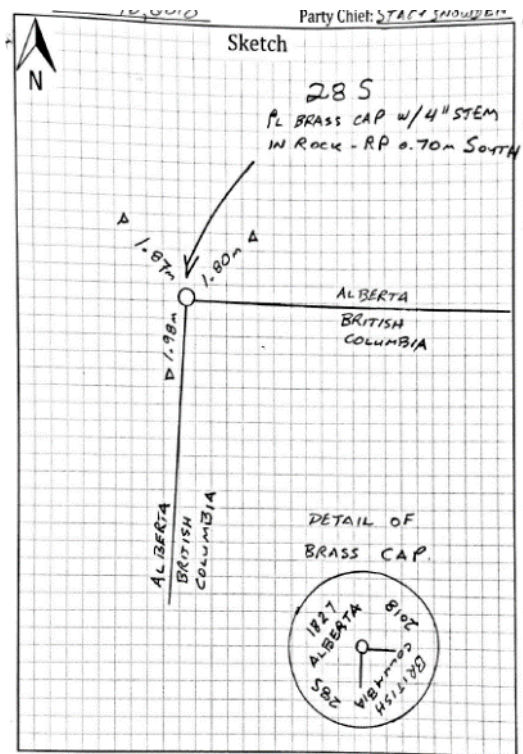
285	MONUMENT RESTORATION
	FOUND MONOLITH W/BASE IN POOR/
	FAIR CONDITION (BEGINNING TO
	CRUMBLE APART). SET SPIKES OFF OF
	MONOLITH AS PER SKETCH ON PG 7.
	REMOVED MONOLITH AND BASE. SET
	BRASS CAP W/ 1/4" STEM IN ROCK USING
	THE REFERENCE SPIKES. PHOTOS
	ATTACHED W/TODAY'S DATA.

Reference spikes were placed around the datum point in order to restore the centre of the monument upon demolition. The entire monument was then demolished to ground level and a standard rock post was drilled in the existing concrete and set using construction adhesive. A reference post was placed 0.7m south. Monument 28S was surveyed using static GNSS observations.

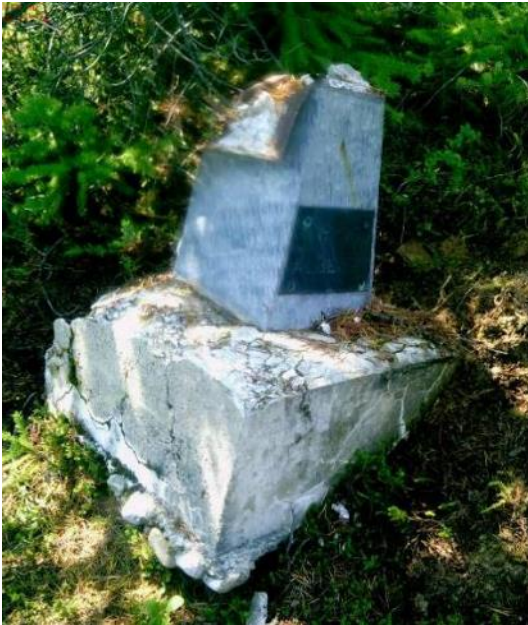
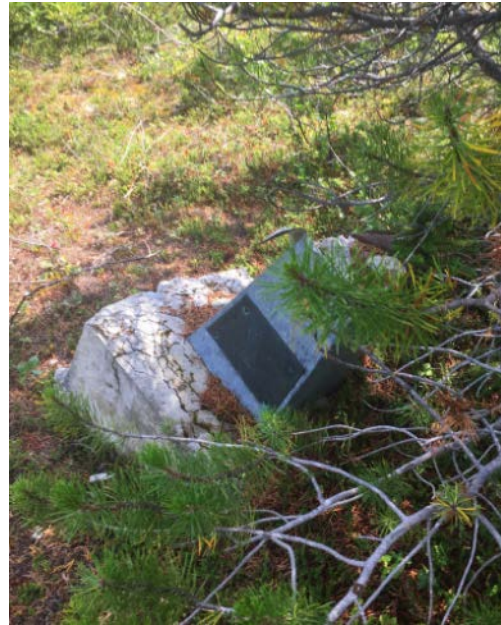
Monument 29S was found in poor condition with both the monolith and base deteriorating and the entire structure off-level due to nearby roots. Upon further inspection, all concrete easily broke off and the removal of the monolith caused further deterioration of the concrete base. There are no visible cutlines in either direction.

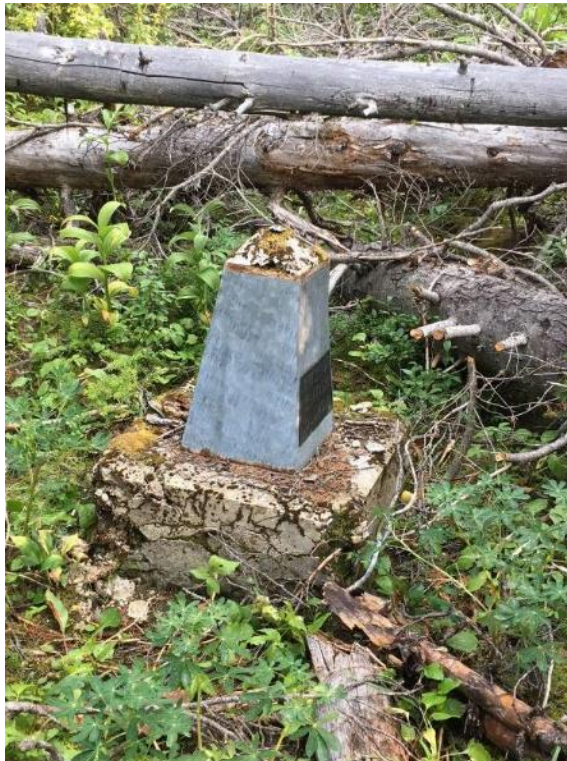
Monument 30S was found in poor condition with both the monolith and base deteriorating. The pillar top was missing but the datum point was still in place. Upon further inspection, all concrete easily broke off and the removal of the monolith caused further deterioration of the concrete base. There is a hint of a cutline to 28S and a clear line of sight to the assumed position of 32S.

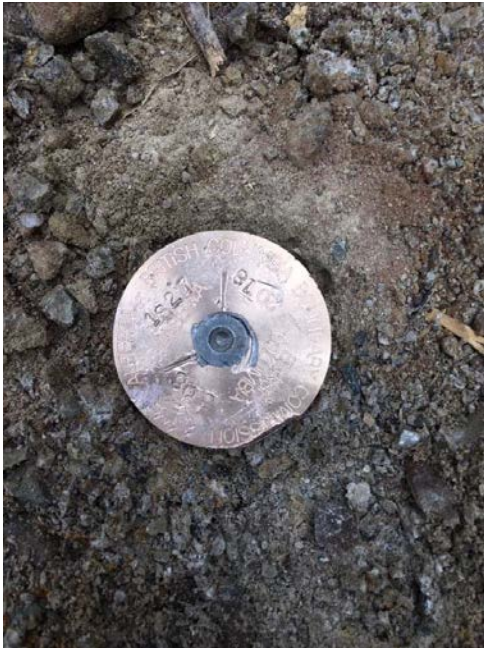
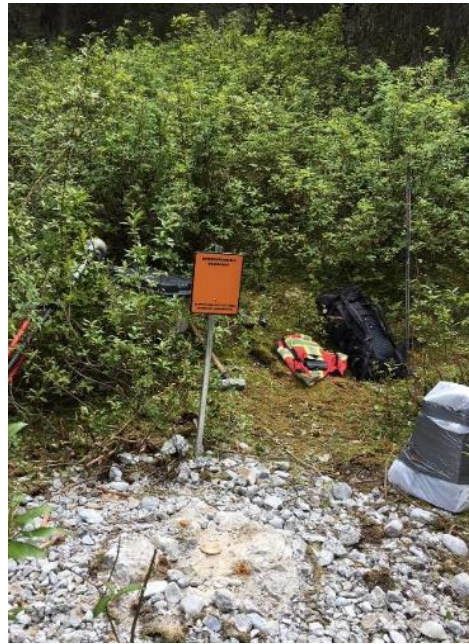
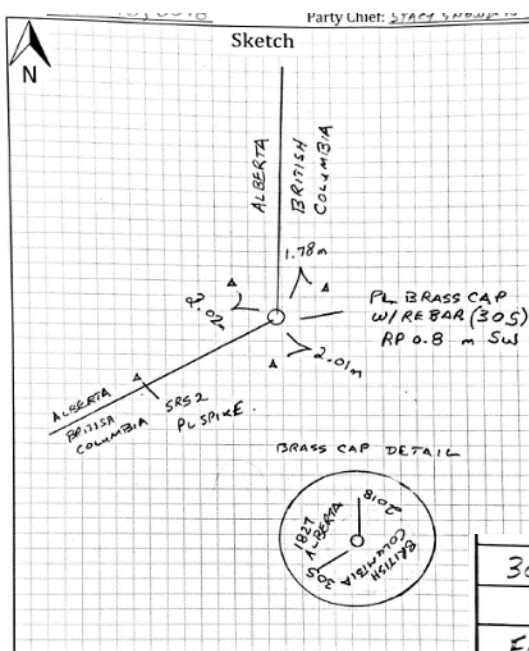
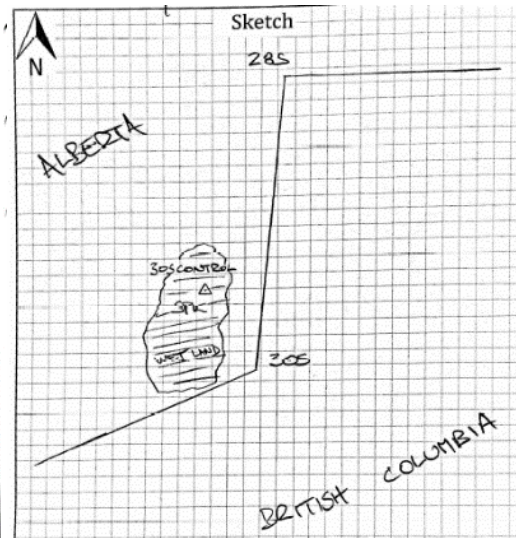
30S MONUMENT RESTORATION	
FOUND MONUMENT W/ BASE IN POOR CONDITION. SET SPIKES OFF OF MONUMENT AS PER SKETCH ON PG 4. REMOVED MONUMENT AND BASE. SET BRASS CAP W/ REBAR USING THE REFERENCE SPIKES. PHOTOS ATTACHED W/ TODAY'S DATA.

Reference spikes were placed around the datum point in order to restore the centre of the monument upon demolition. The entire monument was then demolished to ground level and a standard capped post was drilled in the existing concrete. A reference post was placed 0.8m southwest. Control was set in the nearby field in case the static GNSS observation did not process to within the allowable tolerances; however, upon post-processing, a long static GNSS observation on 30S resulted in acceptable tolerances as per the project specifications.

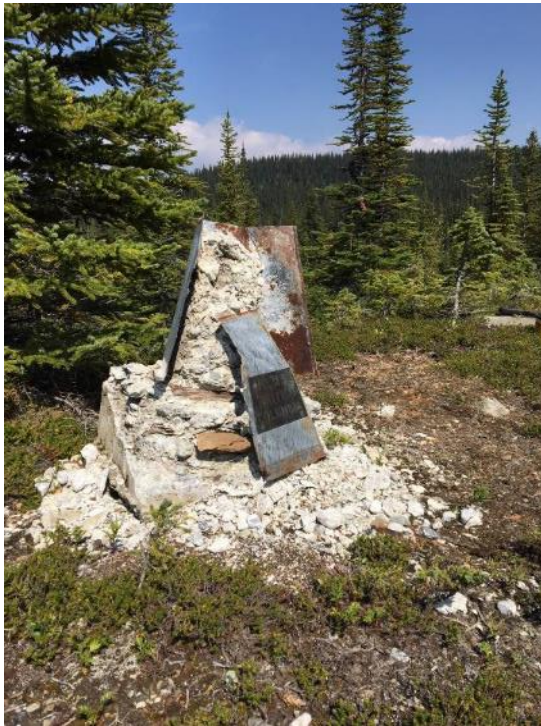
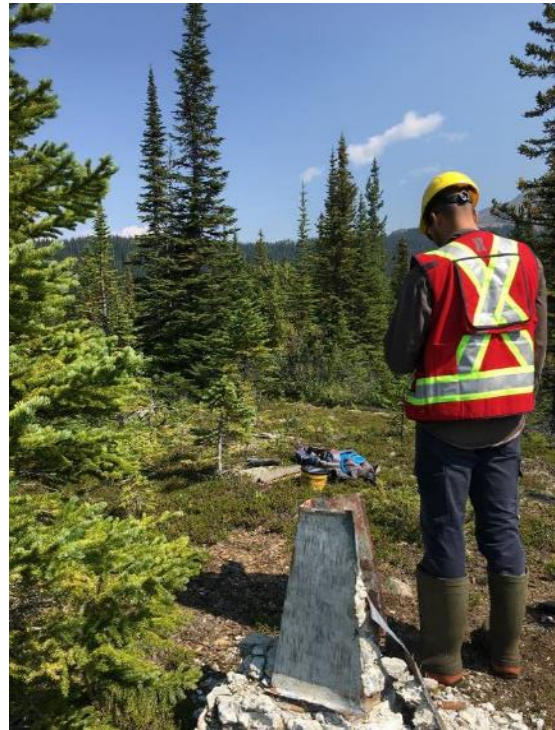
Monument 31S was found in poor condition with both the monolith and base deteriorating. The entire monument was crumbling and the original centre was difficult to locate. Upon further inspection, all concrete easily broke off and the removal of the monolith caused further deterioration of the concrete base. There is a visible cutline to the hill where 33S stands on but nothing visible to 29S.

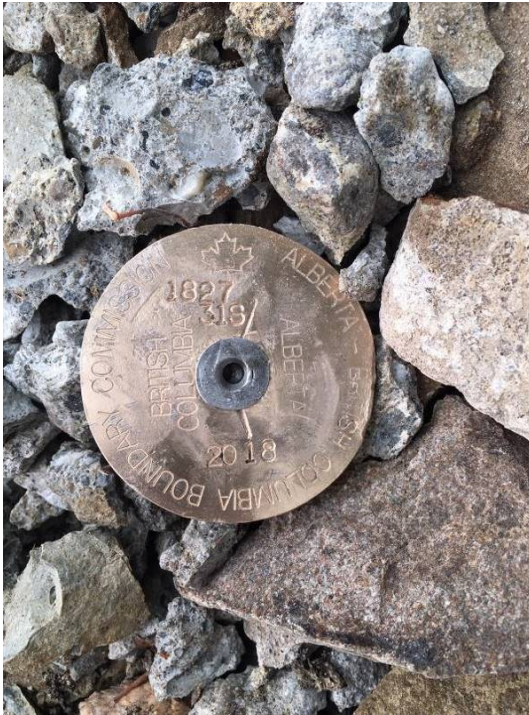
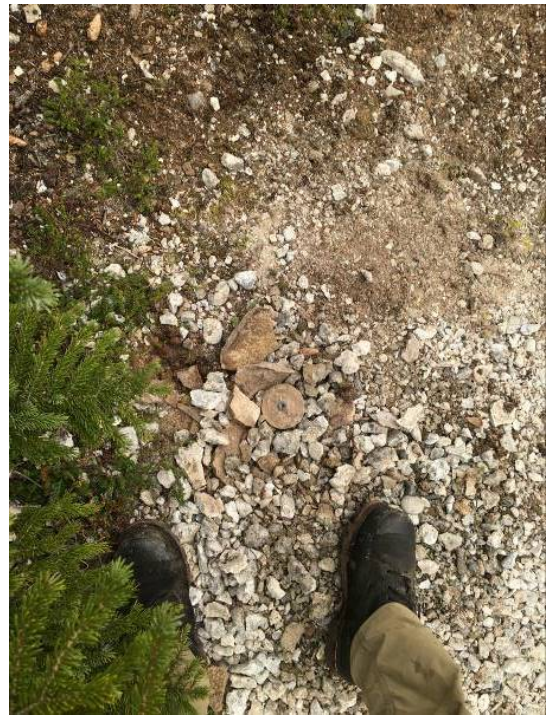
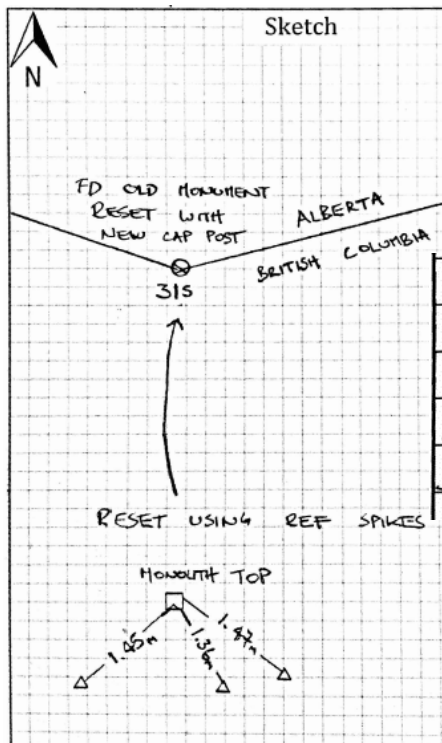
315			
FOUND OLD MONUMENT MONOLITH & BASE DETERIORATING,			
REESTABLISHED CENTRE WITH REMAINING MONOLITH.			
SET 3 SPIKES FOR REFERENCE, REFER TO			
SKETCH. SET CAPPED POST FROM SPIKES.

Reference spikes were placed around the four corners of the concrete base in order to restore the centre of the monument upon demolition. The entire monument was then demolished to ground level and a standard capped post was drilled in the existing concrete. A reference post was placed nearby. Monument 31S was surveyed using static GNSS methods.

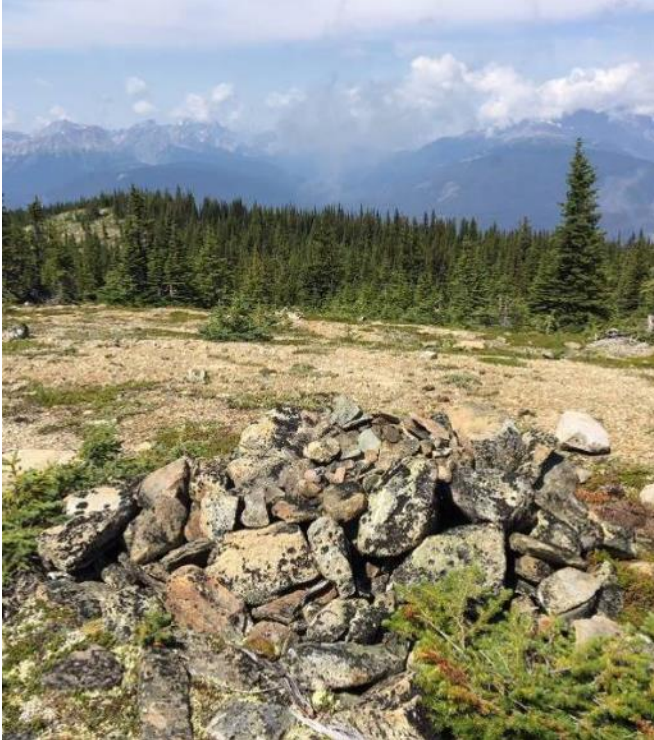
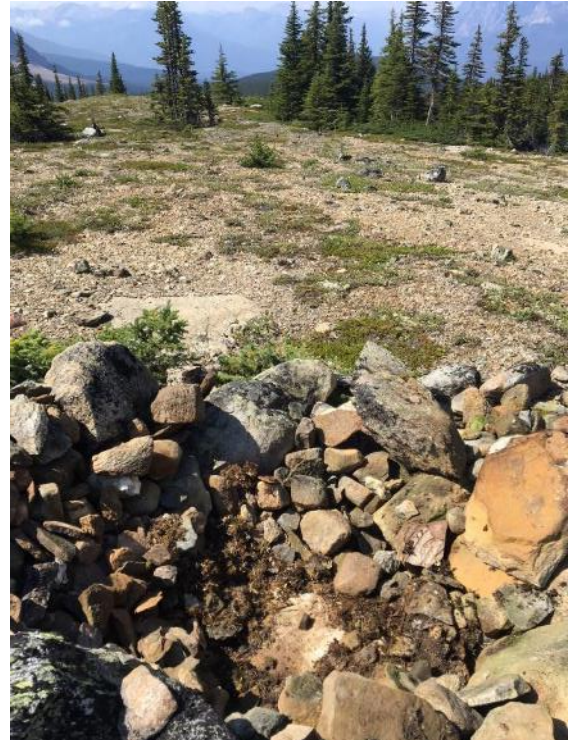
The rock cairn on top of 33S was prominent, although slightly toppled over. Once the rock cairn was carefully dissembled, the brass bolt in concrete was obvious and it was in excellent condition. There was a visible cutline to 31S and a clear line of sight to the top of Miette Hill.

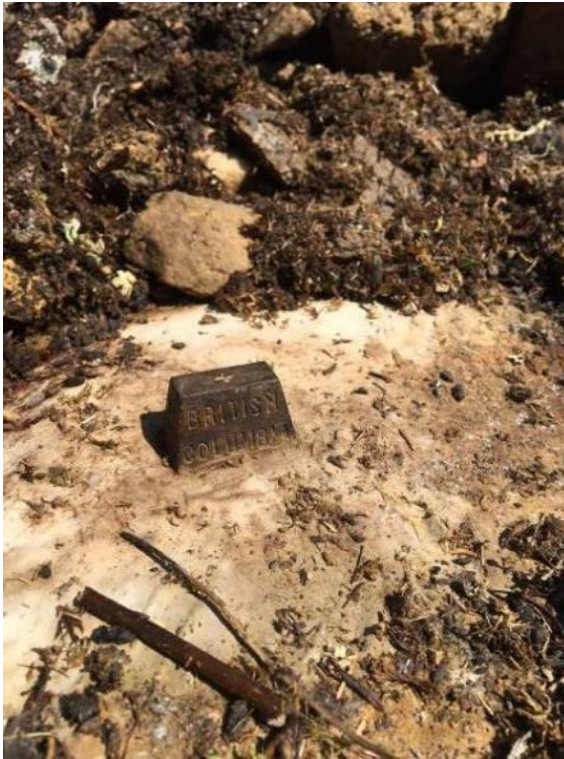
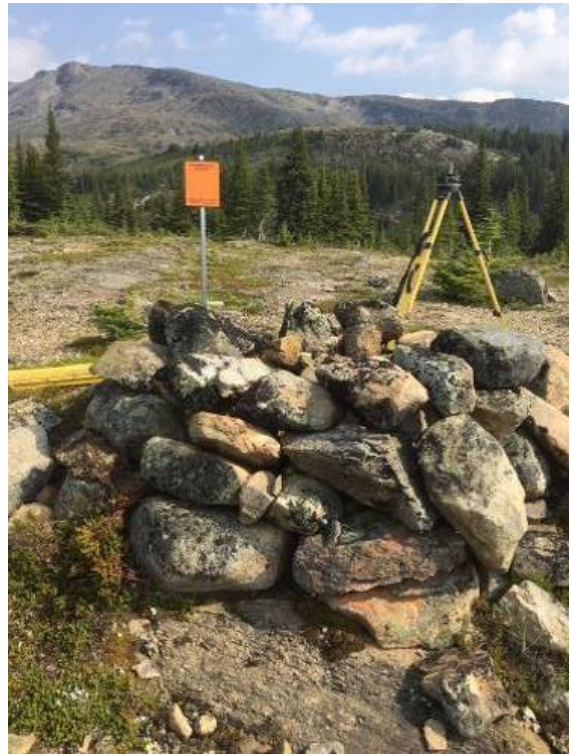
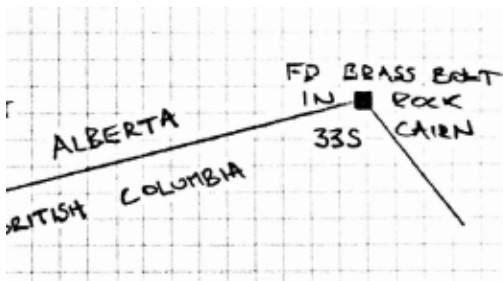
33S			
FOUND	OLD	STONE CAIRN. REMOVED ROCKS	
# FOUND	OLD BRASS BOLT MARKED	"NO 33S,	
		BRITISH COLUMBIA (SOUTH) & ALBERTA (NORTH).	
LOGGED	STATIC	@ 33S OLD BRASS BOLT	
		START TIME: 12:47	
		STOP TIME: 15:17	
		HT: 1.471m

The existing brass bolt was measured using static GNSS. A reference post was placed nearby and the rock cairn was rebuilt once the static occupation was complete.
